REMOTE SURVEY OF TRADITIONAL DWELLINGS USING ADVANCED PHOTOGRAMMETRY INTEGRATED WITH ARCHIVAL DATA: THE CASE OF LISBON

S. Stellacci¹, F. Condorelli^{2*}

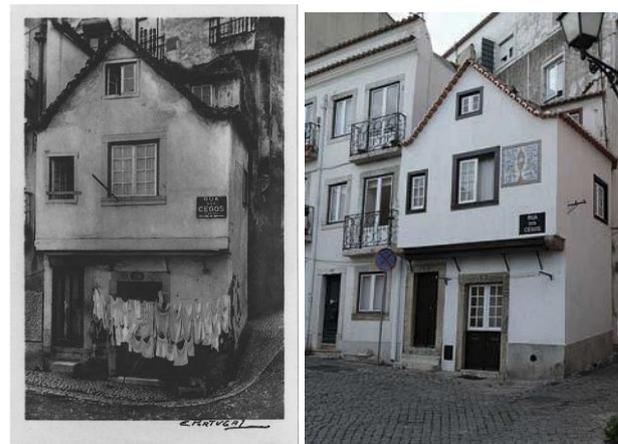
Figure 2. Main façade of case study No.1, *Rua dos Cegos* no.20, Lisbon: (left) in 1940s (Passos, 1997) vs (right) in 2020s.

Among this group, two case studies are analysed in this work. Both are multifamily traditional residential dwellings in a traditional parish in Lisbon. Case study No.1, listed as protected building, has a single overhang on two floors (Figure 1 and Figure 2). Case study No.2, currently a tourism accommodation, has a bilateral overhanging structure on three storeys (Figure 3, Figure 4, and Figure 5).

In this research, it is shown the importance of integrating multi-sourced data for a 3D remote reconstruction of historical buildings, which have suffered numerous changes, e.g., after intrusive rehabilitation works or as a result of emerging cultural paradigm of modern life. In the selected case studies, comparing the historic photographs and the current state (Figure 2, Figure 4, Figure 5), we note that the number of floors, the external wall

In case study No.1, when comparing the archival images of the building at the turn of 20th century, its main distinctive features remain unchanged, i.e., the overall building configuration, the opening layout, and the surface finishing (high chromatic compatibility of the restored building with the original). Significantly, one visible alteration in the external façade regards the ceramic tile, dating back to 1930. A polychrome piece representing the Blessed Sacrament with two cherubs and an iron element to support the lighting system were placed in the main façade.

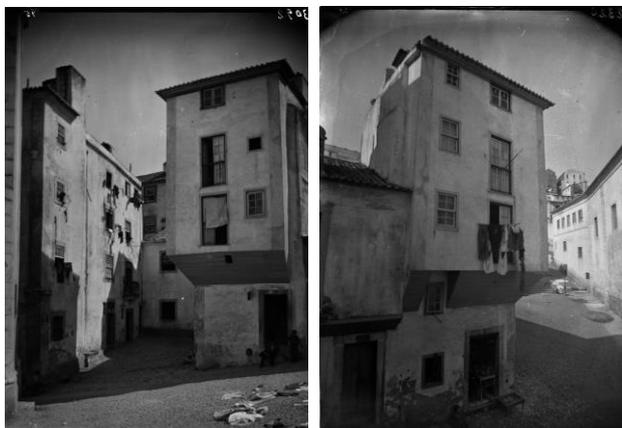
Figure 4. Archival photos of traditional overhanging dwelling in *Beco de São Miguel* no.17, Lisbon (1889-1908).

In case study No. 2, only three images of the main building façades facing the small square *São Miguel* are available in the historic archive. These documents, part of *Fundo Antigo*, was photographed by unidentified author (1889-1908) (Figure 4). After 1930s, Alberto Carlos Lima also framed a high-detailed part of timber balcony (Islamic *muxarabi* or *mashrabiya*) of the upper floor of the main façade (*i.e.*, the upper floor, Figure 5).

In case study No.2, high intrusive rehabilitation works occurred in 1940s under the Salazar dictatorship. As regards the aesthetic form, these works epitomize the reconstruction of an imaginary vernacular architecture during the *Estado Novo* (New State). The comparison between historical photographs and the current state (Figure 5) shows the loss of original architectural elements, such as non-compatible plaster in composition and colour, the removal of the timber boards covering the double overhangs, as well as the introduction of projecting oriel window with carved wood, following the Islamic tradition (*muxarabi*). Indeed, this architectural element was used in the Middle Ages in Lisbon, and it is still visible in other buildings (e.g., in *Rua Benfornoso* no.101-103, Lisbon). Resulting from the low importance of preserving integrity and structural authenticity, the external timber-frame walls on the upper floors were replaced by a reinforced concrete structure, hollow bricks, and cement mortar in 1940s, as proven by consulting the building dossier in the municipal archive (Stellacci et al., 2016).

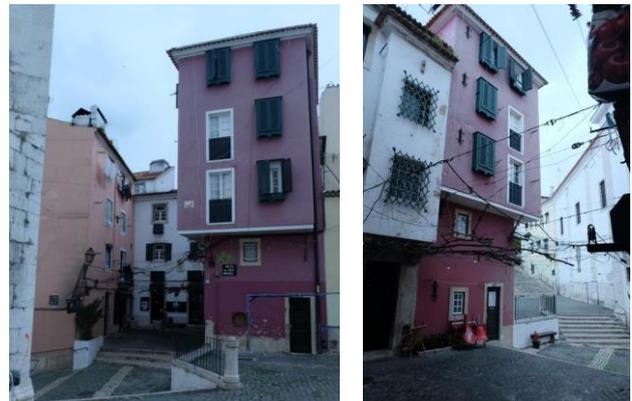
Figure 5. Current state of traditional overhanging dwelling in *Beco de São Miguel* no.17, Lisbon

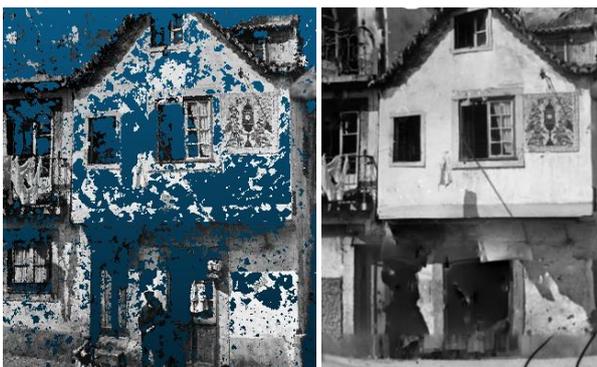
Figure 10. 3D photogrammetric reconstruction of case study No.1, using archival photograph taken by unidentified author (n.d.).

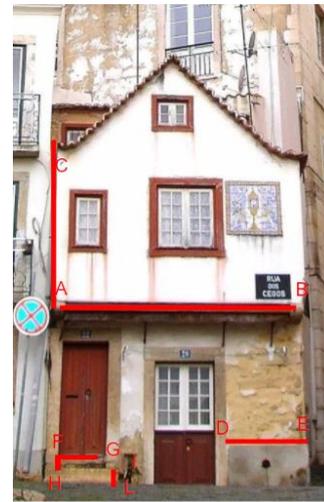
Figure 11. Case study No.1: Measurements from on-site survey used for model scaling the model (DE) and metric comparison.

As result of the matching, a point cloud is obtained (Figure 9). Although being sparse, it includes the points used for the metric evaluation. A known distance was used for scaling the model (shown in Table 1). Table 1 shows the comparison between the distances measured in the sparse point cloud, obtained from the previous step of the workflow (the SfM pipeline), and the same distances measured on the current building (Figure 10), during an on-site survey. Common points are analysed to evaluate the accuracy of the 3D virtual building model.

Distance [m]	Point Cloud [m]	Metric survey [m]	Residuals [m]
DE	1.3	1.3	0
FG	0.9	0.8	0.1
FH	0.1	0.1	0.0
AB	4.3	4.2	0.1
AC	2.7	2.6	0.1
IL	0.2	0.2	0.0

Results show minor differences, which can be neglectable from metric reconstruction. However, the comparison was on the common point between pre- and post- the rehabilitations work.

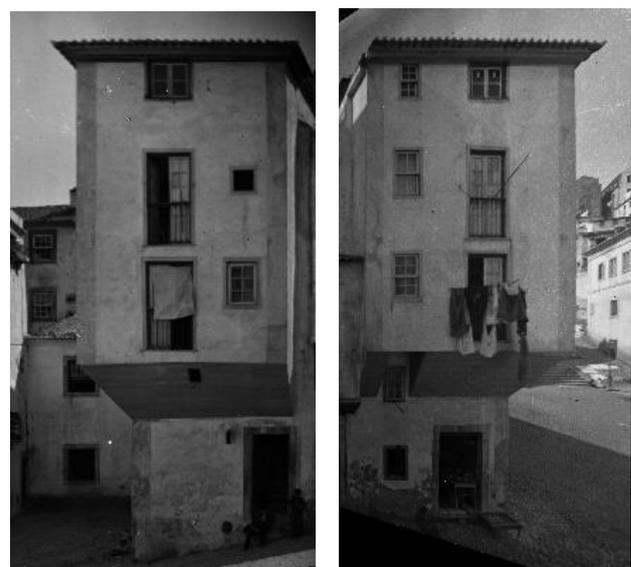
Figure 12. Case study No.2: Rectification of the main building façades of using archival photograph taken by unidentified author (1889-1908).

Figure 12 shows the rectified building façades of case study No.2, using an archival photograph (1889-1908).

The metric evaluation was performed comparing the same measure distance of these rectified images and the design projects, using the municipal building dossier (AML, Dossier no. 21582)(Figure 12 and Figure 13).

Distance [m]	Rectified Image [m]	Design Project [m]	Residuals [m]
AB	5.5	5.6	-0.1
BE	4.1	4.2	-0.1
FG	3.4	3.5	-0.1
CD	0.8	0.9	-0.1
CH	1.8	1.7	0.1
PQ	0.9	0.9	0.0
OL	3.9	3.8	0.1
MN	3.0	3.0	0.0
IL	5.7	5.6	0.1
