## THE ‘MASSERIA ROTA’ IN NAPLES (ITALY). A VERNACULAR HERITAGE TO PRESERVE

R. Amore<sup>1</sup>, L. Veronese<sup>1,\*</sup>

**KEY WORDS:** Vernacular architecture, Restoration, Naples, Masseria Rota, Cercola

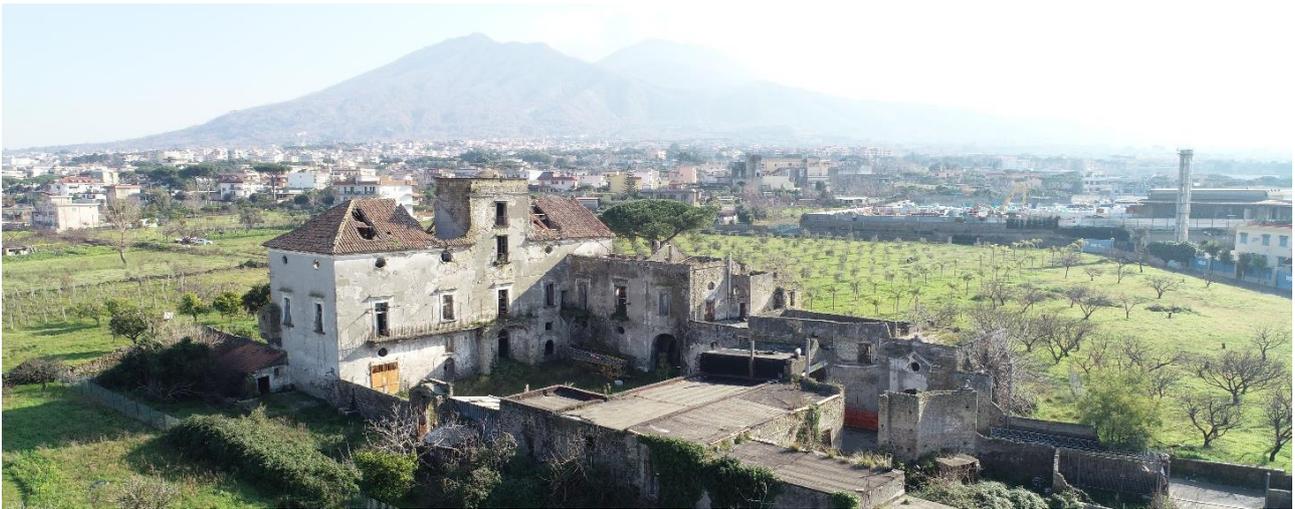
Figure 1. An aerial view of Masseria Rota. (Marco Facchini, M\_Lab, Department of Architecture, Naples, 2020).

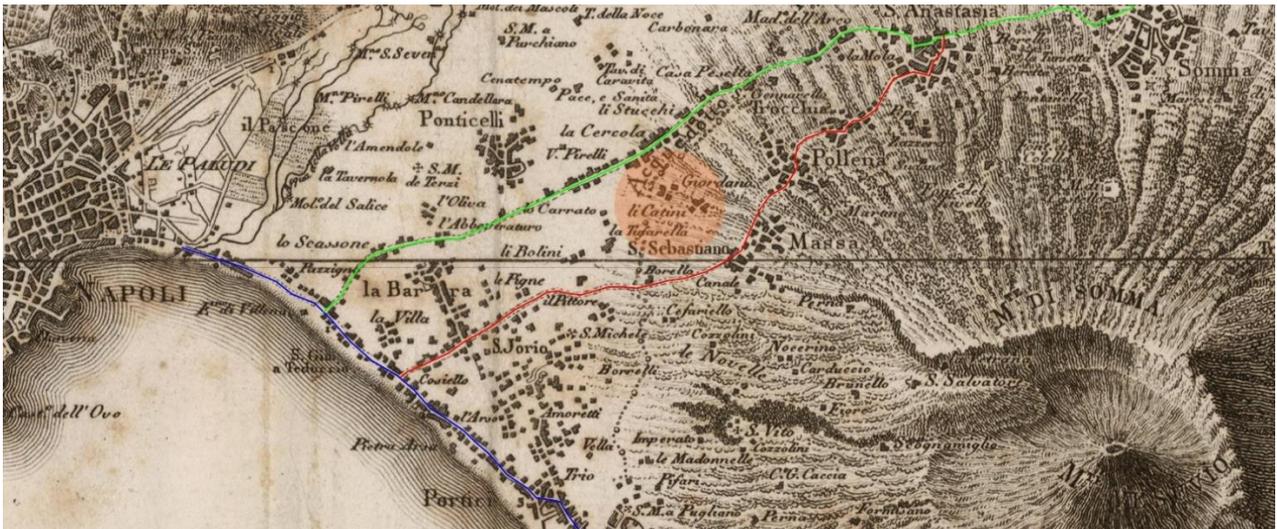
Figure 2. *Atlante geografico del Regno di Napoli delineato per ordine di Ferdinando IV re delle Due Sicilie & C. & C. da Gio. Antonio Rizzi-Zannoni geografo di Sua Maestà e terminato nel 1808.* Naples, s.n., 1788-1812, detail of the paper 14.

On sheet 14 of the *Atlante geografico del Regno di Napoli* of Rizzi Zannoni is represented - passed the area of Piazza Mercato in Naples - the route of the 'Antica Strada per le Calabrie' (in blue in Figure 2), which crosses the ancient village of San Giovanni a Teduccio, Portici and Resina, continuing towards Torre del Greco. Perpendicular to this route, immediately before and after the urban conglomerate of San Giovanni a Teduccio, two roads set off, climbing - more or less parallel - towards the slopes of Vesuvius, to be reunited in the village of St. Anastasia. The first road (in green in Figure 2) crossed the villages of Barra and Ponticelli, first, and Cercola, then; second street (in red in Figure 2) passed the village of St. Jorio (now San Giorgio a Cremano), directed towards the towns of San Sebastiano, Massa and Pollena. The entire area is dotted with farms belonging to noble families: near 'la Tufarella' are represented two groups of three building volumes, which could correspond to those of the Casa del Rota' and the 'Casino Figliola'. These farms are laboriously documented in sheet 14 of *Mappa topografica della città di Napoli e de' suoi contorni di Giovanni Carafa duca di Noja e*

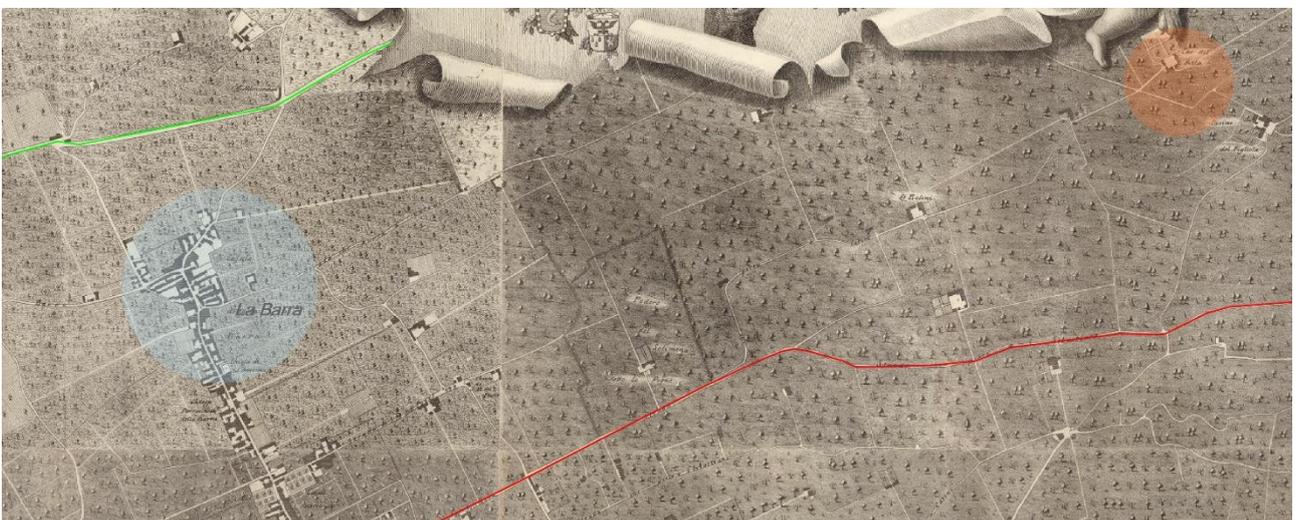
Figure 3. *Mappa topografica della città di Napoli e de' suoi contorni di Giovanni Carafa duca di Noja e Niccolò Carletti, published in the 1775, details of paper 14.*

The plan (35 papers), began in 1750 and ended 25 years later, constitutes a fundamental iconographic document, not only for the description of the city, but also for the use of the most up-to-date methods of the eighteenth-century topographical science. For the first time Naples is represented with its vast suburban territories that go from Resina to Poggioreale in the north, and Bagnoli and Nisida in the east. The long legend of 580 entries enriches the informations.

*Niccolò Carletti, pubblicata nel 1775.* In this map, in which the system of interpoderal roads at the service of the different farms is well delineated, the 'Casale' is represented in a very precise way. During the Nineteenth century, following also the Vesuvian eruptions in 1855 and 1868, which destroyed the city center of Massa, the entire area upstream 'Masseria Rota' underwent important transformations, concerning the creation of new road axes and the development of the newborn municipality of Cercola. Identically, even the downstream area, close to 'Antica

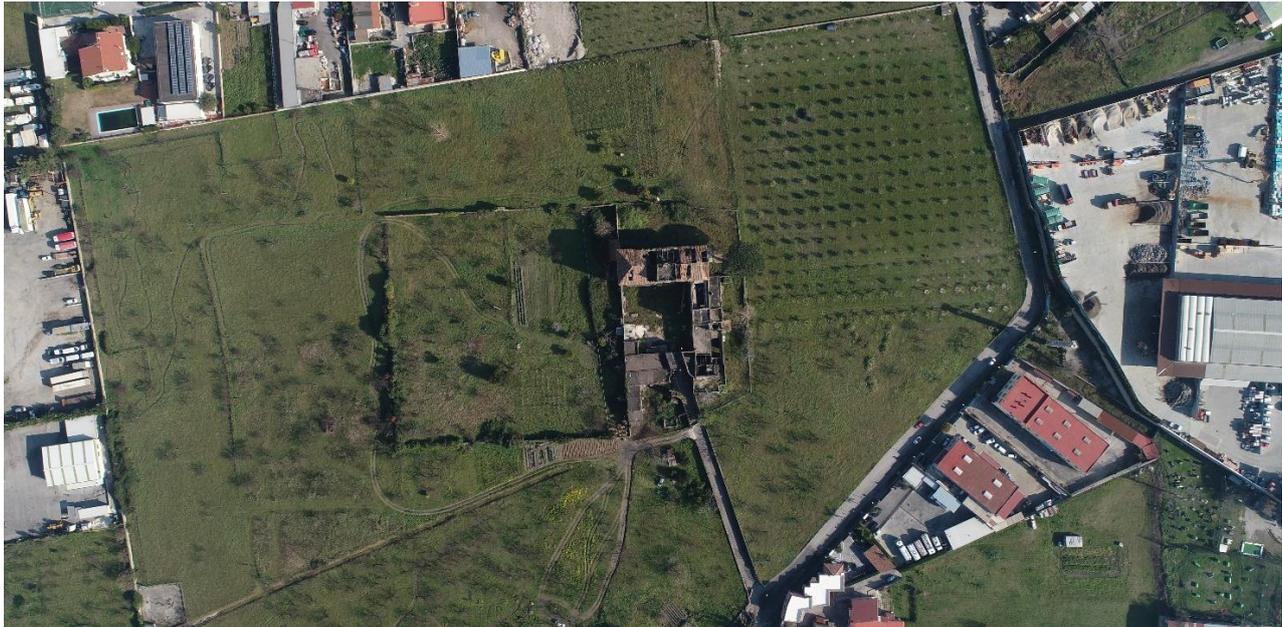
Figure 4. An aerial view of 'Masseria Rota' (M. Facchini, 2020).

The central rectangular courtyard was accessed from two entrances: the first was located to the south-west, and was placed at the end of a road that branched off from the road coming from Naples, whose axis does not coincide with the facade, determining an atypical misalignment between the entrance direction and the facade of the entrance building; the other, on the side facade facing south-east, was instead served by a path that led to the farmland. It should be immediately pointed out that the position of the villa does not coincide with any of the road axes represented in the aforementioned map of the Duca di Noja, and therefore it is conceivable that the access road on the south-west front was built in conjunction with the eighteenth-century restructuring: this it is also supported by the compositional expedient adopted for the reconfiguration of this front, i.e. that of creating an entrance exedra and a hallway with a crooked geometry, useful for prospectively directing those who accessed the *masseria* from that entrance towards the center of the building placed to close the courtyard on the opposite side, intended for residence. The small church dedicated to the Immaculate Conception develops sideways to the exedra, with the entrance rotated 90 degrees with respect to the access to the villa. It constitutes the head of the building facing south-east, whose

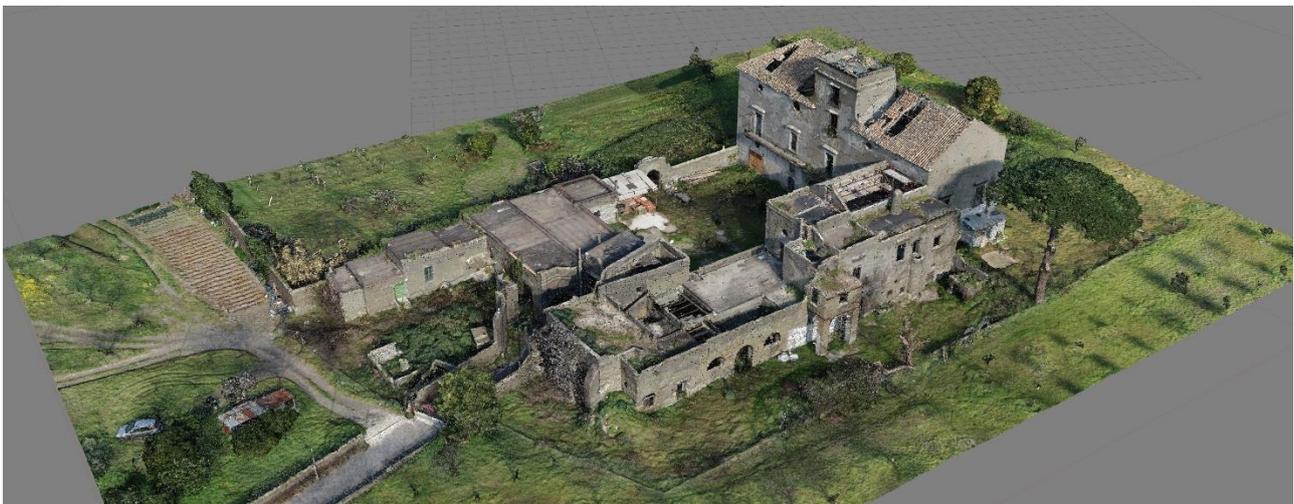
Figure 5. Image of 3D survey obtained by photomodeling being processed (M. Facchini, 2020).

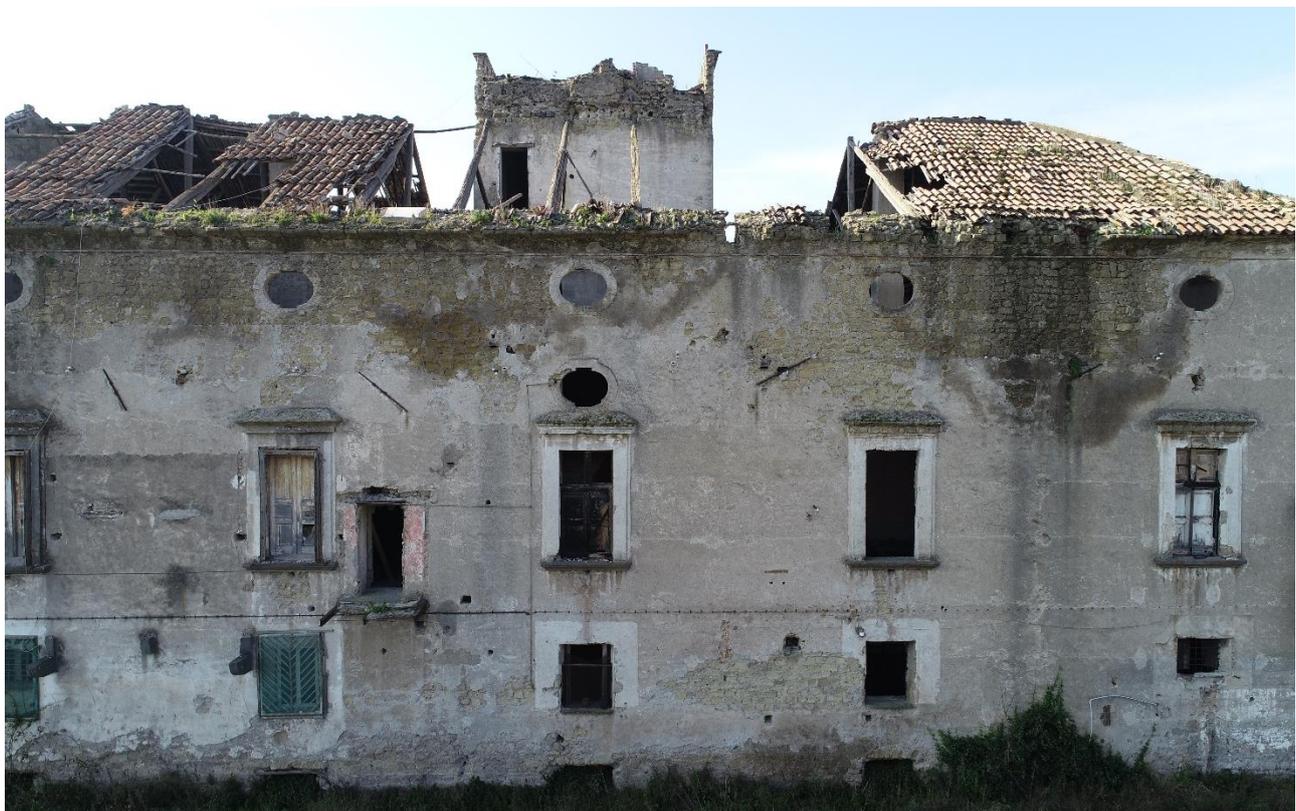
Figure 7. The facade facing Vesuvius (M. Facchini, 2020).

stratigraphic reading is more complex. It certainly represents the oldest part of the factory, and the one that has undergone the greatest transformations. Today it consists of a double row of rooms, partly covered with vaults and better preserved, partly with wooden floors, almost all collapsed or in a poor state of conservation. The study and analysis of the masonry completed leads us to believe that the more external environments, which today configure the facade towards the outside of the aforementioned building, were built later than the internal ones and have been remodeled several times also in recent times. Therefore, originally this building was made up of a single series of volumes, highly altimetrically articulated.

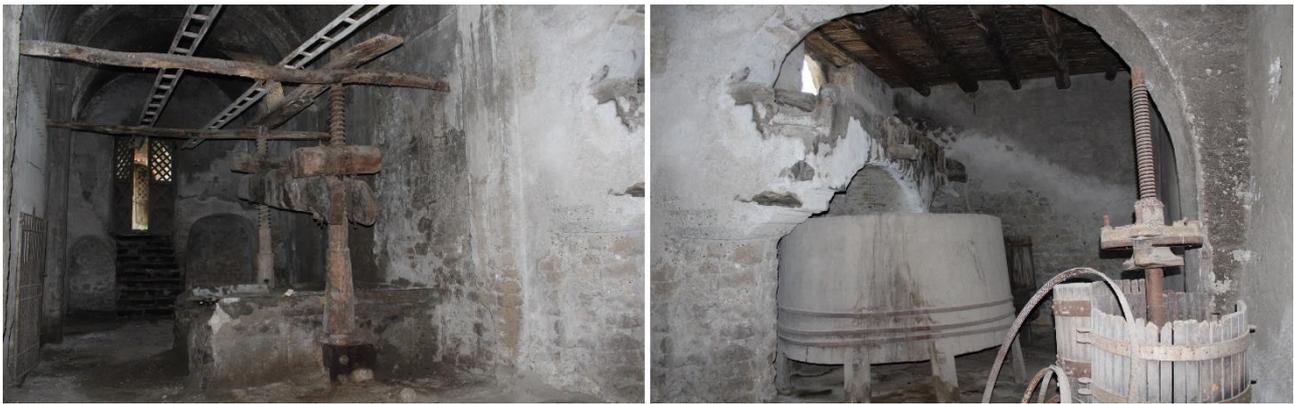
Figure 8. The cellar with the ancient machinery for squeezing grapes.

In the center of the building was the entrance hall which allowed access to the courtyard; to its left, there were three or four one-level rooms intended for storage. On the other side, however, with access from the entrance hall, there are the cellars, at about 2.50 ml, below the level of the courtyard. It comes from the oldest and most fascinating rooms of the villa, intended for the processing and aging of wine. Going down a ramp of about twenty steps, a covered area with a barrel vault, marked between arches, was used for the pressing of the grapes. On the left, in fact, there is a large two-screw wooden press connected through stone canals to two thyme places in a neighboring room where the wine produced was stored, before transferring it to the barrels

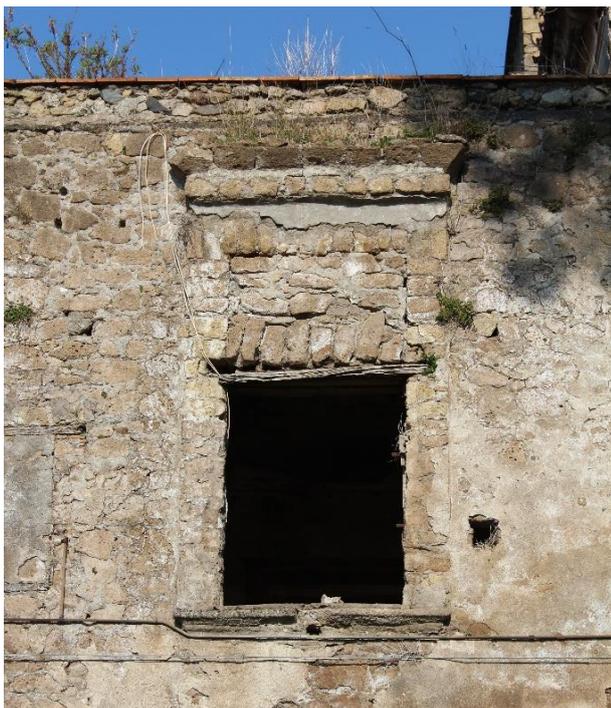
Figure 9. Detail of the south-east.

for seasoning. From an opening at the bottom of this room another room, always covered with a vault, intended for the storage of the barrels. This environment, which develops perpendicularly to the first, is part of the third building block that closes the 'U' shape of the building on the north-east front. This last block has different levels: a ground floor with rooms used as deposits, accessible from the courtyard, a mezzanine floor, reached by climbing the external staircase in Vesuvian stone blocks, the first floor, the real home, served by an elegant staircase at three rampant which starts from the entrance hall and, finally, the attic, also used for the shelter of agricultural products, with access from a stairwell placed behind the main staircase. The first floor used as a residence consists of multiple rooms, some of which still bear the signs of 'wrapped' on the intrados of the wooden floors, subsequently covered by decorated false ceilings, some of which have been lost. The articulation of the elevations reflects the different intended use of the buildings: the only building block intended for residence has finely decorated frames and protrusions, elliptical openings of the seventeenth and eighteenth-century mold and a characteristic jutting brick structure, similar to a sentry box, at the right end of the north-east elevation. The elevations along the south-east and south-west sides more denounce the functional character of the complex and do not have decorations or ornaments.

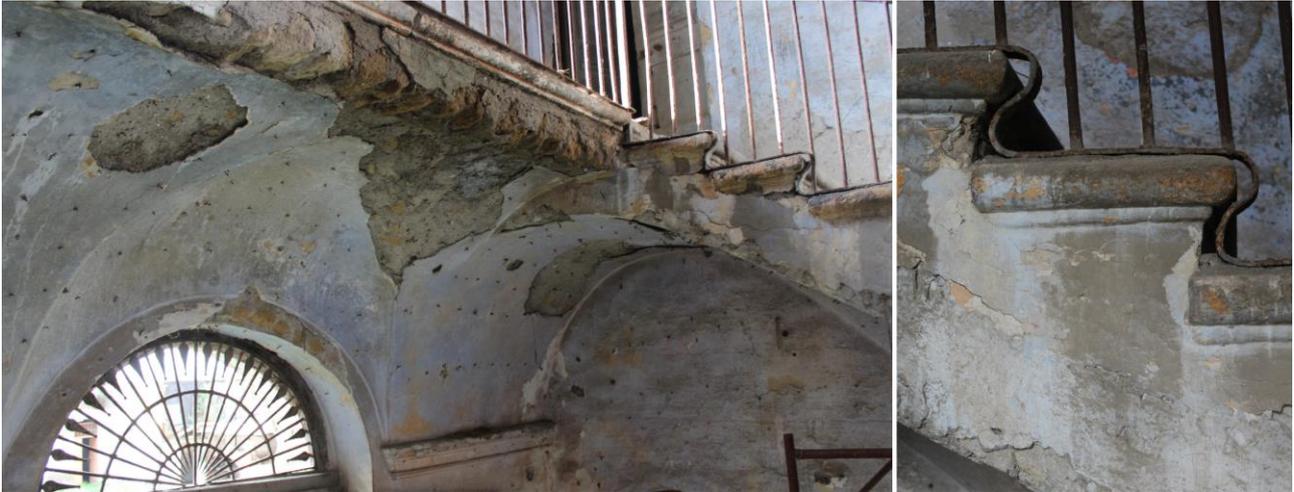
Figure 10. Details of the access staircase to the main floor.

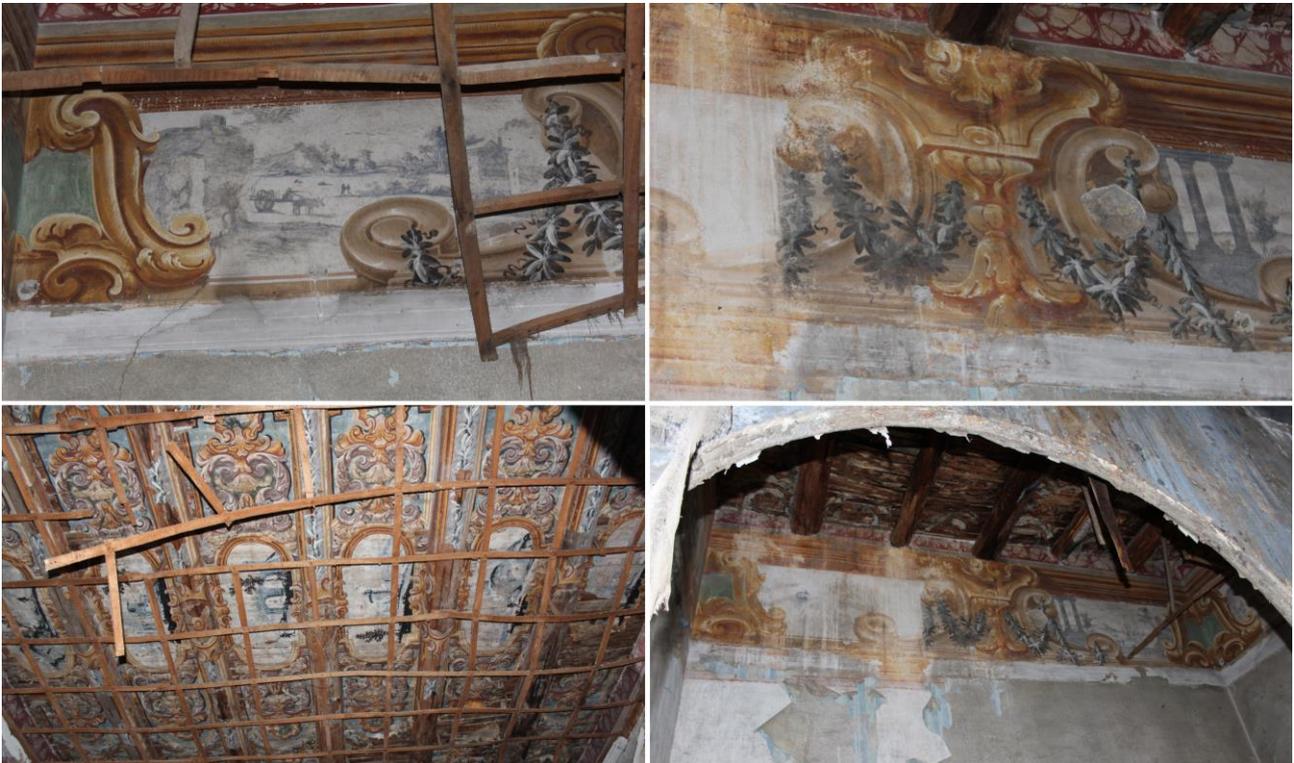
Figure 11. Details of the 18th-century parietal decorations and 'incartate' that covered the wooden floors of the main floor, later covered by ceilings as part of 19th-century modernization.
