EARTHEN ARCHITECTURE – VALORISATION AND UNDERESTIMATION

KEY WORDS: Earthen architecture, earth construction, sustainability, conservation, preservation, maintenance.

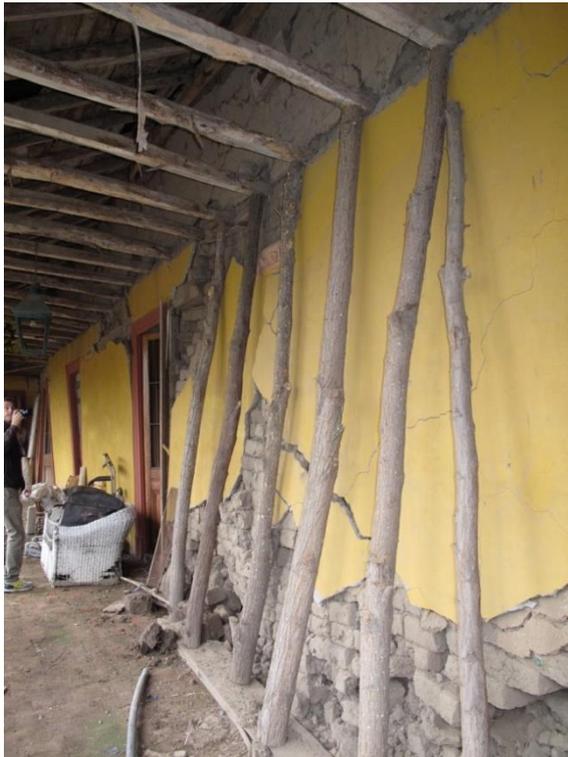
Figure 2. 2010 Chile Earthquake.

In **Chile**, the earthquake of February 27, 2010 damaged a large part of the country's raw earth architecture. "Virtually thirty percent of the buildings declared under the National Monuments Law built in adobe block or some system containing earth was damaged" (Sánchez, 2012).

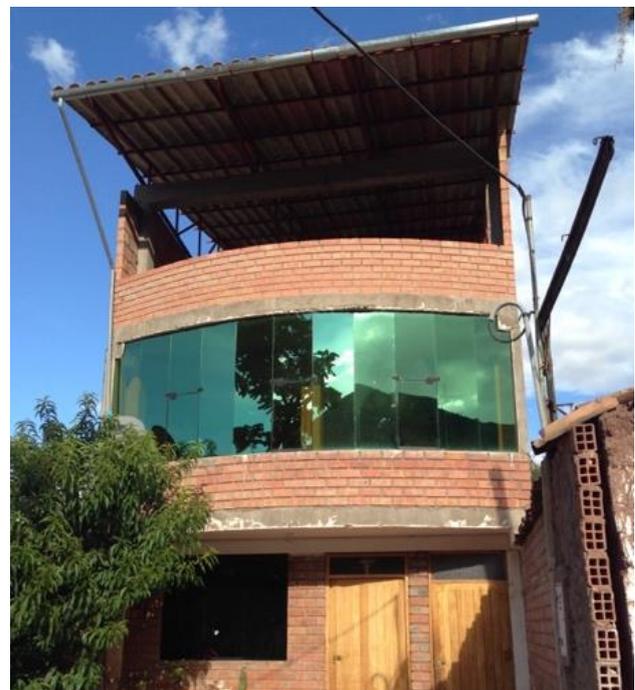
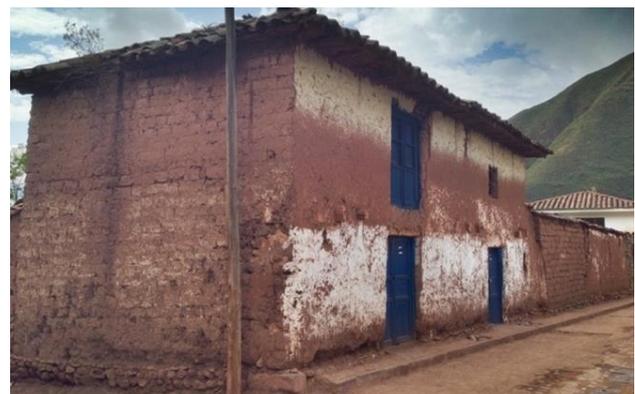
Figure 4. Houses in Cusco, Peru.

In several examples mentioned before, we saw that many of the collapses caused by seismic movements occurred in homes or monuments that had not received proper maintenance. The accumulating effect of earthquakes requires constant maintenance, otherwise, it eventually results in partial or total collapse. As I mentioned earlier, earthen constructions can offer a habitat for insects and invasive vegetation but only when they are riddled with cracks and holes. A well-preserved adobe or tapial wall can be as much or more sanitary than a concrete or brick wall.

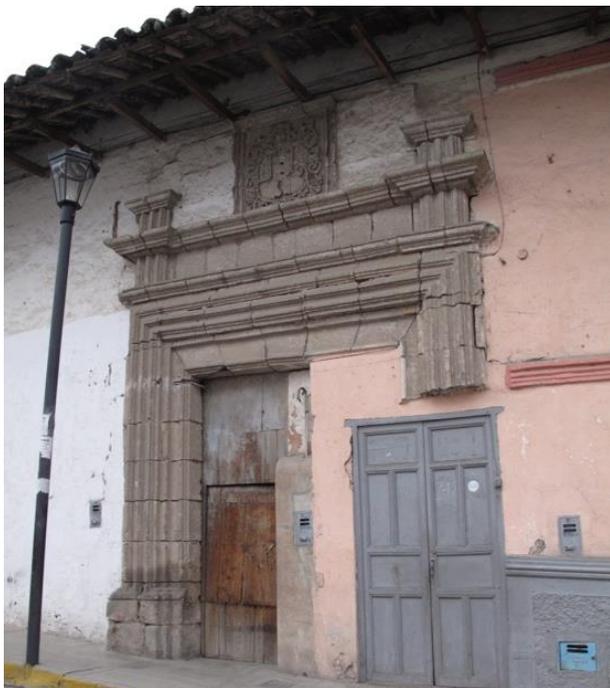
Figure 5. Inappropriate interventions.

The most common intervention is the replacement of mud plaster with a cement one, especially in the lower parts of the walls where the wall is most exposed to use. This obviously creates an impermeable layer that traps the moisture rising by capillarity, causes the accelerated deterioration of the mud wall and eventually, when the cement coat falls due to lack of adhesion, it drags with it parts of the original wall.

The introduction of openings and additions of incompatible materials that cause detachment and separation, or “hammering” during earthquakes, contribute to the loss of the structural unit of the construction.

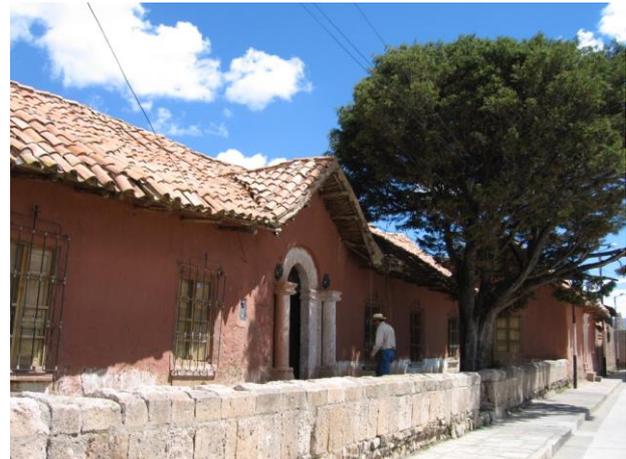
Figure 6. Lampa, Puno.

An interesting example of community maintenance occurs in Lampa, Puno, one of the most beautiful and best-preserved historical cities in Peru, known as the “pink city.” Lampa’s stone and adobe constructions are regularly painted by neighbors or the Municipality using a type of clay known as *chocorosí*, which is obtained from nearby hills. However, this habit of repainting with natural pigments is gradually being replaced by the use of plastic paints.
