## OLD RAUMA (FINLAND): LIVING AND RESEARCHING VERNACULAR ARCHITECTURE

M. Caruso<sup>1,\*</sup>, L. García-Soriano<sup>1</sup>

<sup>1</sup> Universitat Politècnica de València, Valencia, Spain - maticaru@gmail.com, ligarso@upv.es

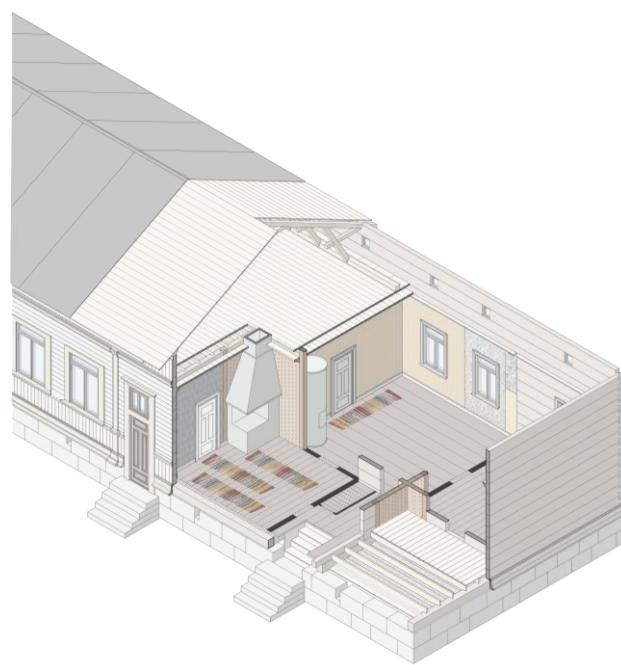
Figure 1. Axonometric section of Tammela's early XX configuration (digital drawing by the author, 2019).

An important amount of architectural and constructive data has been collected during the stay at Tammela and the visit to Toivo, thank to the possibility of directly observe the buildings structure. In there, architectonical components were studied not only through the archaeological windows, which are present in both centres, but also by the direct exploration of the attics and cellars of Tammela. The accessibility of Tammela led to take the building as a reference for the virtual representation of Nordic traditional wooden house (Figure 1).

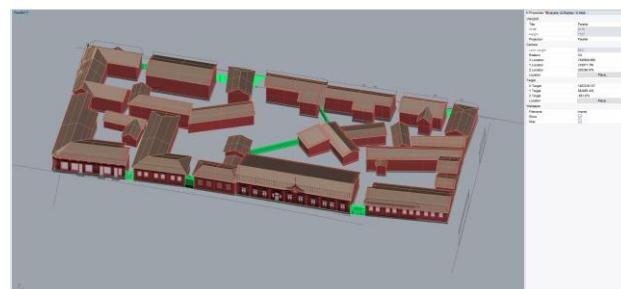
Figure 2. Virtual 3D modelling of Mairela House's block.

Once the 2Ds were ready and verified, 3D virtual modelling was started (Figure 2). The virtual representation was drafted during the stay, in order to check it with local experts. The final form has mostly been carried out after the second phase, during November and December. The data were converted into 2D CAD drawings that were later used as base in the 3D modelling process.

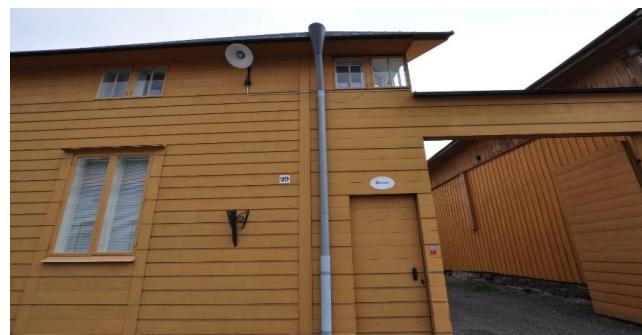
Figure 4. Modern house in Old Rauma (photograph by the author, 2019).

During the 20th century, the World heritage site has been jeopardized by massive architectural transformations, through the building of new modern constructions not compatible at all with the ancient town. This trend started on the first decades of this period, with the construction of buildings like the Hotel in Kalatori. During the following years, it multiplied through new edifications, although it never really brought to the complete disfiguration of Old Rauma: in fact, many of the new buildings remained isolated episodes or they were realized in most marginal parts of the town. Besides, the latest new constructions, that have presumably been built during the last 30 years, appear more accorded to the traditional architecture, attempting to follow its size and composition (Figure 4).

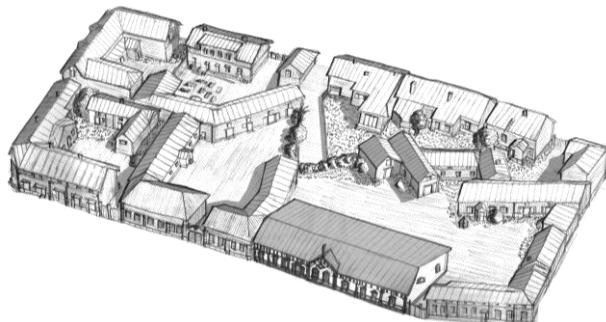
Figure 5. Sketch of a block (drawing by the author, 2019).

Blocks have mostly irregular rectangular shapes, whose perimeter is usually delimited by the linear volumes of the main buildings. The access to the internal yard could be open or marked by a gate, while sometimes fences are used to delimitate the edge. Storage or small secondary constructions are usually located inside the patios, often used, nowadays, as gardens (Raitio, Tammi, 2018) (Figure 5).

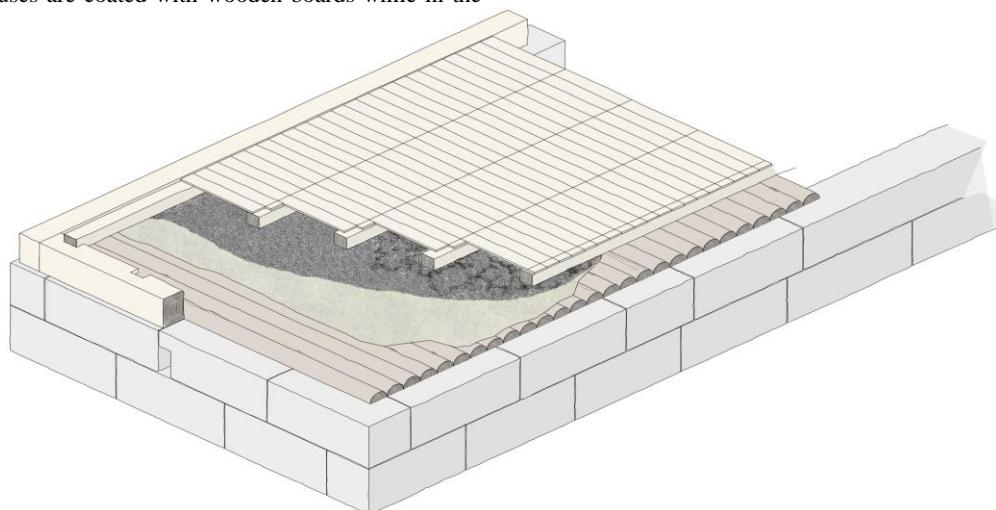
Figure 6. One of the most diffused wooden slab systems: in this case half logs are used as inferior closing surface (digital drawing by the author, 2019).

The base is composed by stone walls, that constitute the building foundations by growing thicker into the ground. The walls top, that lifts up from the terrain, forms the cellar volume which is also the base where the foundation beam of the upper parts rests. This beam also sustains the slab, a sandwich system whose structure is made of a monodirectional wrapping of wooden beams. A layer of wooden boards closes both the superior and inferior side of the slab and in its core sawing and fine pebbles are inserted for providing weight and insulation. The floor finishing usually consists in the same painted wooden boards or, more recently, in linoleum (Figure 6).

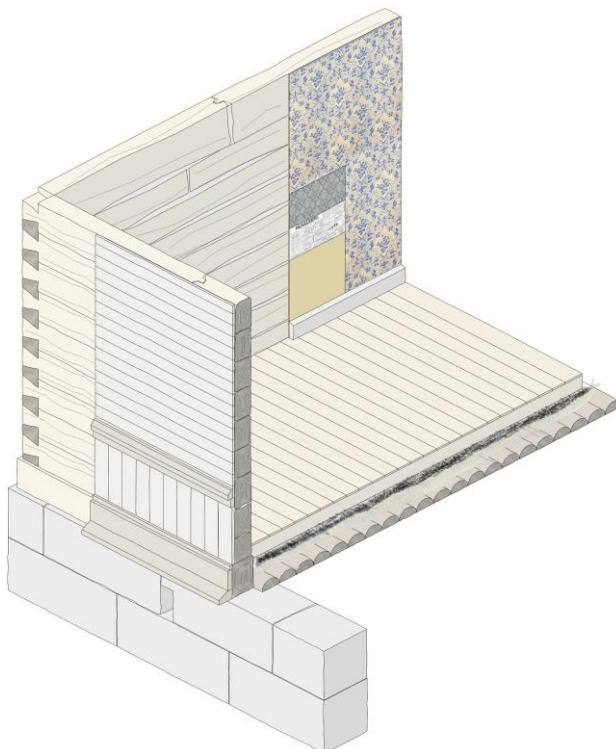
Figure 7. Logs walls system. In the scheme it is also possible to see the slab supported by the foundation beam of walls (digital drawing by the author, 2019).

The wall structure is a wooden system made of piled logs. The exterior ones lay on the beams supported by the cellar structure and they are usually jointed in the corners; the same structural system is employed of interior walls, but their foundation beam

usually rests on isolated piles of stones disposed in the cellar. Exterioly, houses are coated with wooden boards while in the

interior local manufactured wallpaper is used (Figure 7).

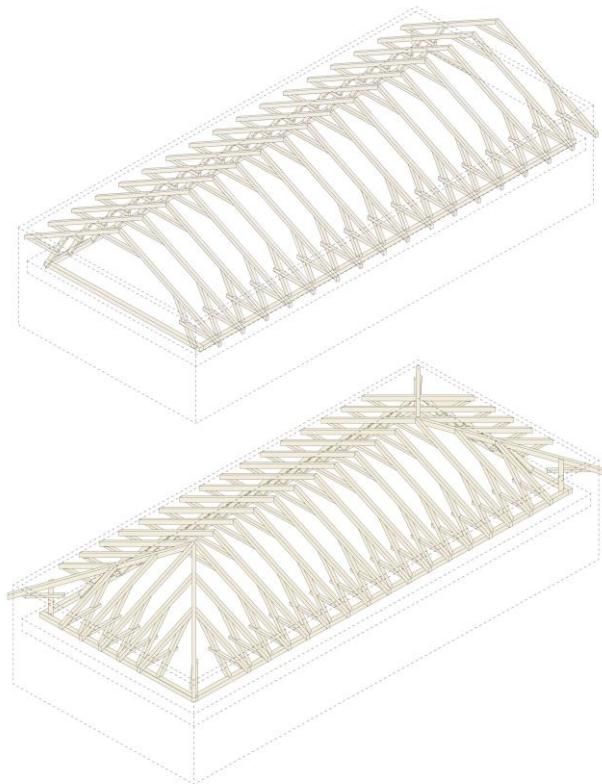
Figure 8. In the upper part, 2 pitches roof structure, in the lower part, 4 pitches roof structure (digital drawing by the author, 2019).

The roof usually consists of a structure of 2 or 4 pitches, made of a similar-truss system (Figure 8). It is formed of 2 sloped main beams supported by a horizontal and an oblique element, respectively fixed to the exterior walls and to the 1<sup>st</sup> floor slab. This system is closed by some wooden boards which often corresponded, in the past, with the final cover layer. Nowadays the most employed coat are metal foils, whose use diffused at the end of the 19th century.

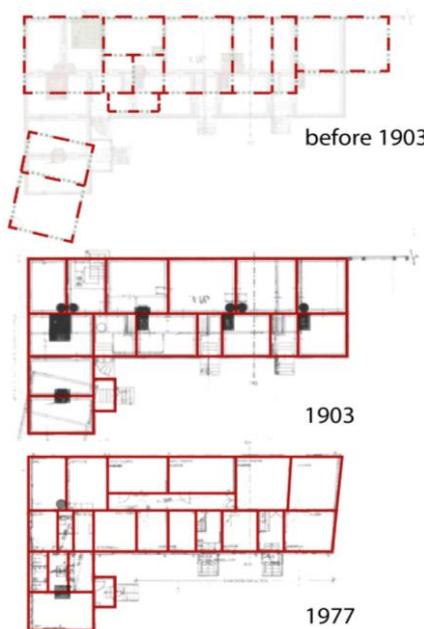
Figure 9. Tammela's evolution process: the original building was probably composed of single room-houses for different families. During the 1903 modifications these units were probably turned into 2 rooms-houses, while the music school configuration shows smaller rooms, all parts of the same school (schematized version by the author of some blueprints from the Centre's archive, 2019).

The residential tradition typology was quite flexible and singular unities within buildings gradually merged to form bigger houses, composed by those previous nuclei (Figure 9). Most of the residencies that still exist in the World heritage site are single-family houses whose rooms once formed singular dwellings. This kind of adaptation responds to the actual residential lifestyle and needing.

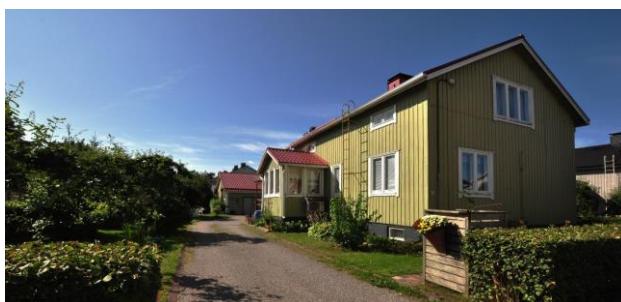
Figure 10. A modern house from the suburbs (photograph by the author, 2019).

**2.3.3 State of Conservation:** during this process, materials and constructive techniques have been mostly preserved, even though it is necessary to remark that also newer elements and systems were introduced (Raitio, Tammi, 2018), such as metallic parts, concrete or more modern insulation fibres. Despite this new trend, the use of traditional constructive culture and materials is still quite diffuse, although in some cases incompatible materials and heavy modifications have been detected. Furthermore, the study of Rauma surroundings pointed out that tradition is still present in some single-family and isolated houses, that maintained conventional materials and composition while using more modern systems (Figure 10).
