THE *DESERT ROSE* DOMES OF THE SOUF REGION (ALGERIA). PRELIMINARY EVALUATIONS ON THE VULNERABILITY OF A UNIQUE VERNACULAR HERITAGE

C.Azil ^{1,2} *, L. Rovero ², B. Djebri ¹, F. Fratini ³, G. Misseri ², U. Tonietti ²

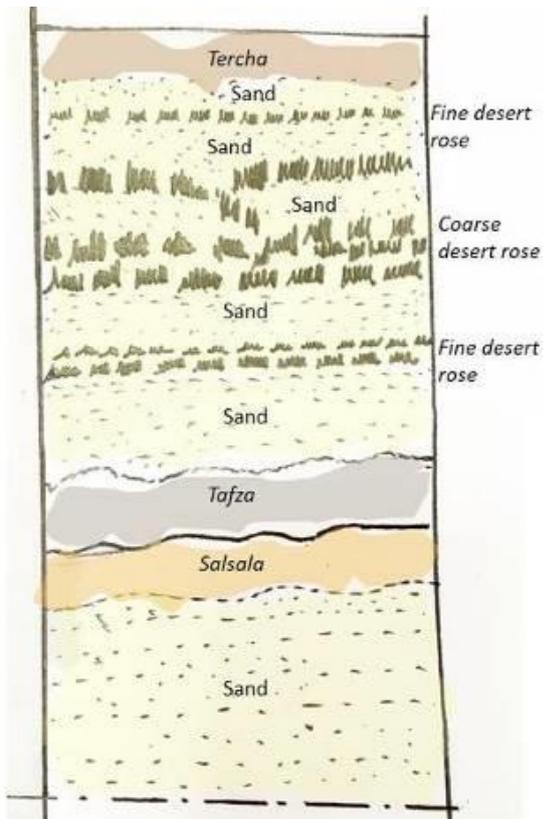
Figure 2. Schematic geological section in the Souf region.

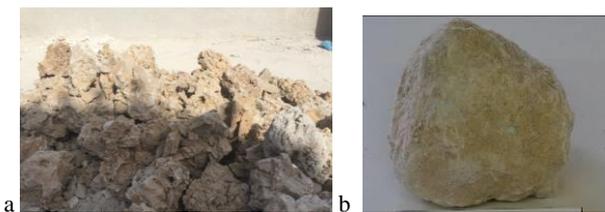
Figure 3. a. ‘Desert Rose’ stone. b. Tafza stone.

Each material undergoes a process of transformation and preparation before being used in construction. The principal building material, the ‘Desert Rose’ stone, constituted of gypsum solidification, is found in layers and in the shape of big blocks (Azil et al., 2018; Azil et al., 2019). The extraction is carried out with different tools such as the plier, the pickaxe and sometimes dynamite. This stone is used in the form of coarse rubbles, with an irregular shape and various dimensions, for the

construction of foundations, walls and domes (Lebsir, 2016). Secondly, the ‘Tafza’ stone, which is a hard, white stone, constitutes the raw material to obtain gypsum binder used for bedding mortar and for plastering. In order to obtain the gypsum powder, the ‘Tafza’ stone is extracted from deepest layers off the ground. Then, following the period of drying (due to the contact of the stone with the water table), stones are reduced in little blocks. After that, the blocks are burned in a furnace for two hours with temperature ranging from 110° to 200° Celcius (Figure 4). After this step, two days are necessary to ‘Tafza’ in order to cool down. In the end, burned ‘Tafza’ blocks are reduced into powder, and during this operation, some wooden ash accidentally mixes with gypsum powder as is shown in figure 5 (Azil et al., 2018). Concerning the ‘Salsala’ stone, this is used, in some cases, for foundations.

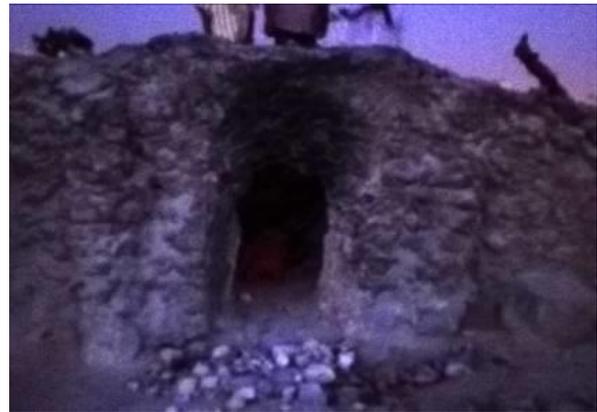
Figure 4. Traditional Furnace of Gypsum.

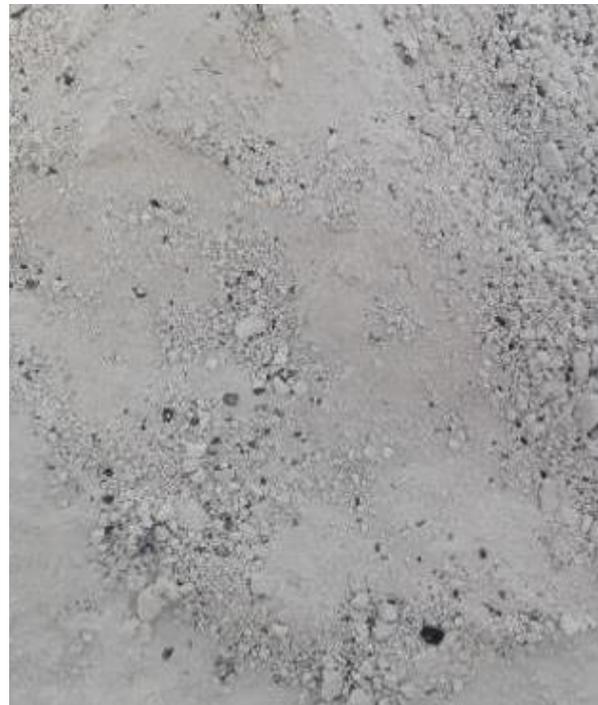
Figure 5. Gypsum powder with wooden ash.

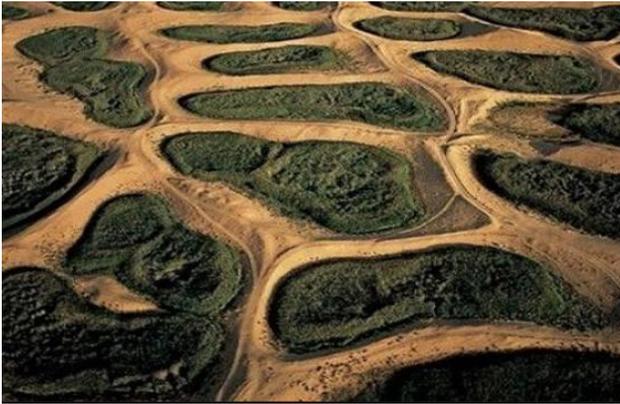
Figure 6. 'Ghitanes' cultivation technique, <https://dzcharikati.net/el-oued-la-phoeniciculture-dans-le-ghout-un-patrimoine-agricole-et-touristique/>, accessed on 20/01/2020.

The extraction process described before is facilitated by the typical cultivation technique of the region; thus, it represents again a perfect balance between human needs and landscape management. Indeed, the region is known for the so called ‘Ghitanes’ (Figure 6), which are micro-oases made by habitants

to implement peculiar technique of cultivation. Basically, the area for cultivation is created by digging the dunes in order to reach the water table. During this process, the blocks of rocks are extracted, and used as building materials in the buildings.

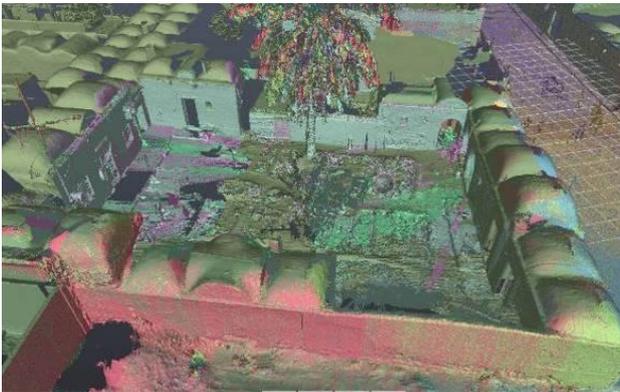
Figure 7. 3D survey of a typical minor building courtyard.

Various investigations *in situ* have been conducted in order to identify common rules of the constructive technique and the geometry of minor and major buildings. The typical minor building, the house, has an introverted organisation around a square or rectangular courtyard, which is surrounded by domed units constituting the perimeter of the house (Figure 7). The domed unit is approximately a square, and its dimension is around 2.5 m. The domed unit can be single or double, and, in this second case, the two volumes are connected by an arched passage.

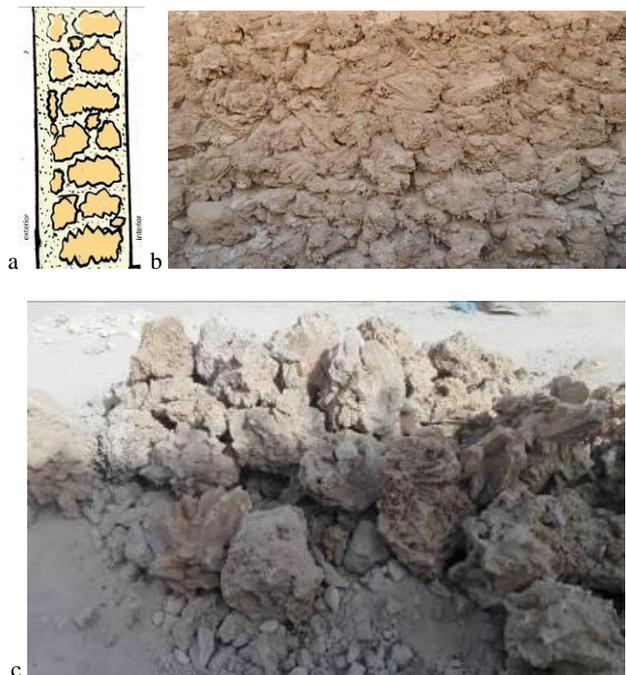
Figure 8. a. Section of 'Desert Rose' stone masonry. b. Wall of masonry building. c. Big 'Desert Rose' blocks.

Foundations could be made of Salsa stone or the big blocks of 'Desert Rose' stone, but this latter is the most common, which are used with bedding mortar consists of gypsum obtained from burning of Tafza stone. To erect masonry portions, the quantity of gypsum mortar is remarkable compared to the amount of 'Desert Rose' blocks, roughly around one-to-one ratio because of the irregularity of the blocks. Foundations depth ranges from 50 to 70 cm and thickness is between 40 and 45 cm. Rising from foundations, walls are slightly less thick. Generally, walls show one or two leaves made of

medium-sized blocks; to fill the gaps, smaller stones are introduced. Due to the irregularity of the blocks shape, the texture of the walls is very irregular; therefore, the walls are plastered with a gypsum-based rough-coating. To this aim, the burned and crushed 'Tafza' stone is employed, after being sifted in order to eliminate the big pieces of wooden ash and to have smooth surface. The thickness of gypsum plastering for inside walls varies according the quantity needed in order to smoothen the surface. Generally, the plaster layer employed for outside walls is thicker, ranging from 5 to 10 cm. At the end, wall thickness varies between 30 and 35 cm in the minor building. After the construction is finished, it is difficult to distinguish the masonry texture, the blocks from the gypsum mortar because the wall appears like a sort of conglomerate (Figure 8).

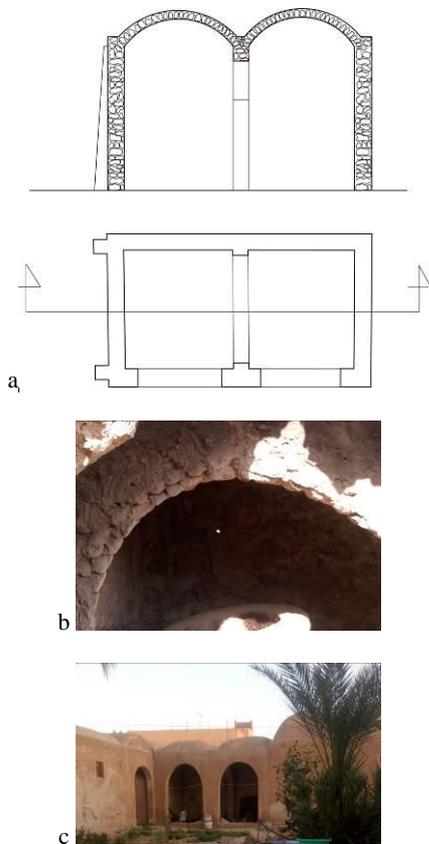
Figure 9. a. Plan-section of double domed units. b. Radial texture of the connection arch. c. Gallery with arcades.

An arch, which is added between two single units, allows to join volumes of them and widen the space (Figure 9.a). The arch rings, average thickness of 15 cm, are built without centring and employing 'Desert Rose' blocks placed with roughly a radial texture and gypsum bedding mortar (Figure 9.b). Arches are also used in the gallery of courtyard (Figure 9.c).

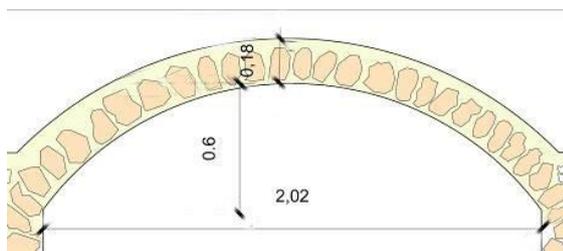
Figure 11. Section of 'Desert Rose' stone dome .

Regarding the domes, to regularise transition between the circular shape of the shell and the square shape defined by the walls, squinches are placed at corners. Concerning masonry execution for domes, which is realised without centring owing to the rapid setting of the gypsum, it raises from the square shape and grows in successive horizontal layers that change from squared shape to a circular one (Figure 10). Consequently, the geometry of the typical dome is a transition between a cloister vault with imperceptible edges, in the inferior part, and a dome of revolution, in the superior part. The dome is slightly flattened: its rise is less than half of its diameter of 2.5 m (Figure 11). The dome is covered by a thick layer of gypsum outside, also, inside gypsum plaster is used to smooth the surface. The thickness of the domes ranges around 15-18 cm.

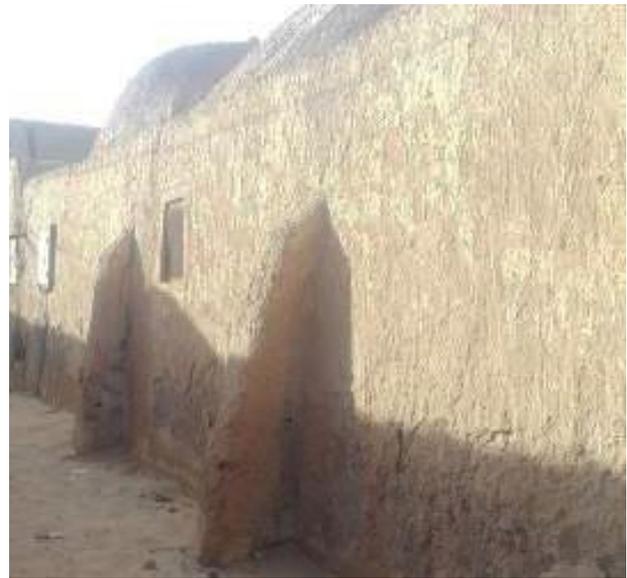
Figure 12. Buttresses of the wall overlooking the alleys.

Buttresses are used in Souf buildings; in rural buildings, due to their dispersed distribution where they do not have a neighbouring unit which permits to counter pushes. In the city, the urban density is high and walls shared between two houses are frequent. In this case, buttresses are limited, e.g. in the exterior wall overlooking the alleys, Figure 12, and in the interior wall overlooking the courtyard.

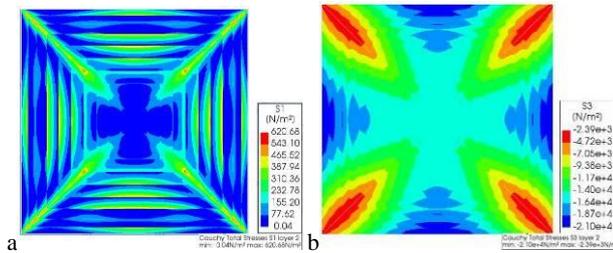
Figure 13. The main total stress results of linear analysis on the medium surface of the first model with pinned constraints: a. Tensile. b. Compression.

The principal stress contour plots of linear analyses are shown in the Figure 13 and 14. For the pinned model, A, Figure 13.a shows that the maximum tensile stress is $6.2e-4$ MPa in the bottom part of the diagonal arches. However, in the figure 14.a, the analysis of the results permitted to note that the maximum tensile stress, in the model with roller support, is $5.45e-2$ MPa in the corner.

Regarding the principal compressive stress, in the Figure 13.b of the model with pinned constrained, the results show that the values of compressive stress vary between $-2.10e-2$ MPa and $-2.39e-3$ MPa, whereas the lower compression is in the lower part of the diagonal arches, and the highest compression is in the middle of the lower part. In the Figure 14.b of the model with roller constraints, the lower principal compression stress is $-6.97e-3$ MPa, which is noted in the middle of the lower part, and the more intense compression stress is $-8.46e-2$ MPa in the corner.

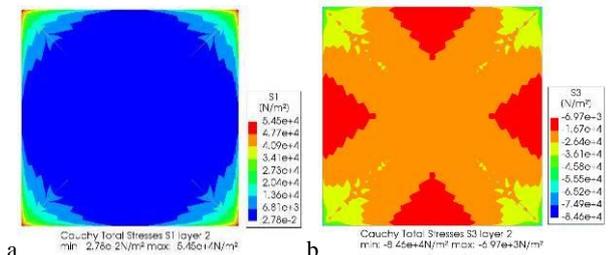
Figure 14. The principal total stress results of linear analysis on the medium surface of the second model with rolled constraints: a. Tensile. b. Compression.

Comparing the analysis results of the two variants allowed to illustrate that the variation of the results is related to constraint support type. The roller support type, provided better quality interpretation of the damage pattern surveyed.

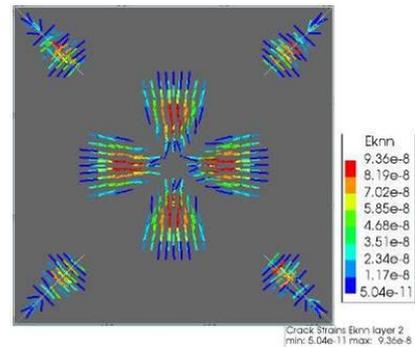
Figure 15. The crack strains result of nonlinear analysis on the medium surface of the first model with pinned constraint.

The Figure 15 and 16 shows the results of crack strains of the nonlinear analysis of the two model variants namely model with pinned constraint and model with roller constraint.

In the Figure 15, in the model with pinned constraint, the crack strains in the medium surface are varied between $5.04e-11$ and $9.36e-8$, and they are situated in two zones that are the lower part of the diagonal arches and in the top part. On another hand, in the Figure 16, in the model with roller constraint, the crack stains are varied between $-2.6e-13$ in the most part of the model and $3.27e-6$ in the corner diagonal arches, due the type of the constraint which allows more displacement comparing to the model with pinned constraints. Due to the higher deformability of the model constrained with

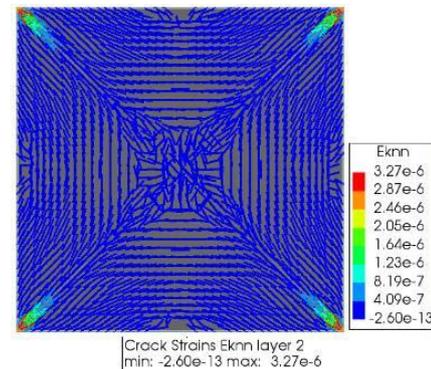
Figure 16. Crack strains distribution from nonlinear analysis, results are referred to the medium surface of the model with roller constraints.

rollers, which clearly reflect the damage visible in dome, only a very limited fraction of gravity acceleration can be resisted, since computation quickly diverges. The pinned model although showing a crack patten more difficult to be related to reality, can easily sustain self-weights, as actually happens. Further investigation will involve the modelling of the whole unit to provide to the dome base balanced stiffness calibrated on wall height and thickness.
