## 3D MODELLING OF THE NEGRO TOWER FOR ITS COMPREHENSIVE ANALYSIS AND A CONSERVATION PROPOSAL

**KEY WORDS:** Tower, 3D Laser Scanner, Photogrammetry, Conservation

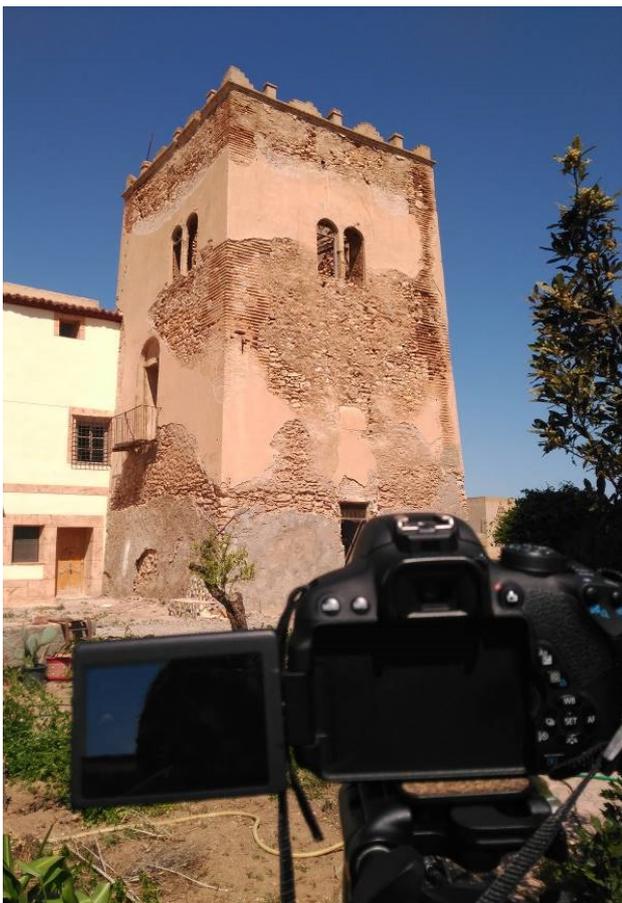
Figure 1. The Negro Tower during the photographic process used for the digital terrestrial photogrammetry. Own production.

Currently the Negro Tower is in a dilapidated state. From its original use as a defense building, it was converted into a residence at the end of nineteenth century. At this time, a private villa was attached to the north and west façades (Figure 1). Furthermore, it has suffered decades of neglect.

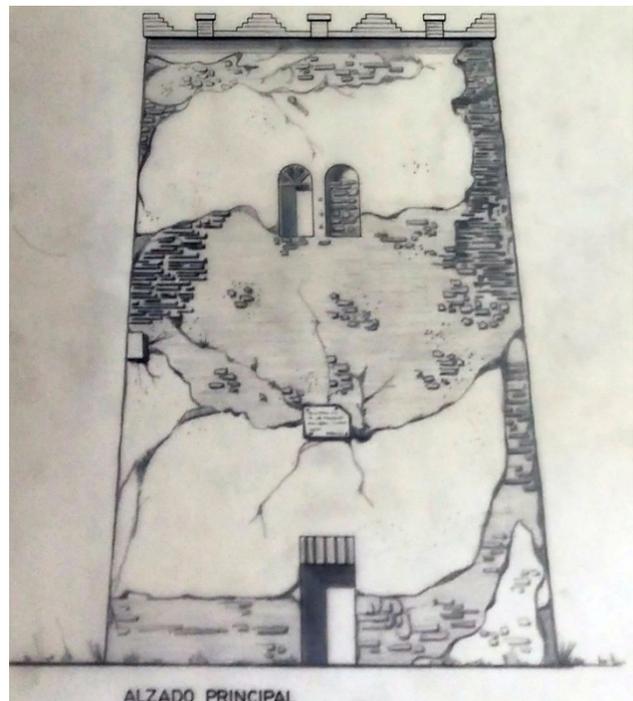
Figure 2. South Elevation of Negro Tower. Hand-made scale drawing. (Cartagena, 1985).

It has also been possible to find documentation on the property in the Municipal Archive of Cartagena. A planimetric diagram has been found, probably dating from 1985. This planimetric diagram contains all the elevations of the tower, with a great amount of detail on its state at that time. As it can be seen in Figure 2, at that time the Tower had widespread pathologies throughout its outer envelope, although it was not in ruins inside (Municipal Archive, 1985). The collapse of the upper deck and the second-floor vault occurred during the 1990s, and there is no proper documentation other than inaccurate oral reports from the inhabitants of the area about this occurrence.

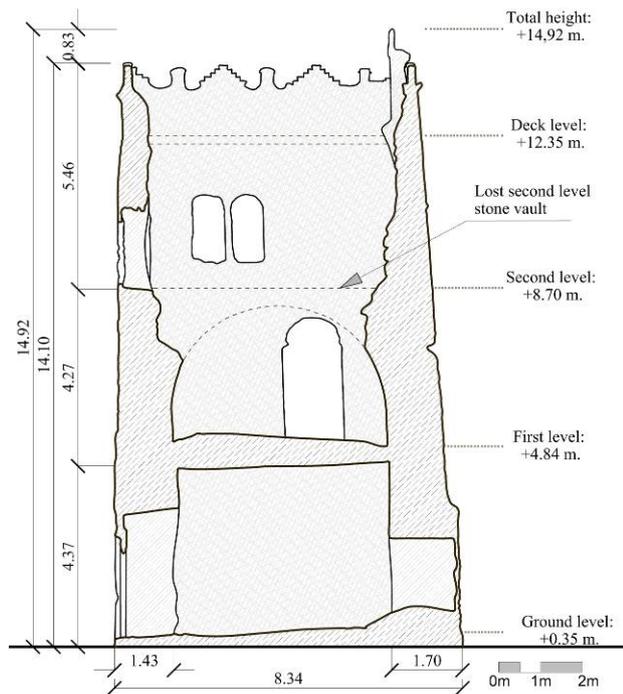
Figure 3. Cross section; north-south direction of the Negro Tower. Current state. Own production.

As can be seen in Figures 3 and 4, the tower is composed of three levels with a flat roof, having a total constructed area of 234.96 sq. m. There is no communication between the ground and first floors. A general characteristic of this type of tower is the absence of any entrance on the ground floor, with the main entrance on the first floor. The purpose of this is to hinder access to attackers. To gain access, mobile stairs would be available and openings on the ground floor would be avoided at all costs. The communication between the first floor, the second floor, and the roof, was through an internal spiral staircase, made of stone masonry and located in the northwest corner of the building.

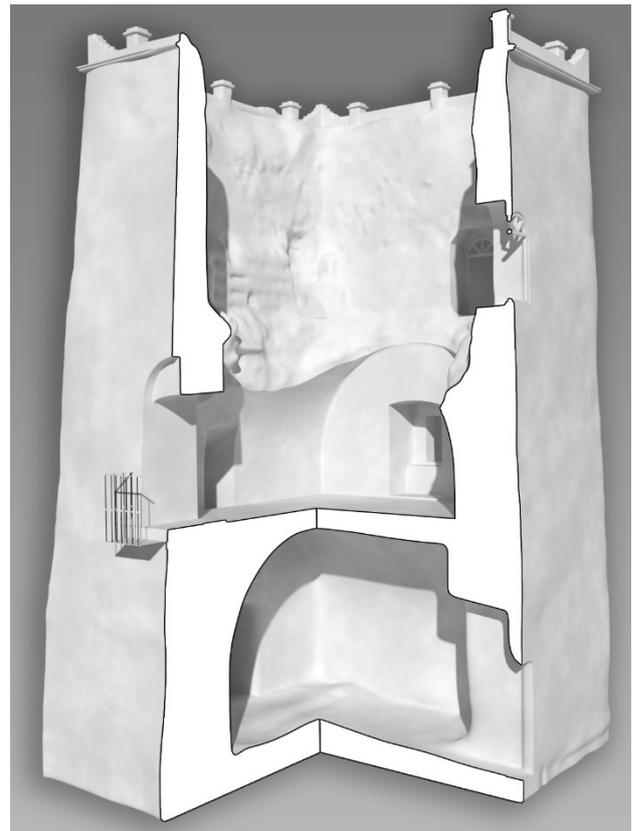
Figure 4. 3D model with cross sections made into it. Own production.

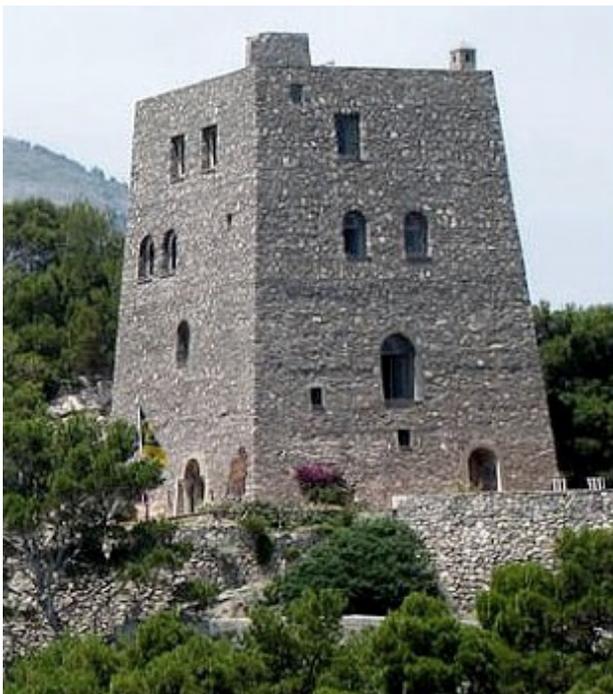
Figure 5 Isola Lunga de Li Galli Tower. (Diaz, 2020).

The Isola Lunga Tower is another example similar to our case study (Figure 5). This tower originally had a very similar constructive distribution. It has the shape of a truncated pyramid with a square base each measuring originally 13.94 m and 14.09 m and a 14.09 m high. Its walls were 3.70 m wide at the base originally, while they currently are 2.30 m after the renovation it was through.

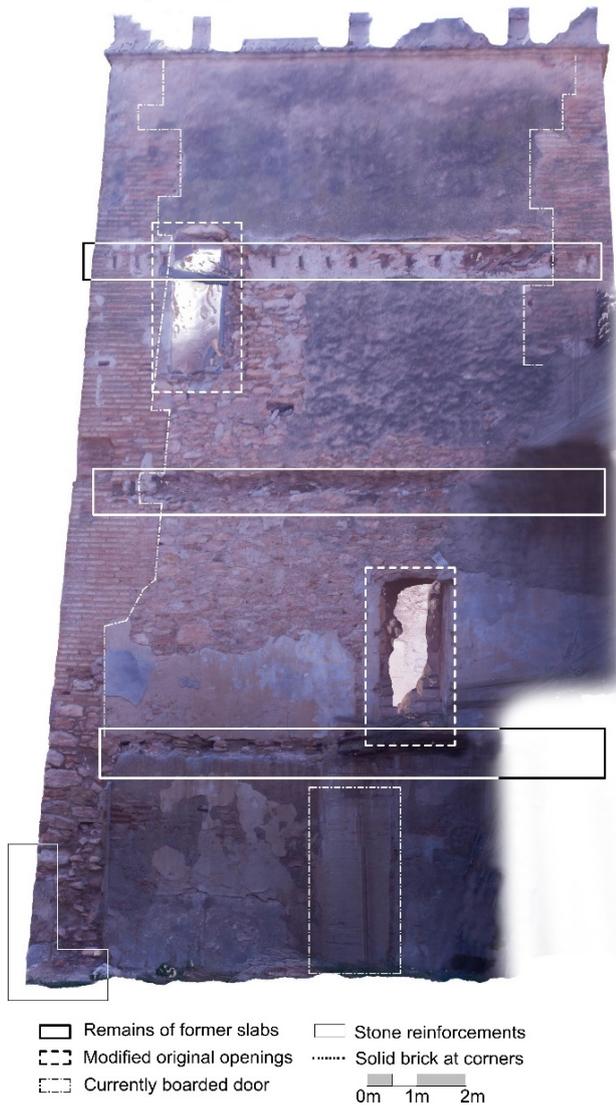
Figure 6. Constructive study of north façade of the Negro Tower. Current State. Own production

Figure 6 shows a part of the construction study carried out; in this case corresponding to the north elevation of the tower. This elevation has been the most affected by the modifications made to attach the country villa. This house collapsed during the 1980s and 1990s, producing obvious damage to this façade. The places where the wooden slabs of the country house were embedded into the tower can be clearly seen. Due to the very poor state of the façade and the total absence of almost any coating, both the stone block reinforcements in the corners and the relationship between the ceramic bricks in the corners and the masonry of the exterior walls are visualized.

The façade openings have also been widely modified. Some openings have survived practically without alterations, like the embrasure on the second floor or the access door on first floor; while window and door openings have been made in the other elevations, mostly taking advantage of former defensive-based openings. The boarded door on the ground floor on the north façade is worth mentioning. It was probably opened during the adaptation to residential use in order to enable communication with the attached house and was nonexistent in the original design (Figure 6).

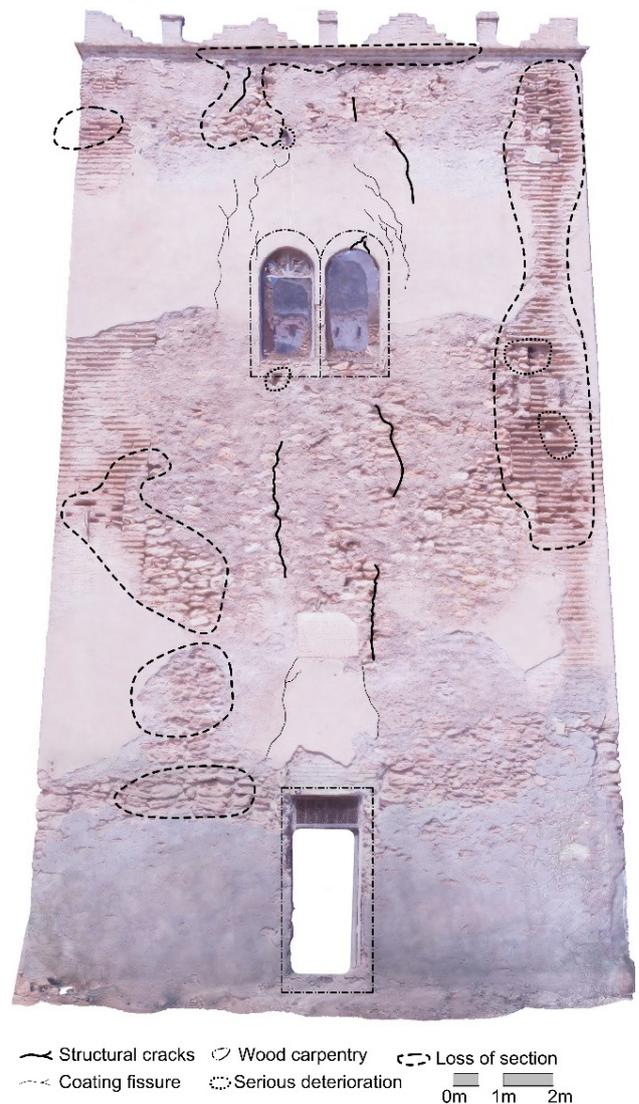
Figure 7. Study of pathologies of south façade of the Negro Tower. Current State. Photogrammetry modelling. Own production.

All these pathologies have been represented graphically in the pathological study made. An example of this can be seen on the south façade, made with the texture of the photogrammetry model that can be seen in Figure 7, where the different pathologies described have been represented.

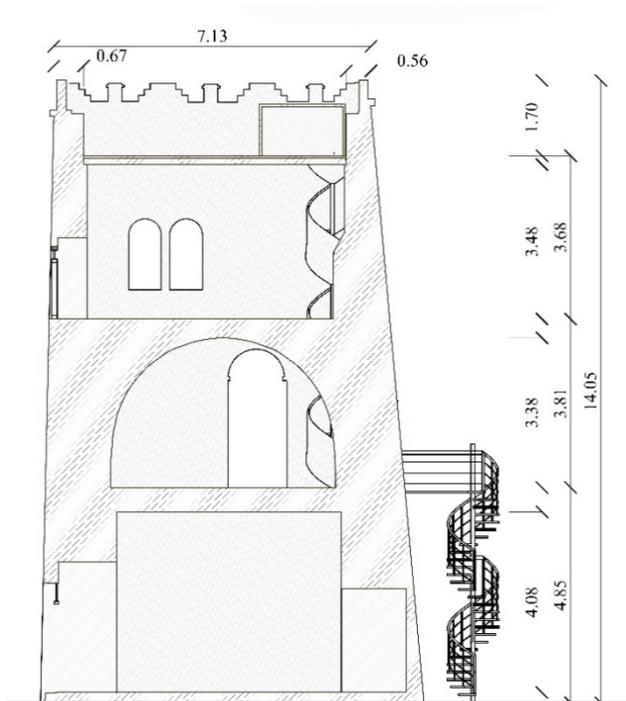
Figure 8. Cross section. Restoration proposal. Own production.

The proposal contemplates the reconstruction of the stone vault of the second floor, the deck slab of wooden beams and interwoven brick, and the interior spiral brick staircase. As a permanent alternative to resolve access to the first floor, an exempt spiral staircase made of weathered steel with a lightweight design is suggested. The proposed staircase will not affect the exterior image of the tower. Although this solution does not include universal accessibility, it has to be bear in mind that the proper conservation of the historical identity of the monument it is very important. (Figure 8).
