## PRELIMINARY STUDIES TO VALUE ENHANCEMENT OF THE OLD CITADEL IN ORIA, ALMERIA, SPAIN.

**KEY WORDS:** Wall, Rammed-earth, Photogrammetry, Stratigraphic analysis, Constructive-typological taxonomy, Pathology

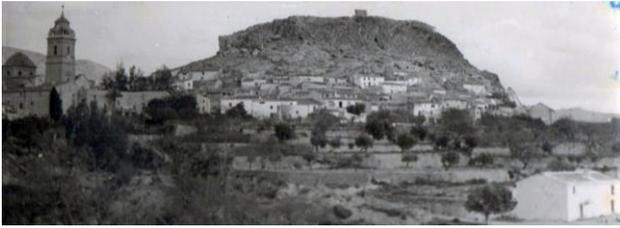
Figure 3. View of Oria in 1950. The 'Alcazaba' wall section can be seen on the southern side.  
Source: Todocolección 2019.

According to the drawing of Oria from the Cadastre of Ensenada, the fortress probably had retained at least its north-side walled enclosure in the 18th century (Figure 2). By the mid-20th century, the ‘Alcazaba’ had the same wall sections on its north side and some sections on its south and east sides (Figures 3, 4 and 5).

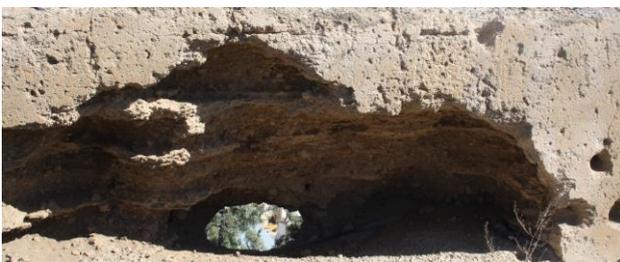
Figure 6. Loss of mass and wall section in north side of the 'Alcazaba' rammed-earth wall. Photography: Jorge Moya Muñoz 2019.

The 'Alcazaba' has been considered protected heritage since 1949. Initially, its status came from the lax<sup>2</sup> Decree of the BOE of the 22 of April of 1949 on the Protection of Castles and, later, from Law 16/1985 on Spanish Historical Heritage, which registers it as an Asset of Cultural Interest (BIC by its Spanish acronym) under the legal classification of Monument. However, at the beginning of the 21st century, the only intervention<sup>3</sup> carried out in the 'Alcazaba' has been the conditioning of the surroundings for tourist visits. No action has ever been taken to conserve the wall structures, because of that they are currently in an advanced degradation state (Figure 6).

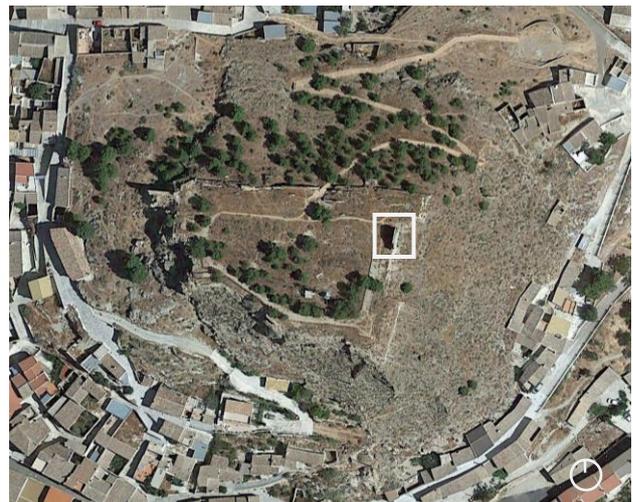
Figure 7. Location of the eastern section of the 'Alcazaba' wall.  
Source: Landsat / Copernicus. IBCAO.

One of the purposes of this work is to broaden the knowledge about the rammed-earth constructions of eastern Andalusia, especially representative village's fortifications. From the architectural perspective, the alcazaba of Oria is a model that allows analyzing its material components, the rammed-earth wall constructive characteristics and the wall conservation state. In addition, this research allows us to have an integral approach to the wall consolidation works. In this first research phase, one of the existing wall sections is selected: the rammed-earth wall located on the eastern side of the fortified enclosure (Figure 7).

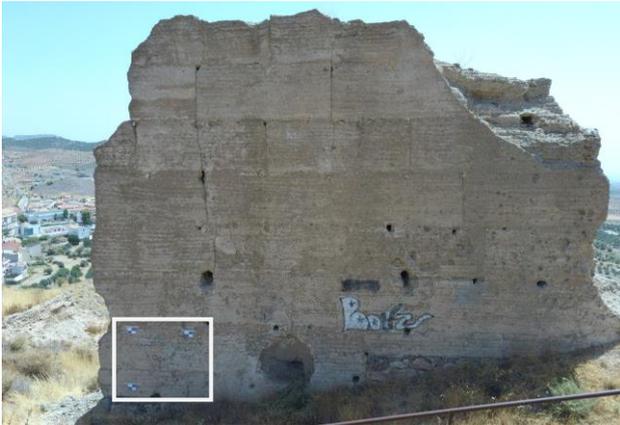
Figure 8. Control points location in the wall section studied. Photography: Félix Pérez Moreno 2019.

Firstly, three control points were positioned 1 m apart on the lower third of the inner surface of the selected section of wall using laser levels and plumb bobs. These three targets subsequently made it possible to scale and establish a relative coordinate axis with which to suitably orientate the wall in the graphic restitution program (Figure 8).

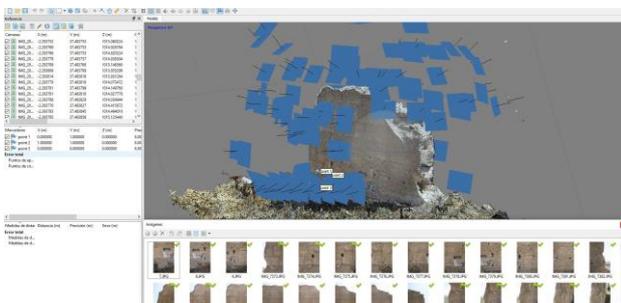
Figure 9. Markers location and photographs position in the Agisoft software. Source: Authors 2019.

From a total of 148 photos, all the images were restored using the Agisoft PhotoScan Professional software (Figure 9). Once the wall images had been processed, a cloud of points forming its three-dimensional model was created in order to be exported as a txt file to Recap PRO 2019. Thus, the file that defines the graphic base to work in Autocad 2019 had been completely extracted.

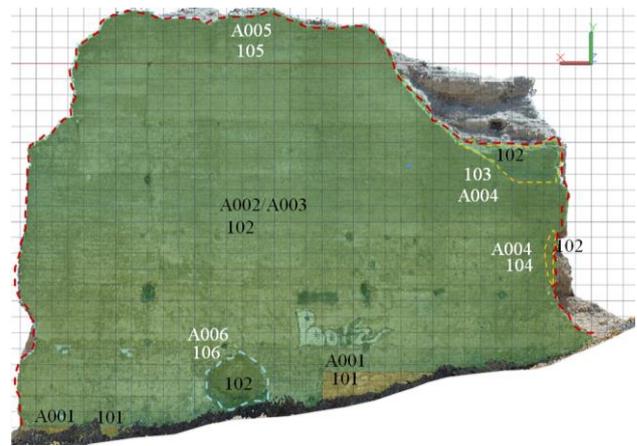
Figure 10. Intrados wall view: S01 SUs identification and demarcation. Source: Authors 2019.

The rammed-earth wall section considered is part of S01. The identification of the SUs that define it stratigraphically would start with the SU of the foundation. However, SU101 has been considered the starting point because it is impossible to test it as SU101 overlays with the wall linked to the A001 action. This action corresponds to the process prior to the wall construction. The following is SU 102, associated with the rammed-earth wall and A002 and A003 construction actions of the wall structure. The loss of whitewash and mass of the rear wall is related to SUs 103, 104 and 106, interfaces that

cause SU101 to lose coating. Both SU103 and SU104 are related to actions A004 and SU106 to A006. Finally, SU105 is related to the wall mass loss associated with action A005. (Figure 10).

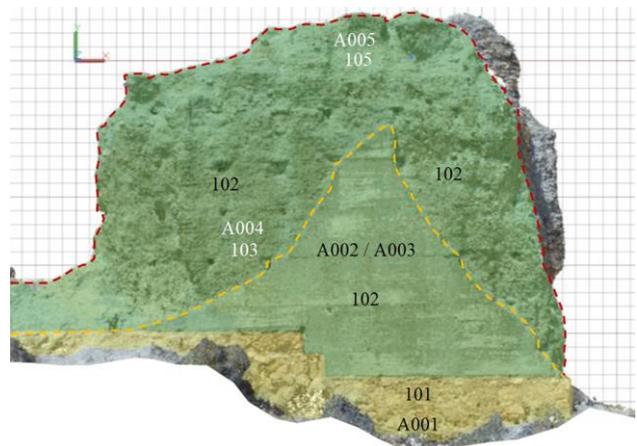
Figure 11. Extrados wall view. S01 SUs identification and demarcation. Source: Authors 2019.

Accordingly, after analyzing and understanding the relationships between SUs and actions, the second study phase that allows interpreted these relationships in chronological order is proposed. The result is exemplified by the Harris matrix (Harris, 1986) and is related to the colour representation of Figures 10 and 11 (Table 3).

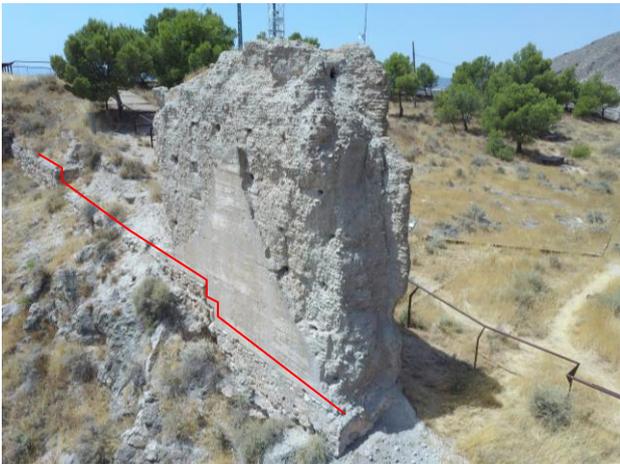
Figure 12. Staggered line from the top of the ‘Alcazaba’ wall. Photography: Félix Pérez Moreno 2019.

It is necessary to specify that the foundation on which the wall rests cannot be raised by photogrammetry. To properly define it, it would be necessary to carry out test pits and surveys, which are not feasible at this stage of the research. However, it is possible to discern its staggered construction by adapting it to the mountain topography, based on the understanding of its superimposition. It was built using stone masonry taken from lime mortar. In the wall section studied, a variable height of up to one metre can be observed. (Figure 12).

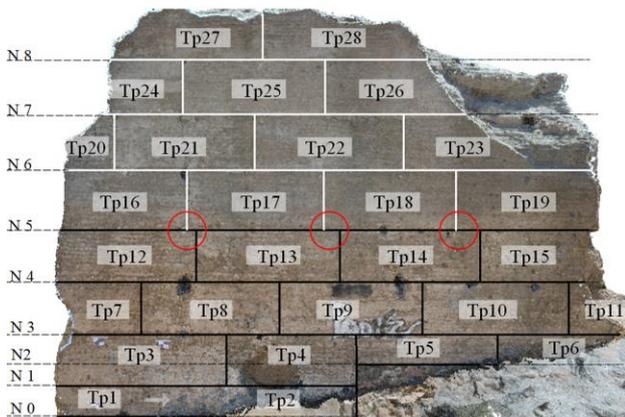
Figure 13. Intrados wall view: identification of the walls and levels. Source: Authors 2019.

Once an approximation of the foundation has been made, the wall is studied. In terms of configuration, the wall section measuring approximately 8.5 x 6.5 m<sup>2</sup> is made up of direct contact rammed-earth walls (except at the start of the wall, where we can see regulating aggregates), which form a structure that supports the overlay. The identification of the rammed-earth walls has been carried out, listing them under the letters TP and followed by a number, so that later their metric, formal and constructive aspects can be analysed. The rammed-earth blocks total number is 28 units, according to the vertical construction joints that have been observed. In 13 of them, their dimensions can be measure (length x height). For their characterisation, a number is assigned and associated with the level of their base -or construction elevation marks- (Figure 13). The levels are the following: level 0, corresponding to +0.00m (1013m above sea level), level 1, elevation +0.475m, level 2, elevation +0.80m, level 3, elevation +1.26m, level 4, elevation +2.08m, level 5, elevation 2.89m, level 6, elevation +3.82m, level 7, elevation +4.58m, and level 8, elevation +5.54m. (Table 4).

Although, in order to obtain definitive results for the dimensions, it would be necessary to consider the size of the boards of the rammed-earth (Graciani and Tabales, 2008), it can be observed how, in the first four levels, the height of the fences would correspond to the low module (black in Figure 13), while in the upper levels it would correspond to the high module (white in Figure 13).

In turn, this mark indicates that the execution direction of the TP2 rammed-earth wall is towards the overlay that served as a border (Figures 13 and 22). It can also be deduced that the formwork would have been at least 14 cm behind this pattern.

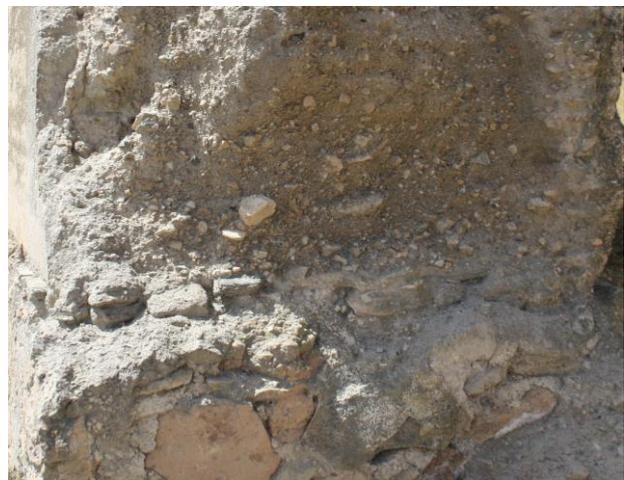
Figure 14. Wall section view: the layer of stones for the regularisation of the rammed-earth wall on the top can be observed. The whitewashing, the interior material components and the aggregates measure used can also be seen. Photography: Jorge Moya Muñoz 2019.

wall section finishing is whitewashing on both sides, with a thickness which varies between 13-20 cm (Figure 14).

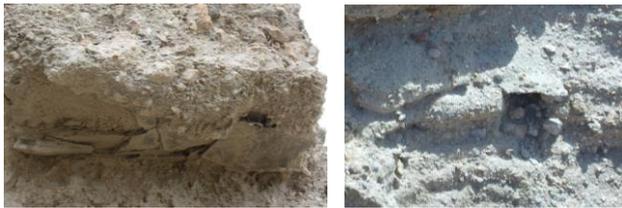
Figures 15 and 16. Square section hole impressions with a slab roof. Photography: Félix Pérez Moreno 2019.

Finally, the parameters related to main function that the rammed earth blocks have in the execution of the wall have been studied. Regarding the needles, they are always through and are found throughout the section fenced within the lower thread, with a slate sky without laterite rocks to allow their subsequent recovery. The square hole or putlogs hole of these varies only at the base of the wall, where there are rectangular sections of 7 x 3 cm<sup>2</sup>. In the rest of the wall, square section holes of approximately 10 x 10 cm<sup>2</sup> have been identified (Figure 15-16).

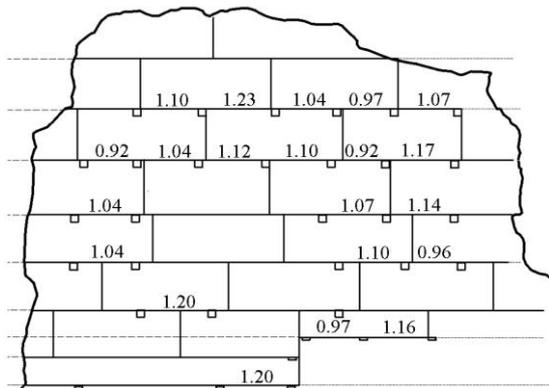
Figure 17. Location and distances between putlogs holes of the rammed-earth wall. Extrados wall. Dimensions in cm. Source: Authors 2019.

The separation distance between the needles is relatively constant, with distances ranging from 90 to 120 cm (Figure 17). Their length varied between 176 and 181 cm, considering that a dimension of about 10-15cm<sup>8</sup> stands out on each side. This measure funtion are not only the need to support the sacking, but also the possibility of supporting a scaffolding structure.

Analysing the putlogs, it is evident that the rammed-earth wall was built according to two different orderly sequences. From level 0 to 4, there are two putlogs for each rammed-earth wall, while from level 5 there are 3 putlogs for each wall. (Figures 17 and 18).

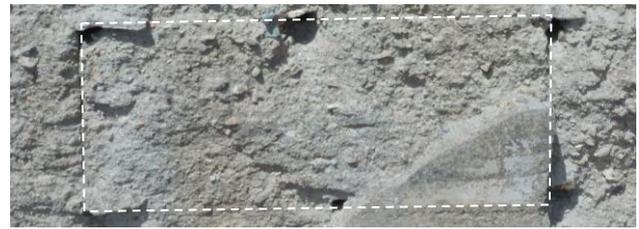
Figure 18. Demarcation of TP22 rammed-earth block corresponding to three ordered putlogs. Photography: Félix Pérez Moreno 2019.

Therefore, it can be deduced that each rammed-earth wall was supported by three putlogs. This evidences an important level of planning. Thus, a wall would use the last putlog of the previous wall to form the next one (Figure 18 and 19). From this premise, the hypothetical dimensions of TP23 and TP26 rammed-earth blocks can be completed by knowing the holes that were used for their execution.

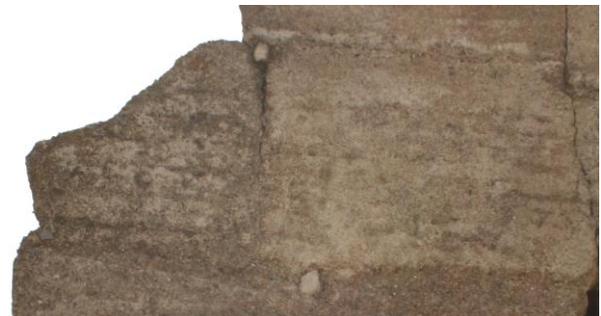
Figure 20. View the putlog holes filled with stones. Photography: Jorge Moya Muñoz 2019.

After the putlogs are removed, the hole they leave is covered with a same wall material mortar and the surface is smoothed out while still fresh (Gallego, 2014). Besides that, to ensure adherence when applying the coating, stones are inserted to facilitate its application (Figure 20).

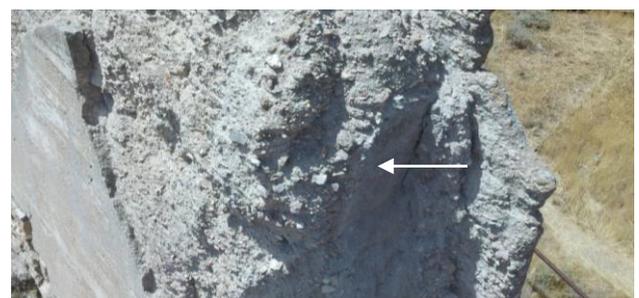
Figure 21. Mark of the headboard of rammed-earth wall 21. Photography: Félix Pérez Moreno 2019.

Furthermore, on the western wall section no markings can be seen that would allow us to know the number and measure of the formwork panels. The mark on the headboard of the TP3, TP19 and TP21 coatings can be seen (Figure 21). This mark has made it possible to determine the dimensions of TP3 and TP19 coatings.

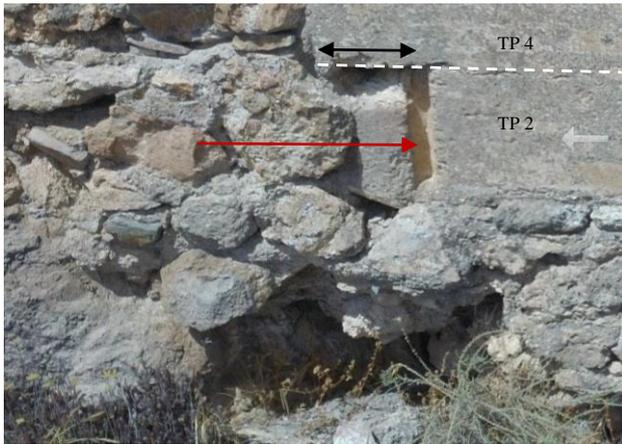
Figure 22. Semi-circular pattern on TP 2. Photography: Félix Pérez Moreno 2019.

In addition, a 7 cm deep semi-circular section can also be seen on the TP2 rammed-earth wall which makes it possible to deduce that it was not necessary to place the headboard on this rammed earth wall. This hypothesis is reaffirmed because the mark corresponds to the height of the wall (Figure 22).

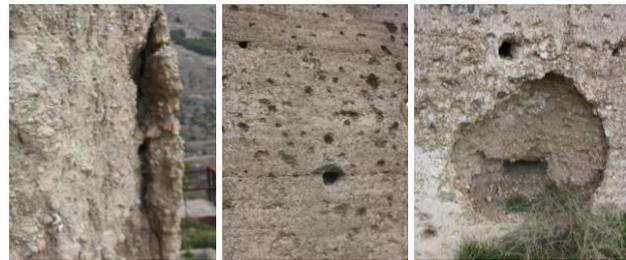
Figures 23, 24 and 25. Loss of whitewash as a result of internal wall washing, shrapnel marks and the presence of plant organisms are shown in sequence. Photography: Félix Pérez Moreno and Jorge Moya Muñoz 2019.

In the section of the wall studied, physical, mechanical and chemical damage was observed, most of it related to direct and constant exposure to atmospheric agents and others to anthropic action. The table 5 is a simplified summary of the wall section damages according to their location, based on the classification made by Canivell (2011):

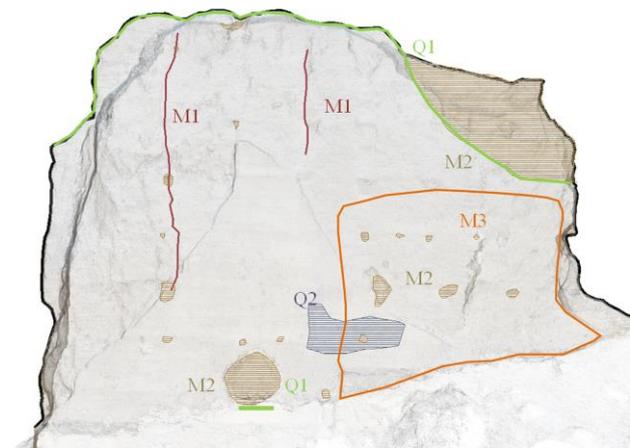
Figure 26. Intrados wall view: damages identification. Source: Authors 2019.

In Figure 26 and 27 localised damage in a simplified manner for the extrados and the intrados of the rammed-earth wall.

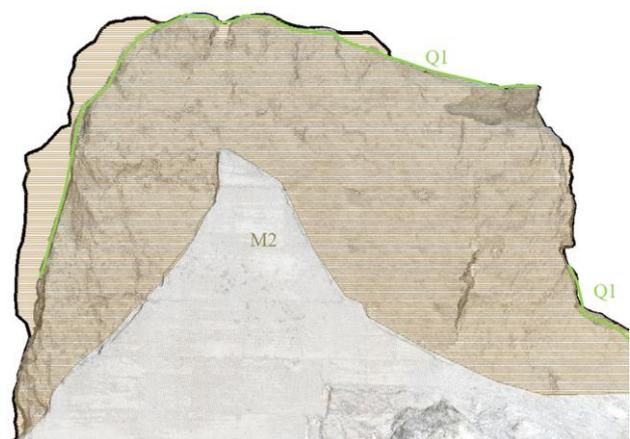
Figure 27. Extrados wall view: damages identification. Source: Authors 2019.
