THE “*GABINETTO* OF GILDED STUCCO” IN THE ROYAL PALACE OF PORTICI, NAPLES (ITALY): SURVEY AND DIAGNOSIS FOR CONSERVATION

KEY WORDS: Architecture, Gilded Stucco, Portici, 18th Century, Diagnosis, Conservation

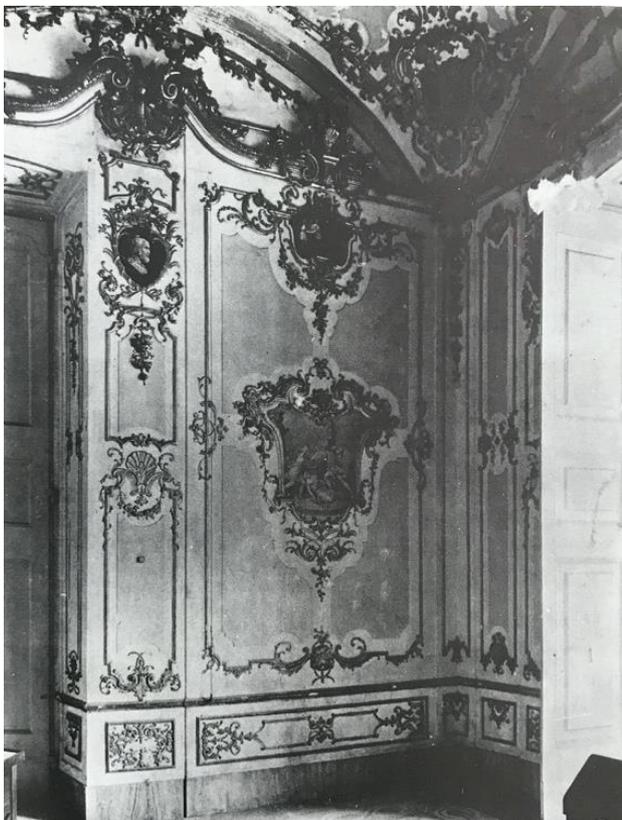
Figure 3. The *Gabinetto* of gilded stucco in 1980 (De Seta, Di Mauro, Perone, 1980). The lambris and decorations on the vault and wall on the right were still quite intact and paintings visible.

The *Gabinetto* of gilded stucco was originally largely decorated by gilded ornaments. Unfortunately today all the surfaces are affected by severe decay, which has wiped out entire portions of these decorations. Main causes are negligence – for the room has been used up to now as an academic department and furnishings lean on surfaces with no space left in between – together with moisture and water infiltrations mainly from the two balconies. Evidence is provided by the observation of a more considerable decay in proximity to the two openings and on the outer walls. The ceiling, for instance, presents missing parts towards the balcony while the parts towards the access corridor show better conditions. Consequently, mortars are affected by efflorescence and powdering, plus by bursting which is worsened by the resulting corrosion of metal fixings. Due to the lack of any recent intervention, today decorative elements are poorly inbuilt into the substrate, therefore every slight pressure causes detachments and fragments continuously fall. No surprise that deterioration has increased over the past years; in fact a picture of one of the corners of the room published in 1980 (De Seta, Di Mauro, Perone, 1980) (figure 3) shows a much greater entirety of the decorative apparatus compared to the present situation.

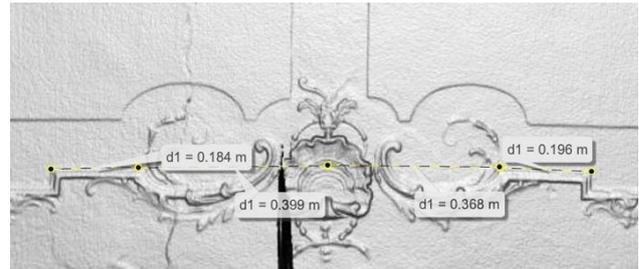
Figure 4. Measurement of stucco ornaments on laser scanner white-meshed model.

The survey performed in the room was fundamental to clear doubts regarding the stucco molding process in which dimensional and morphometric data are decisive. No archival document found, in fact, reveals whether or not the ornaments were prepared using molds. Starting from the premise that the use of molds results in producing identical pieces, it was important to understand if some sets of stucco elements were dimensionally identical to know where and if molds had been used. Thus, the measurement of frames on the three-dimensional model revealed slight differences in lengths (in the order of 1 to 5 cm) while more elaborate and sinuous moldings showed differences in the radius of curvature. Furthermore, white meshes applied to the model made reliefs more visible. These measures taken on the white-meshed model demonstrated that ornaments had been made by hand, either on site or in the workshop, but certainly without using molds (Figure 4).

Models and orthophotos have been also important to graph all the information, assign metric data to each stucco ornament and, once the characterization phase will be concluded, they will be useful to map stucco composition.

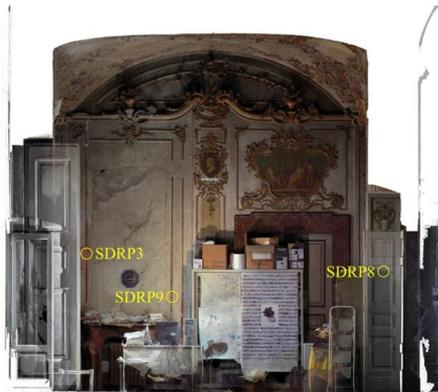
Figure 5. Laser scanner survey of the *Gabinetto* of gilded stucco. Wall 1 with sampling points.

Materials were sampled as shown in figures 5 to 7 to be representative of each kind of ornament in the room and selected from weakly bonded points to minimize damages on surfaces. They were labelled as shown in Table 1. Samples include: horizontal frames dividing the boiserie from the major ornamental part (SDRP1, SDRP2); outer horizontal and vertical frames of the main decorations (SDRP3, SDRP5, SDRP9); ornaments made on-site (SDRP7); ornaments possibly made prior in the workshop (SDRP6, SDRP8); painted finishes (SDRP4). Material characterization is being led with a multi-analytical approach: some analyses are still under way, while those already carried out are synthetized in Table 1.

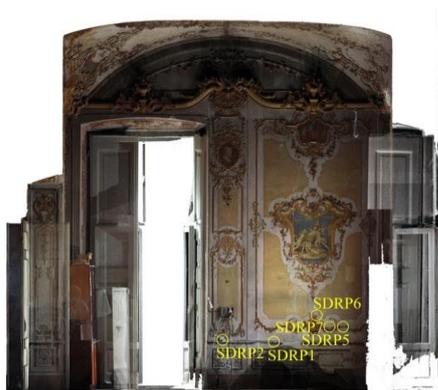
Figure 6. Laser scanner survey of the *Gabinetto* of gilded stucco. Wall 2 with sampling points.

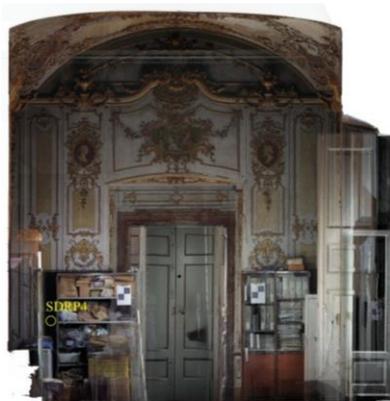
Figure 7. Laser scanner survey of the *Gabinetto* of gilded stucco. Wall 3 with sampling points.

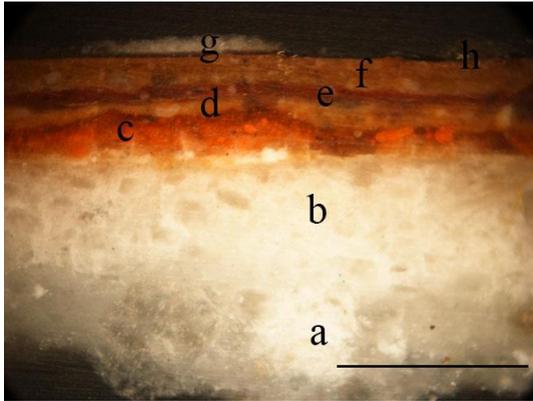
Figure 8. Cross section of SDRP1 showing several layers: (a) gypsum and aerial lime with traces of magnesium; (b) finish lime; (c), (d), (e), (f) sulphur, lead, iron; (g) sulphur, aluminium, iron and other; (h) gold leaf fragments.

SDRP1 consisting in a layer composed by a mix of gypsum and aerial lime with traces of magnesium (a Figure 8), a lime finish (b Figure 8) followed by an alternation of different layers composed by sulphur, iron and lead, probably given by minium and iron oxides. Only few, discontinuous fragments of gold have been found, while a quite continuous organic layer – still to be examined – covers the outermost surface.

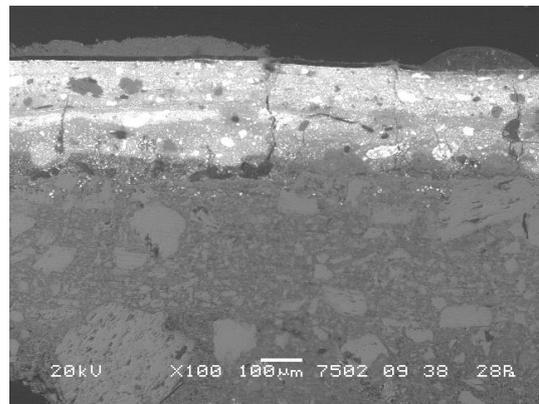
All samples have been primarily observed with stereomicroscope and subsequently cut in cross section to obtain a view of the sequence of layers: levelling, finish, and gilding. Up to now, an elemental determination has been achieved with SEM-EDS (Jeol 5910 LV) for the first three samples. An example of stratigraphy with the maps of the elements is shown in figures 8, 9 and 10 for

Figure 9. SEM-EDS image of sample SDRP1.

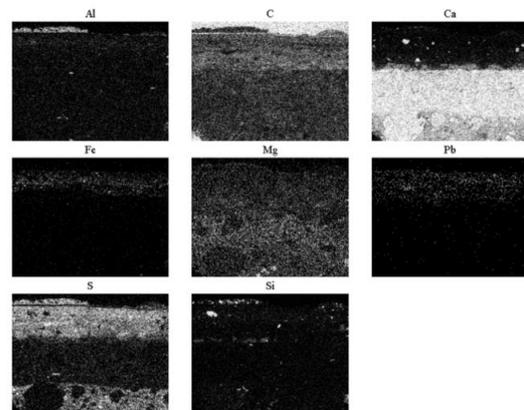
Figure 10. Map of the elements of sample SDRP1.

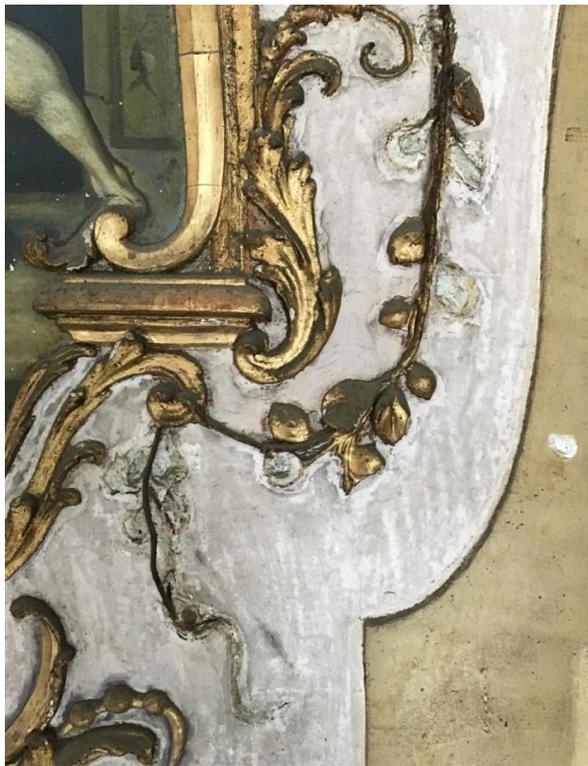
Figure 11. Wall 2: detail of the iron wires resembling stems from which leaves and blossoms hang.

called «stucco nails»⁹ which were placed at regular distances to hold stuccoes made on-site, and iron wires which were used both to hold stucco and to resemble stems from which flowers, blossoms and fruits were hanging (Figures 11 and 12). Generally in the case of on-site molded stuccoes mortars are lime-based with additions of gypsum, only-gypsum mortars were used when thin layers of flat stucco had to be applied as proven by the X-ray diffraction.

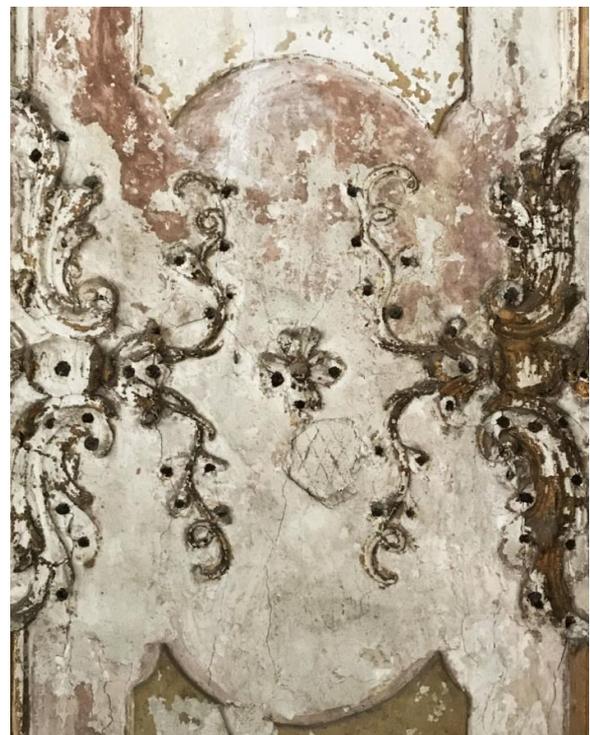
Stucco, used as surfaces' flat finish, was applied on carefully scraped keying coats (ICOMOS-ISCS 2008), as some lacunas revealing scratched substrates show. When stucco had to be molded to design ornaments, instead, procedures were consequently more elaborate. Depending on how much those decorations had to hang out of the surface, different structural elements were adopted. In the golden room for instance decayed spots clearly show two different types of such elements: the so

Figure 12. Wall 4: detail of the keying layer and of the iron nails used for on-site made stuccoes.
