VERNACULAR LANGUAGE WITHIN THE TRADITIONAL BELL TOWERS: BETWEEN STAIRS, LANDINGS AND FLOORS

A. Mondello^{1,*}, A. Salemi¹

KEY WORDS: Traditional bell towers, Traditional building techniques, Seismic vulnerability, Conservation, Eastern Sicily.

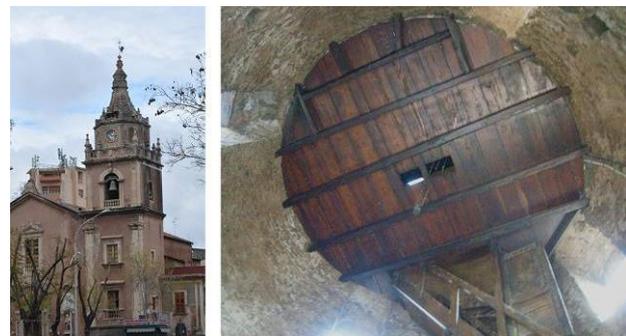
Figure 1. The bell tower of *Sant’Agata al Borgo* in Catania. On the right, the floor under the cusp.

Examples of this type are in the bell towers of the eighteenth-century churches of *Sant’Agata al Borgo* in Catania (Figure 1) and in *Sant’Antonio Abate* in Pedara (Figure 2), where beams and planking have been replaced during restoration works but re-proposing the original building techniques. In this case, according to common practice in minor residential architecture, there is a beam with a larger section under the floor supporting the main beams of the floor; this beam was probably added as support for some beams considered to be damaged (De Felice et al., 2006).

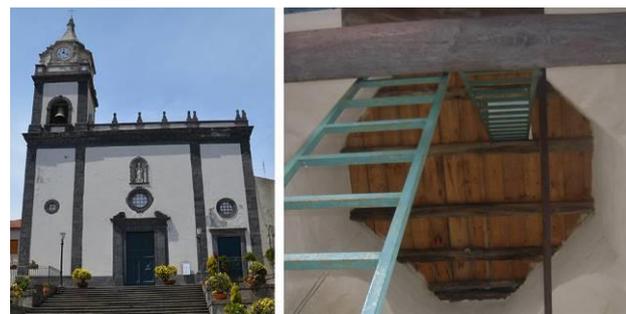
Figure 2. The bell tower of *Sant’Antonio Abate* in Pedara (Ct). On the right, the floor under the cusp.

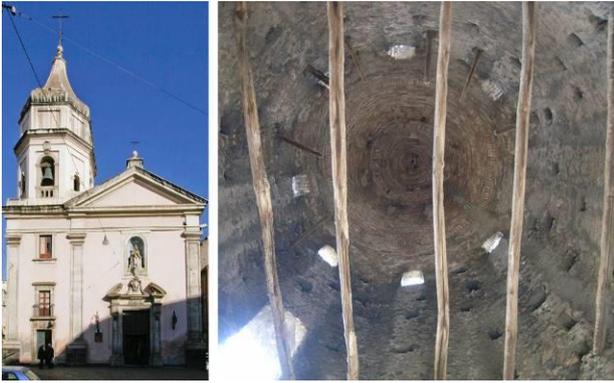
Figure 3. The bell tower of *Santa Maria di Monserrato* in Catania. On the right, original beams of the floor under the cusp.

Other examples of very light floors, with small beams (with cross-section of a diameter of 8 cm) can be found above the bell cell of the church of *Santa Maria di Monserrato* in Catania (Eighteenth century), now without planking (Figure 3), or in that of the church of *San Giovanni* in Bronte (Figure 4), dating back to 1614.

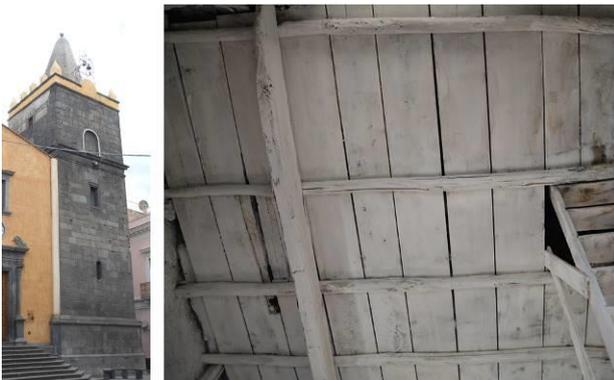
Figure 4. The bell tower of *San Giovanni* in Bronte (Ct). On the right, the floor under the cusp.

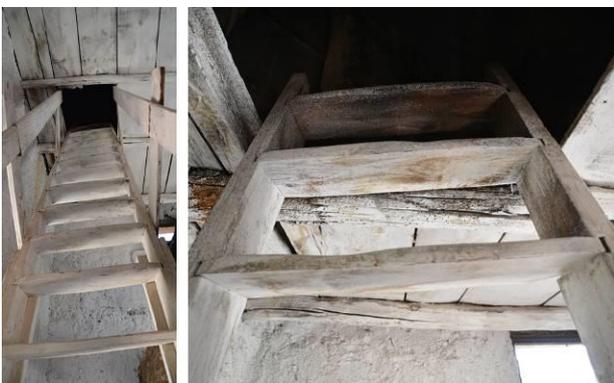
Figure 5. Stair in the bell cell of *San Giovanni* in Bronte (Ct).

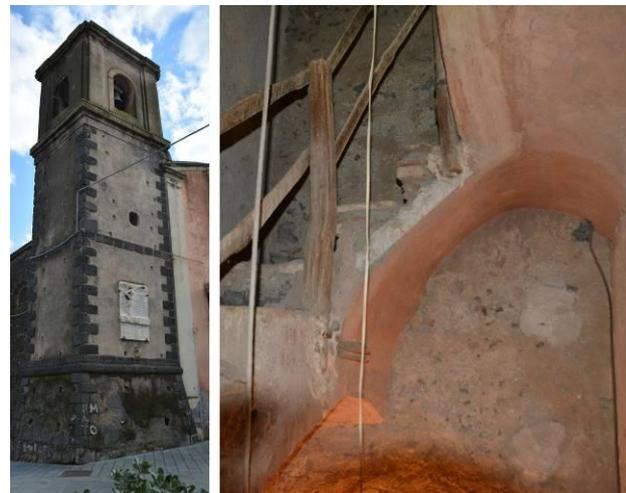
Figure 6. The bell tower of *San Giuseppe* in Aci Castello (Ct). Stairs on rampant vaults.

In the analysed specimens, such as the stairs of the bell tower of *San Giuseppe* in Aci Castello datable around 1742 (Figure 6), the thickness of this concrete shell is about 15 cm. The steps of this type of stair are in pressed brick masonry, with treads in quadrangular slabs of calcarenite or terracotta.

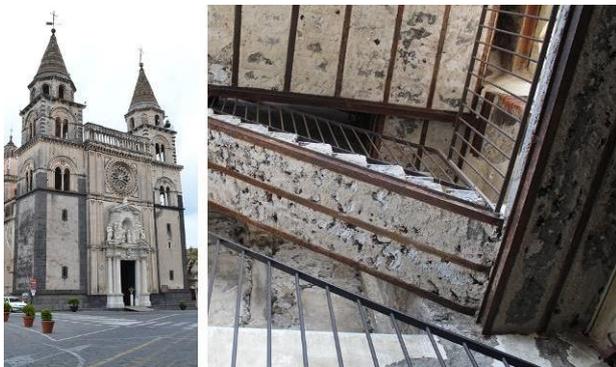
Figure 7. The bell towers of the Cathedral of Acireale (Ct). Floors, stairs and landings with NP iron beams.

The replacements (now “historical”) often involved the intermediate wooden floors and stairs systems on rampant vaults. Until the first half of the twentieth century, in the Etna area, these components were often replaced by floors, ramps and landings with double-T iron beams (called “Normal Profile” or “NP”). These beams are arranged with variable spacing between 60 cm and 80 cm. The filling, between one beam and the other, changes according to the age of construction. In the oldest cases, this was in pumice stone and gypsum mortar, in analogy to the building techniques of the vaults (Randazzo, 1988). We can find examples of this type in the ramps and landings of the towers of the Acireale *Cathedral* (about 1544) (Figure 7) or those of the bell cell in the church of *San Filippo* in Aci San Filippo (1559) (Figure 8). In more recent cases, the filling in pumice and gypsum mortar is replaced by brick panels, as we can see on the second floor of the tower of *San Giovanni* in Bronte. In this tower, the replacement intervention has not erased the memory of the original construction system, so the support beams of the previous wooden floor remain below the new structure (Figure 9). In the case of the flights of stairs made with this technique, the steps are in concrete.

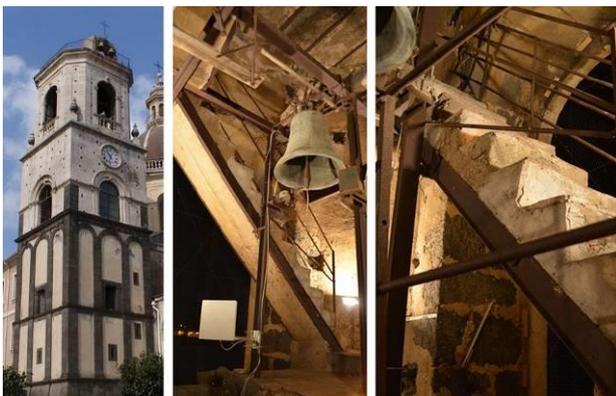
Figure 8. The bell tower of San Filippo in Aci San Filippo (Aci Catena - Ct). Stairs with NP iron beams.

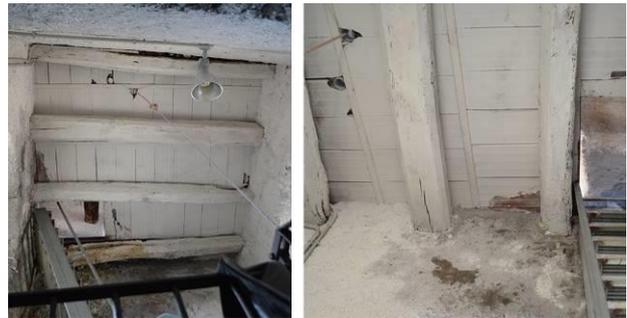
Figure 9. Intermediate floor in the bell tower of *San Giovanni* in Bronte (Ct).

Where wooden floors have been replaced with iron beam systems, wooden stairs have also been replaced with similar iron ones. In some cases, the emptying of the tower involved the installation of an iron spiral stair, like in the belfry of the *SS. Crocifisso di Majorana* in Catania. (Figure 10).

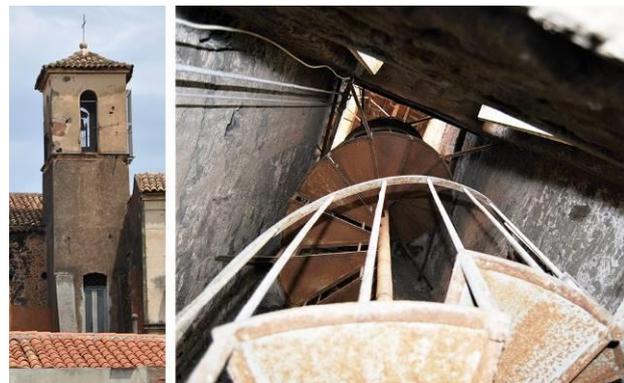
Figure 10. The bell tower of the *SS. Crocifisso di Majorana* in Catania. Iron spiral staircase.

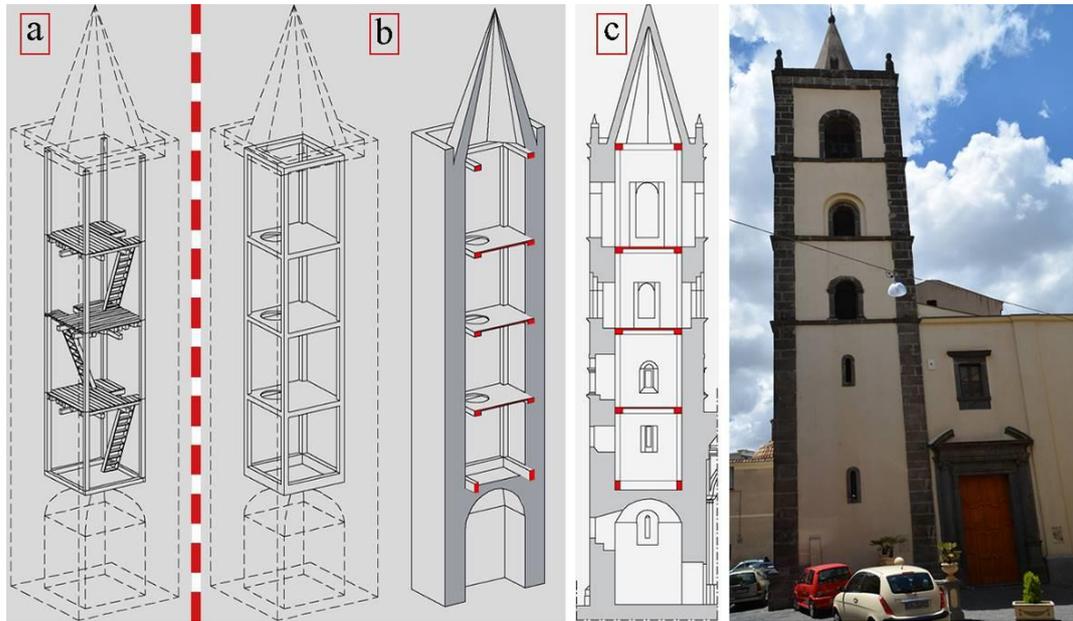
Figure 11. The bell tower of SS. Trinità in Bronte (Ct): a) 3D scheme of one of the hypotheses on the original wooden structure. b) Overall dimensions of the reinforced concrete structure inside the tower: three-dimensional scheme. c) Cross-section of the tower: in red, the reinforced concrete structure.

The belfry of the *SS. Trinità* church in Bronte was built in subsequent stages starting from 1579. The sixteenth century pastoral visits date the start of the construction of the internal staircase systems from 1598 (Mandalà, 1997). The tower follows many dictates of the C. Borromeo “Instructions” for the new churches (Della Torre et al., 2000). About 30 m high and with a quadrangular plan of about 13 m², the bell tower is leaning against the main nave and has a pavilion vault on the first level; a high pyramidal cusp crowns the top of the fifth level. Some pictures dating back to 1966, preserved in the Archive of the Superintendence of Cultural Heritage of Catania, allow us to formulate some hypotheses on how the interior of the tower could have looked before the interventions that transformed it between the 70s and 90s of the twentieth century. Despite the narrow field of view of the examined frames, which does not allow a complete understanding of the complex wooden structures, a first hypothesis that we can formulate would indicate the intermediate levels of the bell tower characterized by rudimentary floors with twin main beams.

These beams were roughly hewn and supported the upper planking. Under these, additional auxiliary beams were placed next to the stair and placed orthogonally to the main beams of the floor.

As already mentioned for other buildings, these reinforcing beams may have been added later, since their location near the archivolts of the windows indicates an incongruous arrangement for the organisation of the masonry and weaving of the original floor (De Felice et al., 2006) (Figure 11). The stairs were either wooden ladders with pegs or ramps with “cosciali”.

Instead of the described floors, another hypothesis (not very usual in this area) could suggest a system of wooden stairs and balconies, leaning against the internal perimeter of the tower and consisting of cantilevered wooden floors supported by several auxiliary beams.

In both hypotheses, moreover, it is certain that at the inner corners of the bell tower there were four wooden columns, for the whole height of the tower and resting above the pavilion vault on the ground floor (perhaps above a wooden curb). These columns, fixed to the walls with specific iron brackets, supported the wooden structures on which the bells were hung on the last level. At the end of the 60s of the twentieth century, the parish priest reported to the Superintendence evident vertical cracks on the façades. These cracks connected the windows of each level of the tower and were the evident trace of an incipient damage mechanism by vertical subdivision in the absence of effective chaining of the perimeter walls.

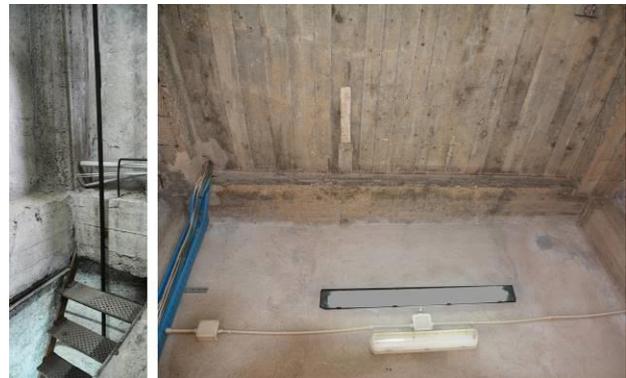
Figure 12. The new reinforced concrete structure in the bell tower of SS. Trinità in Bronte (Ct).

The new construction is characterized by beams (27x40 cm), pillars (27x27 cm) and thin reinforced concrete plate slab (8 cm thick) (Figure 12). This frame is characterized by a lower curb (with a cross-section of 27x52 cm), which rests above the vault of the ground floor; at the upper end, the frame supports the steel beams on which the large bells are now hung. The spiral staircases installed are made of steel. (Figure 13).

The high reinforced concrete structure (without a real foundation) of the *SS. Trinità* bell tower in Bronte shows dynamic behaviour that is different from the masonry structures to which it is leaning. In the event of an earthquake, the two adjacent structures could resonate, oscillating independently of each other and triggering a dangerous interpenetration of the concrete frame in the masonry.

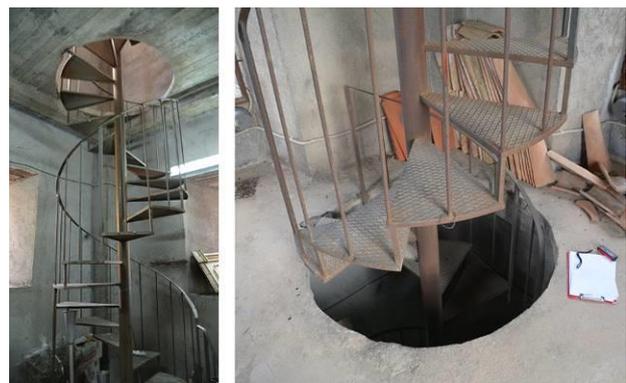
Figure 13. The steel spiral staircase in the bell tower of SS. Trinità in Bronte (Ct).

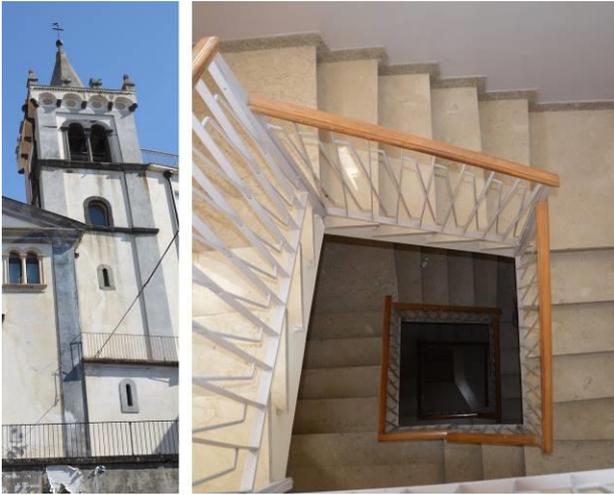
Figure 14. The bell tower of Santa Maria della Catena in Bronte (Ct). Inner staircase.

Although we have not found the documentation during the archival investigation and we cannot know what the internal space originally looked like, it is evident that a replacement work with a system of reinforced concrete stairs has been carried out (Figure 14). This structure does not lead to the bell cell but is used as a service staircase for the school buildings built in adherence to the tower, in the second half of the twentieth century.
