PRELIMINARY ANALYSIS OF EARTHEN ARCHITECTURE RESPONSE TO FLOODS: THE CASE OF ALZIRA (SPAIN)

F. Trizio ^{1,3,*}, C. Mileto ^{1,3}, F.J. Torrijo Echarri ^{2,3}, M. Lidón de Miguel ^{1,3}

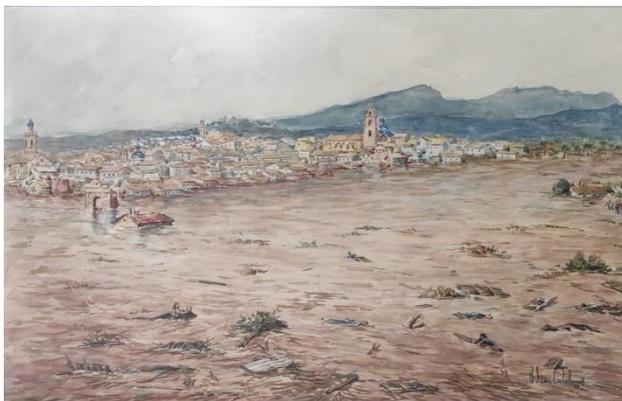
Figure 2. Alzira after the 1864 flood.
(Archivo Municipal de Alzira)

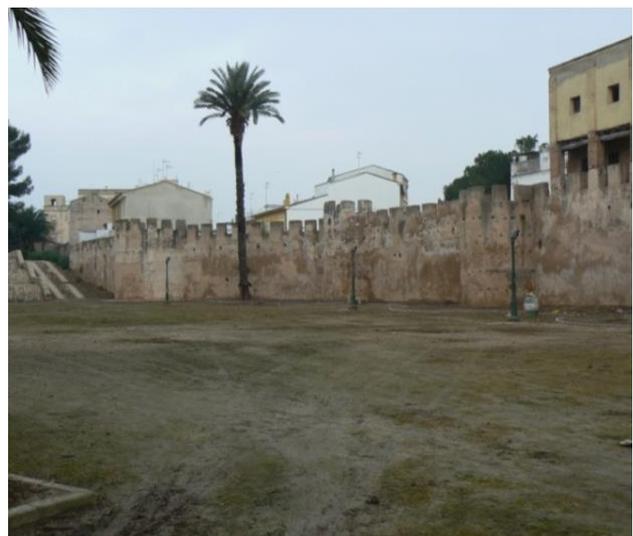
Figure 3. The Moorish wall (PEP – Alzira).

In the historic centre of the Vila of Alzira, the role of the Moorish wall is of great historical and architectural interest. The wall is a defensive construction which, according to documents, dates back to the 13th century. It is built almost entirely of rammed earth, with merlons and semi-circular towers, and is an important example of monumental earthen architecture which has managed to survive the ravages of time, despite repeated exposure to floods and other causes of degradation.

The defensive function of the wall was two-fold, as it provided military defence from possible invasions while also acting as protection from the numerous floods of the river. This hypothesis is suggested by the semi-circular towers, since as opposed to square configurations, semi-circular shapes make it possible to avoid corners, which would suffer the greatest deterioration in case of flooding. One of the consequences of the frequent floods has been the gradual rise of the ground level; this has buried the lower section under deposits of detritus. Today the wall appears partially modified, as parts of it have been embedded between the adjacent buildings over the centuries, as can be seen in the towers and some areas of the wall. Between 1975 and 1982 the wall was restored creating a park with the wall (Parque de las Murallas), and in 1986, the new Parque de Arabia Saudi was opened to the public.

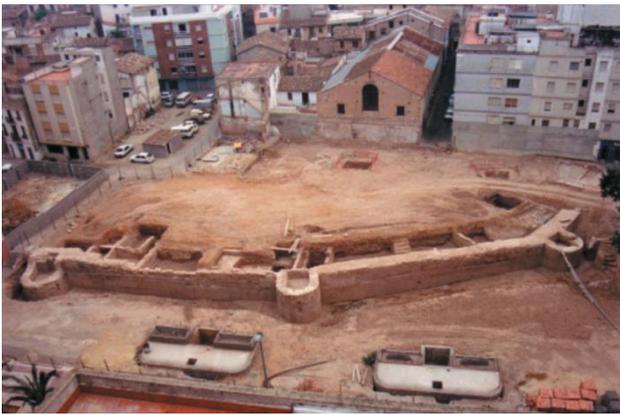
Figure 4. Archaeological excavation of the wall. (PEP – Alzira)

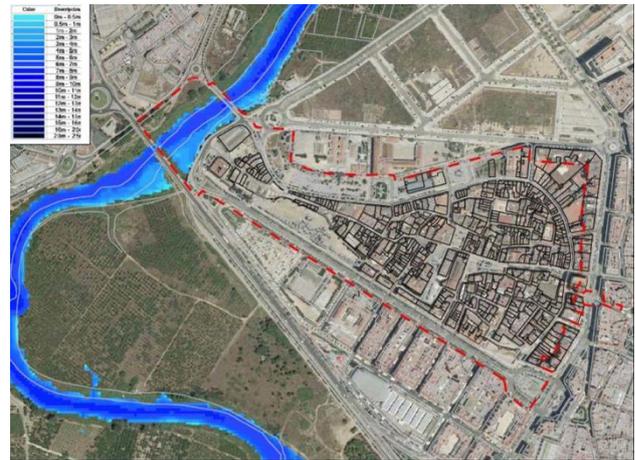
Figure 5. Draught levels. Return period of 10 years. (SNCZI)

For this purpose, systematic analysis of the sources is useful for establishing the criteria for content analysis and drawing up evaluation forms to catalogue and encode any elements of significance found in the analyses. Similarly, predictions and analyses will help determine the surrounding flood areas, assessing flood hydrographs for the considered return period.

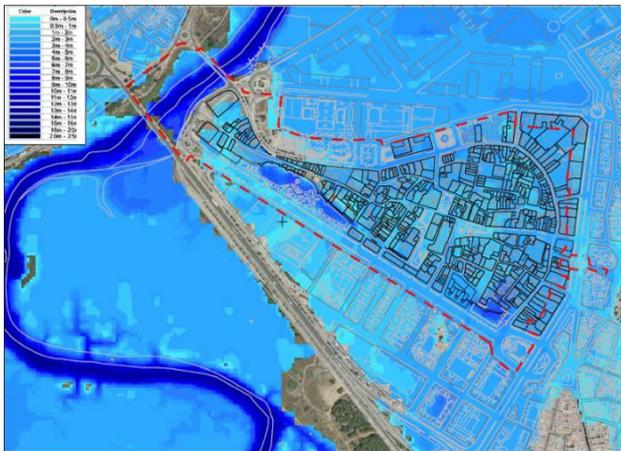
Figure 7. Draught levels. Return period of 500 years. (SNCZI)
