ARCHITECTURAL HERITAGE AT RISK: THE CASE OF THE MAGNANO HAMLET (PIEDMONT, ITALY)

This contribution aims at illustrating the results of an investigation conducted in Magnano's hamlet in order to highlight discrepancies between theoretical issues, regulatory requirements and operating practices. The latter testifies to a lack of respect for the identity characteristics of the architectural artefacts that are altered without identifying appropriate compromise solutions between functional requirements and conservation issues.

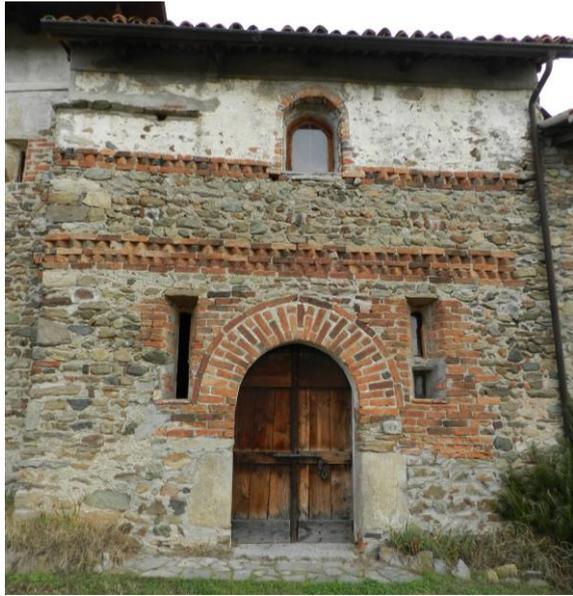
Figure 5. Brick decorative elements (credits Manuela Mattone).

The openings are mostly delimited by fired bricks to be referred to interventions carried out in the XVth century on the existing wall structure (Vigilino Davico, 1978). Sometimes, bricks are also used for decorative purposes: elements such as cornices and notches adorn some buildings' façade (Figure 5).

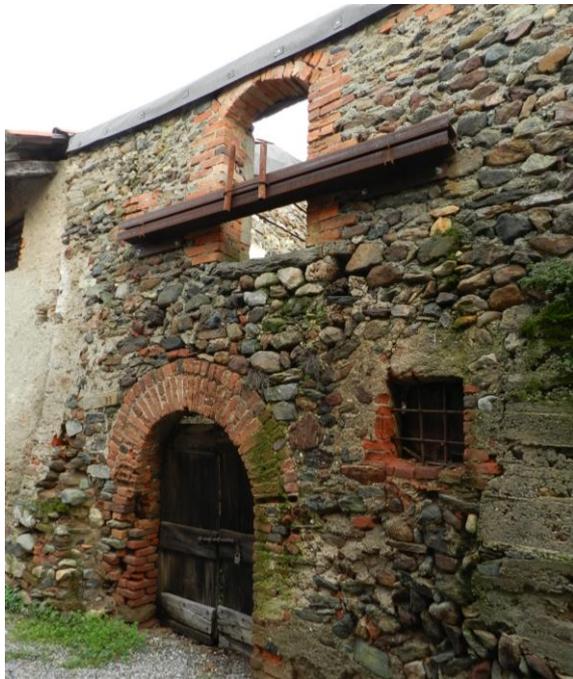
Figure 6. Building C - Temporary consolidation intervention carried out by the municipality (credits Manuela Mattone).

Abandoned for years, some buildings are without roof and their stability is guaranteed through temporary static aids, positioned by the municipal administration in order to avoid their collapse (Figure 6).

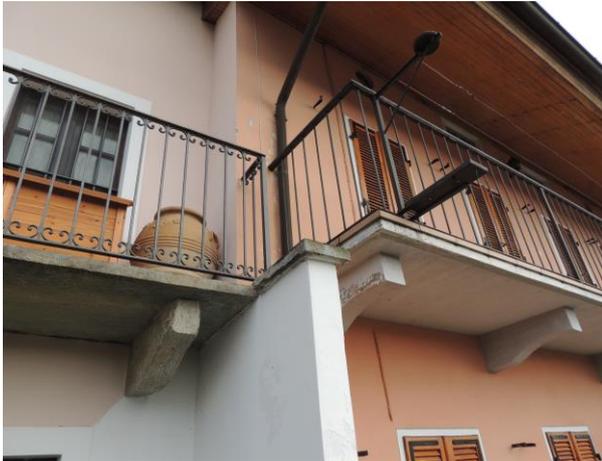
Figure 7. Building E - Balcony with reinforced concrete structure (credits Fabio Fratini).

2.2.1 Adaptation of the historical built: Over time, some of the buildings of the hamlet have undergone interventions aimed at ensuring their re-use for residential purposes. They provided for the restoration of missing parts and the reshaping of the buildings in relation to aesthetic tastes and functional needs of the owners. Specific conservation requirements of the cultural heritage have not been sufficiently taken into account and interventions compromising its integrity and inherent values have been carried out. They led to a significant transformation of the buildings which often lost their specific features. The only recognised value was the use value, which lead to the adaptation of the built to changing conditions in order to make it able to suit the new needs. The insertion of balconies with reinforced concrete structure (Figure 7); the insertion of stone slab coverings along the baseboards and of ceramic tiles on the external floors (Figure 8); the addition of wooden battens in the overhang of the roof (Figure 9); the replacement of windows and the application of finishing plasters testify to the lack of attention towards the architectural heritage which is altered without paying sufficient attention to its historical-cultural as well as formal characteristics. Integrations and replacements are carried out by compromising the preservation of the architectural artefacts both at the typological and construction level and causing the irremediable loss of their identity.

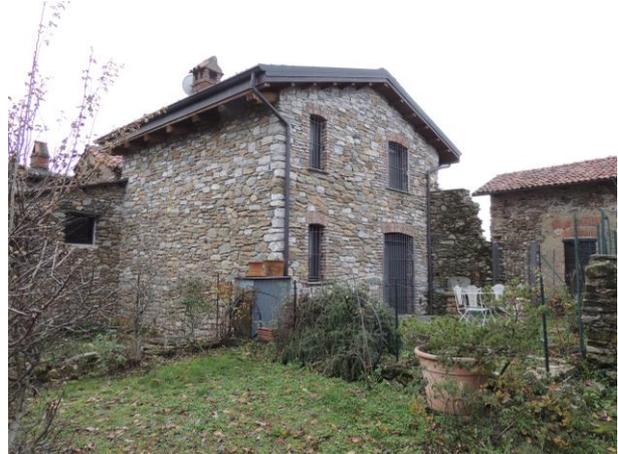
Figure 10. Building D - Reintegration of the upper part of the walls and of the roof (credits Manuela Mattone).

The same applies to restoration interventions that involve the reintegration of destroyed parts of the buildings such as walls, roofs, windows. Although the materials used are similar to the original ones, the treatment reserved for them is totally different. The methods of laying the stone and the bedding mortar change; the thickness of the roof is improved, presumably in relation to the desire to guarantee higher energy performances (Figure 10).

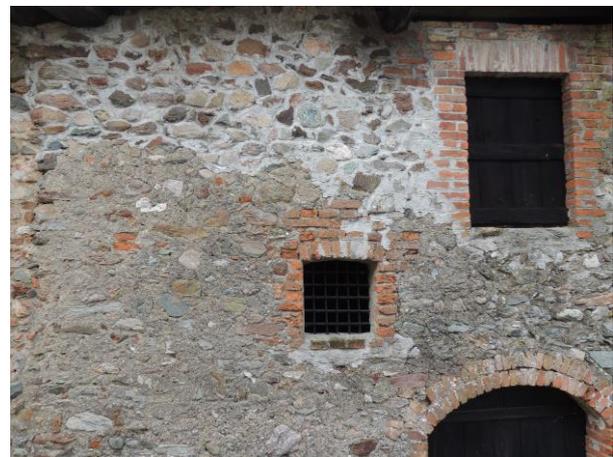
Figure 11. Building B - Reintegration of the masonry adopting inappropriate materials (credits Fabio Fratini).

2.2.2 Incompatible materials and technique: Numerous inappropriate punctual interventions have also been done. Restoration of the walls has been often carried out using inadequate laying materials and methods. Particularly noteworthy is the widespread use of cement mortar not only for the bedding of bricks, but also for the reintegration of cracks and heavily eroded bricks (Figures 11 to 15).

This intervention is incompatible not only from the mechanical point of view (elastic modulus of the whole), but also as regards the chemical (development of saline efflorescence) and physical compatibility (different behaviour towards water both in liquid and vapour form).

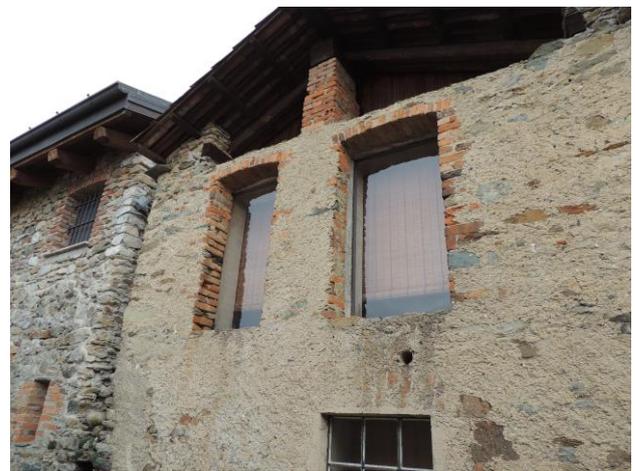
Figure 16. Building F - Intervention preserving both the external masonry surfaces and the roof (credits Silvia Rescic).

Interesting in this sense are the examples of Figures 16 and 17. In the first case, the intervention aimed at ensuring the re-use of the building was carried out without changing the characteristics of the masonry surface and of the roof, whose thickness was not altered.

In order to solve the problems due to the lack of light in the interior, windows were replaced adopting thin window frames (Figure 16).

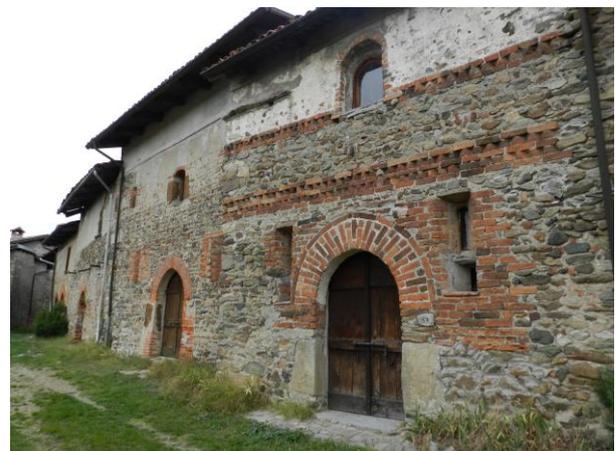
Figure 17. Building H - Preservation of the surface of the external wall and of the access portal (credits Silvia Rescic).

Preservation of the external wall surfaces and their stratifications, as well as of the finishing elements (such as the access portal) characterise also the intervention shown in Figure 17.
