MULTISENSOR DATA FUSION FOR CULTURE HERITAGE ASSETS MONITORING AND PREVENTIVE CONSERVATION

The research was carried out on the church of San Michele Arcangelo in Padula, affected by plaster detachment from the frescoes on the intrados of the vaulted systems. The work was conceived to support a mainly qualitative assessment regarding a possible relationship between micro-environmental variations and visually perceived degradation phenomena to provide a first indication of the conservation status of the investigated surfaces. The analyses were conducted through algorithms that, as such, are repeatable and objective. In addition, these processes, as they were applied to the models derived from the architectural survey, made it possible to make the most of these outputs. Therefore, by combining the algorithmic manipulation of the digital representations with the necessary critical interpretation of the data by the specialist, it was possible to address some actions of direct intervention and guide the most appropriate choices for subsequent in-depth diagnostics, more targeted, reducing the damage to the historical heritage.

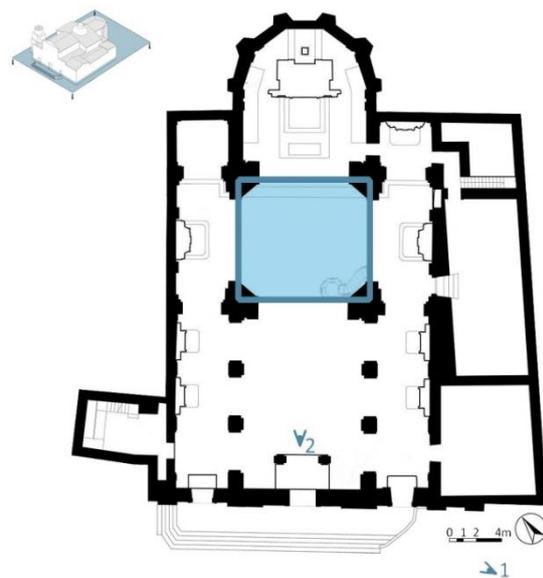
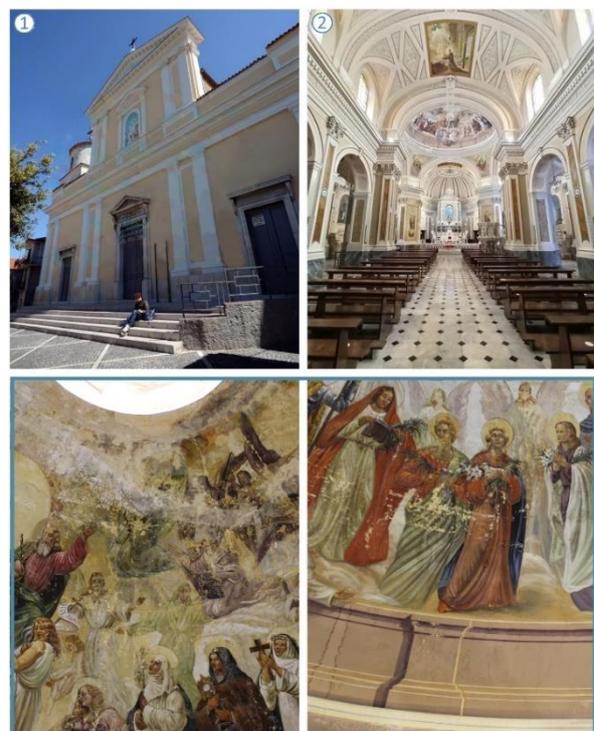
Figure 1. Church of San Michele Arcangelo in Padula. Plan and photographs of the façade and interior. Detailed images of the damaged frescoes of the dome.

Several fresco cycles adorn the vaulted roof systems, mainly by the artist Rocco Pennino and dating from 1954. Among these, the figures on the dome covering the transept today show the signs of the most serious deterioration, with phenomena that can be attributable to the detachment of the surface plaster (Fig. 1).

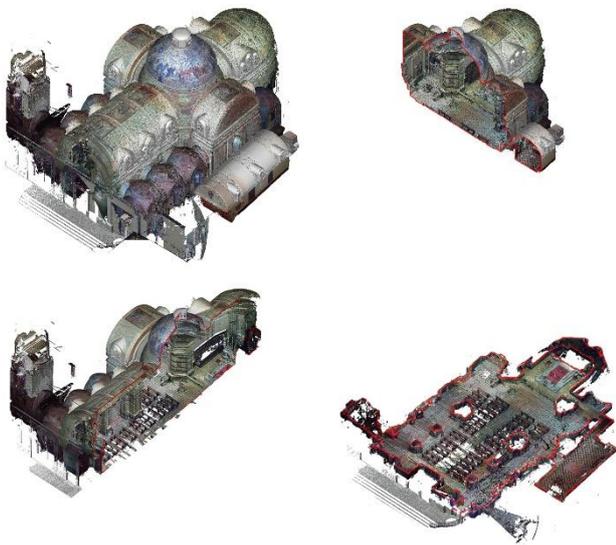
Figure 2. TLS point cloud. Section operations with horizontal and vertical planes for the extraction of orthophotos.

The resulting cloud was used as a starting point for the subsequent steps of informative expansion and deepening of the details. First of all, traditional 2D graphics were prepared, obtained by manipulation and integration of the lines automatically extracted from orthophotos, obtained by setting cutting planes of the points cloud, with both horizontal and vertical orientation (Fig. 2).

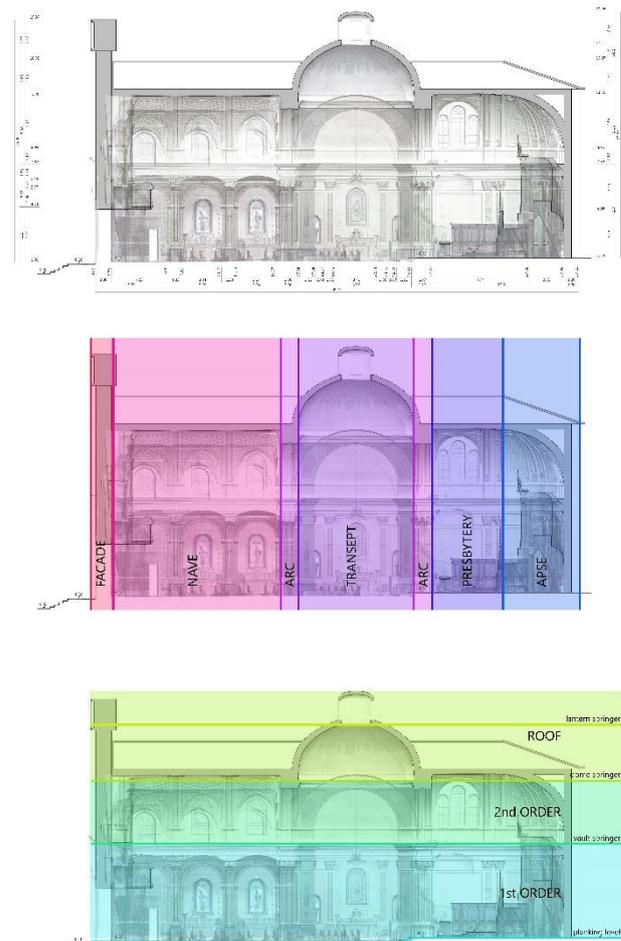
Figure 3. Traditional technical drawings related to the semantic conceptual segmentation of the model according to the AAT thesaurus and historical treatises.

the domain of interest; on the other hand, to historical treatises and specific manuals on sacral architecture for the geometric perimeter of the macro and micro semantic components (Fig. 3).

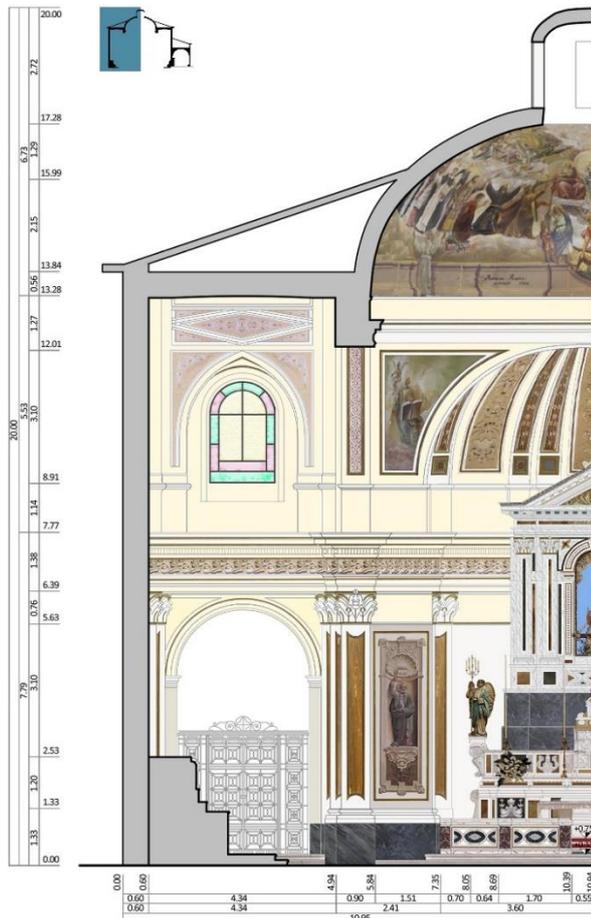
Figure 4. Example of filing and mapping of materials and their colours in relation to the architectural space, segmented and annotated with the semantic concept of "transept".

Once the model of the church had been semantically broken down into conceptual form, analysis and mapping sheets were produced for the main materials present, organized in a critical manner and related to the semantic elements, which the cathedral was divided. The graphic representation of the catalogued materials follows the indications of the Italian standard UNI 3972:1981 for the graphic representation of architectural materials.

The catalogued materials have also been associated with a sampling of their respective colors; this result has been obtained, in this first cognitive phase, with a computerized recognition system, based on the comparison with a computerized color catalogue. Each color is expressed both in the additive RGB color model and in the subtractive CMYK model, in order to take into account both the digital/informative aspect of color-sampling and the printing of the schedules produced (Fig. 4).

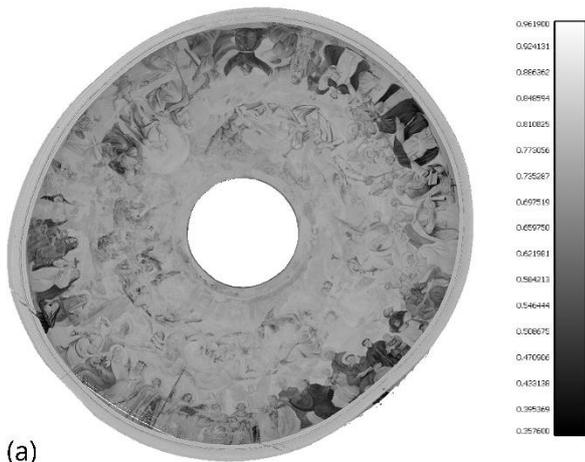
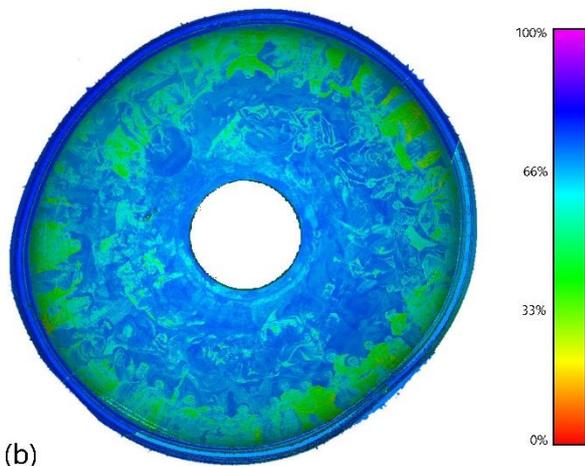
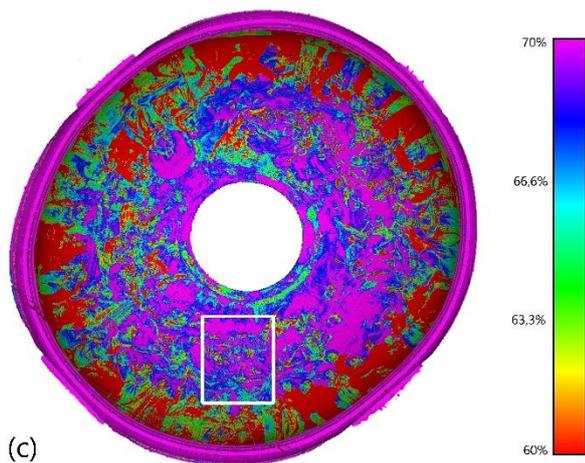
Figure 5. Manipulation of the reflectance maps obtained with the TLS survey (a, b). By varying the range of the percentage value (c) it is possible to extract progressively more significant information for the damaged portions of the fresco.

At a first impression, shown in (Cera, 2021), the reflectance map with these intervals seems not to reveal significant data for the areas affected by the plaster detachment. In fact, these areas are not distinguishable by shape in the colour palette, showing, on

the contrary, part of areas with homogeneous macroscopic behaviour (Fig. 5a, 5b).

portions of the map comprising the damaged sections, the ranges of values were manipulated, working in steps of 5 and 10 percentage points. The resulting new map now shows more clearly small, isolated areas, with reflection values around 60%, in contrast to the macroscopic behaviour of the surrounding region (Fig. 5c). The geometry of these small areas can be traced back to those areas affected by the plaster detachment. These can now be easily traced back to the pathological phenomenon and not to a chromatic variation of the finishing layer since they are located in areas where the figurative continuity of the representation is clearly interrupted (Fig. 6).

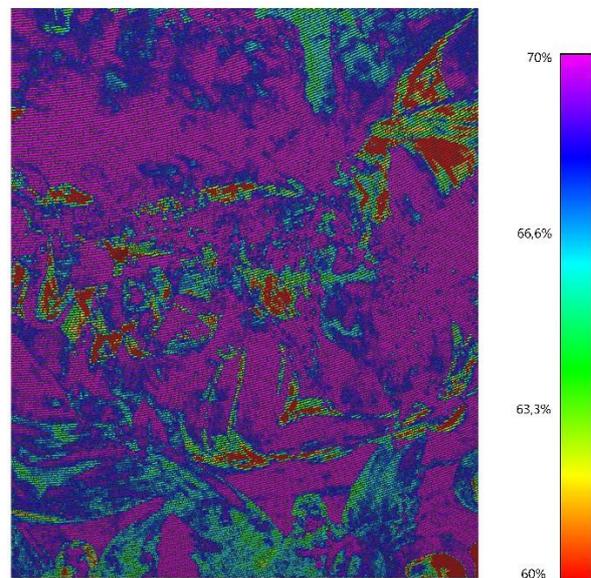
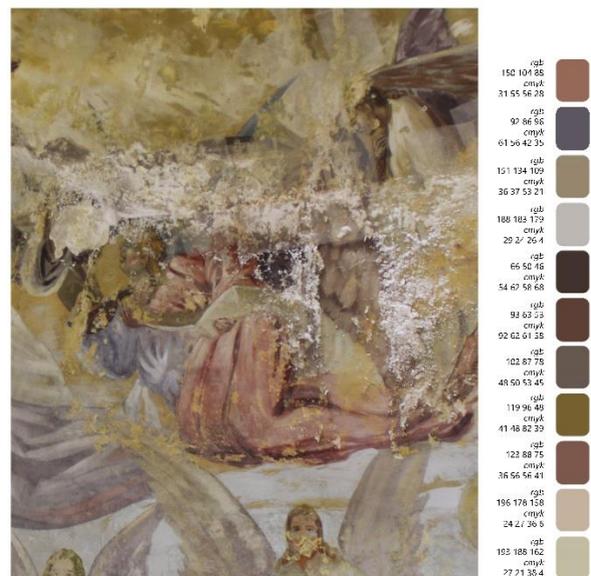
Figure 6. Reflectance map and colour classification for a detailed portion of the damaged fresco. The variations highlight portions with inhomogeneous and inconsistent behaviour.

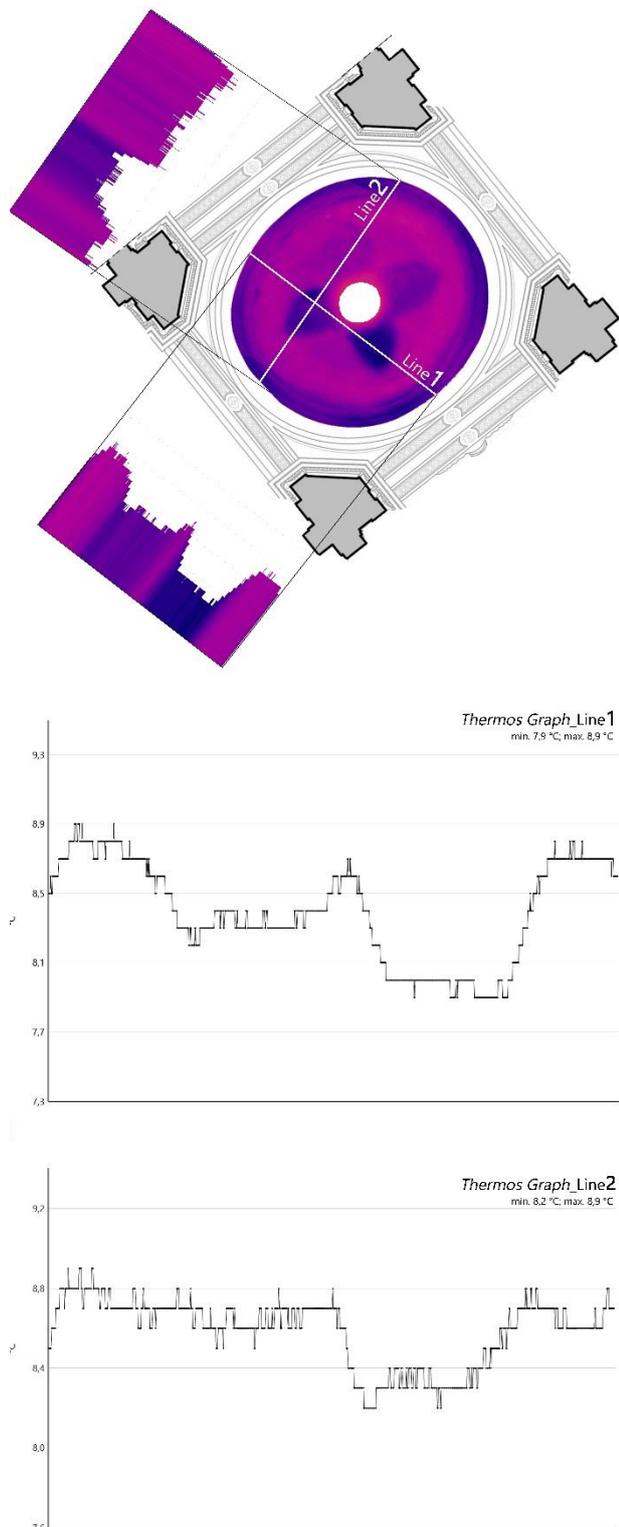
Figure 7. Model of the thermal behaviour of the dome. The extracted graphs show the 4 coldest areas and their temperature variations.

To support this new consideration, the investigation was deepened by cross-referencing the variations in reflectance with the thermal states. Both in summer and winter, the thermographic reading reveals the presence of 4 cold areas descending from the lantern towards the springer, with a lower temperature (0.8 or 1.9 degrees depending on the season) than the surrounding areas and much more extensive than the visually affected parts (Fig. 7).

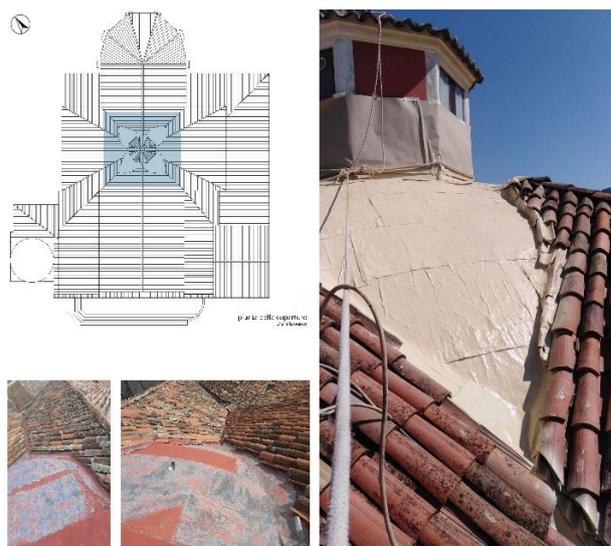
Figure 8. Situation at the extrados of the dome. It is possible to clearly see the 4 areas without waterproofing.

A previous visual inspection carried out on the extrados has already made it possible to trace these portions back to areas of the dome surface where adequate insulation, now installed, was not present (Fig. 8).
