## DETECTION OF RESTORATION WORK BY APPLYING THE RANSAC ALGORITHM TO THE POINT CLOUD DATA FROM LASER SCANNING: CASE STUDY AT OSTIA

**KEY WORDS:** Laser scanning, RANSAC algorithm, Restoration, Roman building, Ostia

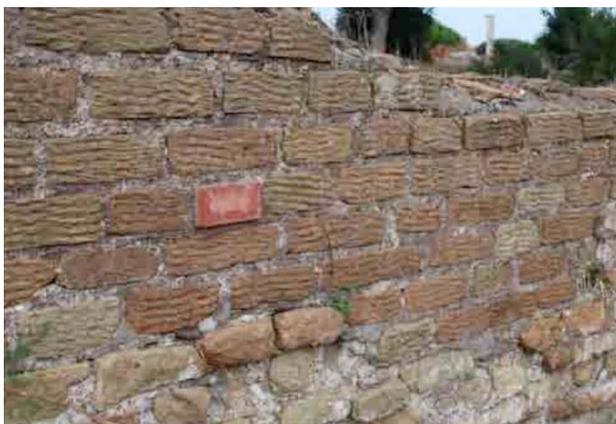
**Figure 2.** Restoration in Guild Temple with a small plaque with restoration year and scratched bricks [Rinaldi, 2012]

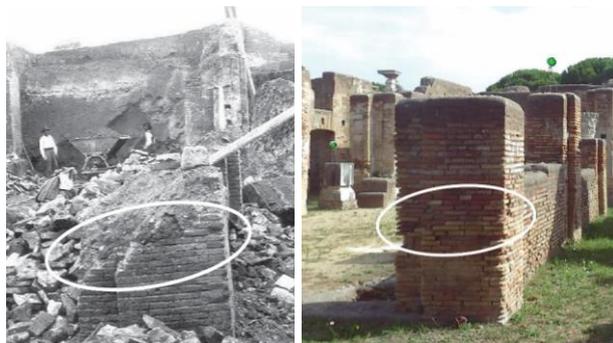
**Figure 3.** Restoration in Houses of Triclinium [left: old photograph of Parco Archeologico di Ostia Antica A 2474, right: photograph taken in 2015]

In Ostia site, we still could find some restoration parts which are easy to be differentiated from the original ancient Roman parts. The traces of restoration and reconstruction work are left purposely. For example, the bricks with the restoration year stamped on them are embedded in the restoration areas, and the bricks in the restoration areas are scratched purposely to make it easier to be identified from the ancient Roman remains. (fig. 2) Especially during the large-scale excavations, some remains have not been restored in this manner. Thus, it is difficult for later generations of researchers, craftsmen, and technicians to identify the restoration parts without the help of restoration traces. (fig. 3)

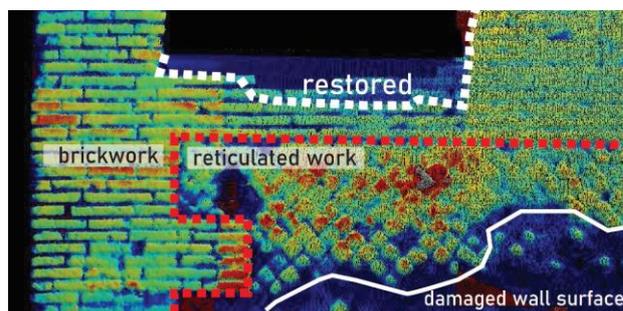
**Figure 5.** Traces visible in the colour gradation

The point cloud was coloured gradations based on the deviation of the surface from the most optimal plane. Points almost on the plane were coloured in green, ones behind the plane are coloured in blue and ones in front are coloured in red. A surface of Roman buildings can be distinguished from a restored surface without archaeological expertise, based on a clear gap in the colour gradations. In this way, some damaged parts were also found out because weathering surfaces of burned bricks or tufa (a kind of limestone) does not perfectly match an optimum plane. Such clearly dividing lines on colour gradations can be regarded as joints between original Roman buildings and restored parts. (fig 4,5)

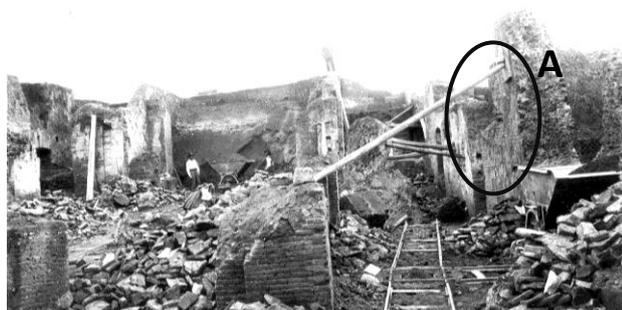
**Figure 7.** Excavations of the Houses of Triclinium [Old photograph of Parco Archeologico di Ostia Antica A 2474]

An old photograph depicting the excavation work at Houses of Triclinium is shown in figure 7. Unfinished restoration works can be seen in this figure. In the photograph taken in 2015, the restoration parts could be easily traced comparing with one in the old photograph. (fig. 8) However, it is difficult to distinguish the restored parts from the original Roman building parts without comparing with figure 7. The edge of the restored part which matches with the edge of the broken column in the old

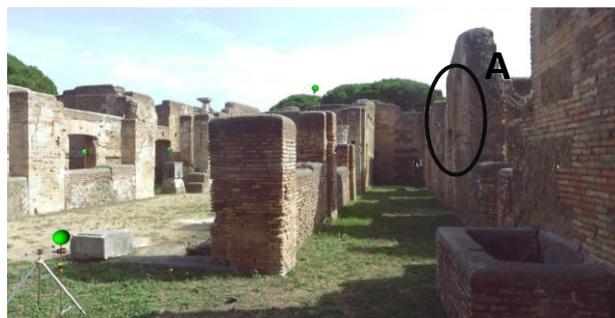
**Figure 8.** Houses of Triclinium in 2015

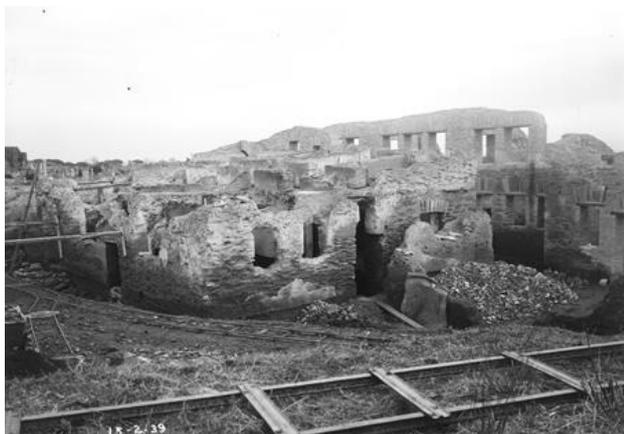
**Figure 11.** Excavation of the House of Painted Vaults in 1939 [Old photograph of Parco Archeologico di Ostia Antica B 2803]

By comparing the excavation photo with the remains nowadays, the higher parts in the façade of House of Painted Vaults have been restored. (fig. 11, 12) A few dividing lines are observable without analysis. These dividing lines are probably caused during the restoration. Other than these visible dividing lines, more uneven parts which could be considered as the joint of the restoration were also observed from the parts showing a clear gap in the colour gradation in Figure 13.

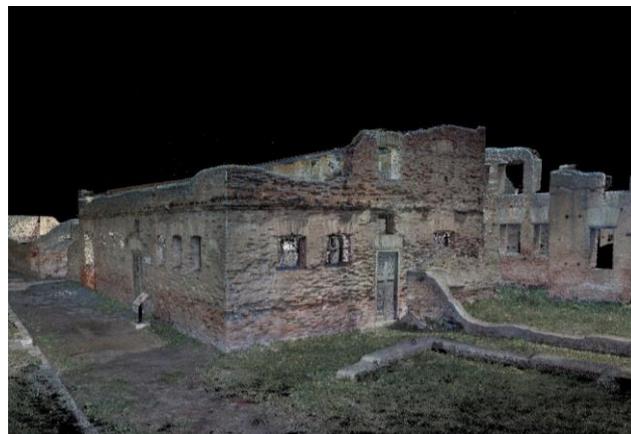
**Figure 12.** House of Painted Vaults in 2019

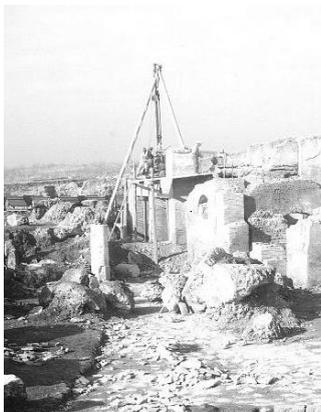
**Figure 16.** Restoration of the Houses of Chariot Coachmen (1939). [Old photograph of Parco Archeologico di Ostia Antica B2765]

In Houses of Chariot Coachmen, the restoration work was going on when the photo was taken in 1939. (fig. 16) Compared with

the coloured point cloud, the exterior wall with the windows was reconstructed. There are several clearly visible and continuous parts showing a clear gap in the colour gradation from one end of the wall to the other. (fig. 17) These could be the joint between the restored section and the original wall.

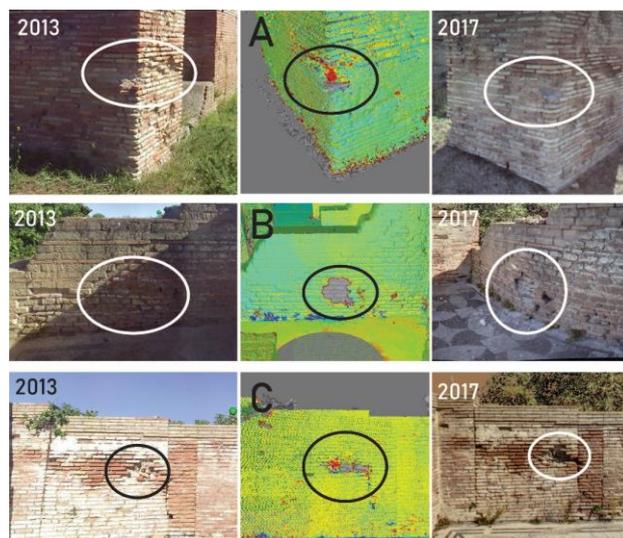
**Figure 19.** Parts showing changes in the House of Wrestlers

House of Wrestlers was surveyed in 2013 and 2017. The ruins of House of Wrestlers only partly remain in the lower part. Figure 18 shows that the inclination problem did not occur during this five year. Most of the parts are shown in green, which means that the deviation between these two point clouds is almost 0. From the comparison result, we found some bricks and stucco (mortar) falling off the wall. (fig. 19) The change in stucco (mortar) falling off is difficult to identify from the figure. In order to make the before and after changes in the mortar easier to identify, we made use of the RANSAC plane analysis explained in the previous chapter. (fig. 20, 21)
