DOCUMENTATION OF STRUCTURAL DAMAGE AND MATERIAL DECAY PHENOMENA IN H-BIM SYSTEMS

KEY WORDS: HBIM, damage modelling, decay, structural damage, HBIM Toolbar, web-based platform

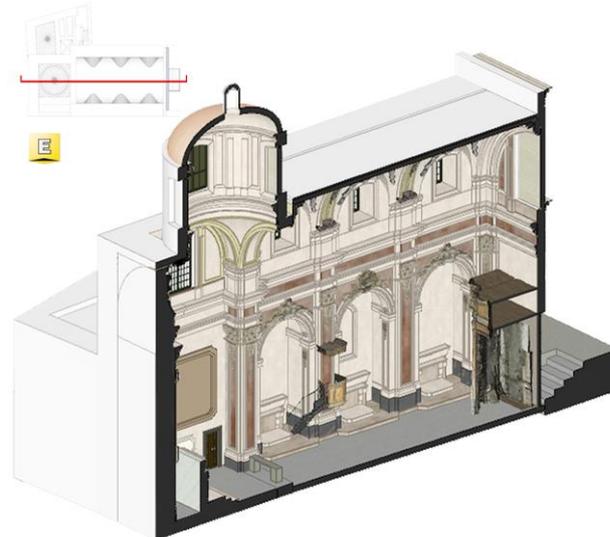
Figure 1. Church of San Pietro in Vinculis, Naples (Italy): BIM model in *Edificius*.

This paper reports the results of these experimentations, in relation to a case study located in the Church of San Pietro in Vinculis in Naples (fig. 1). The peculiar condition of decay, due to the abandonment of the church in the last decades, has made it possible to test the compliance of the digital tools set up, in relation to a wide range of phenomena (figg. 2, 3)

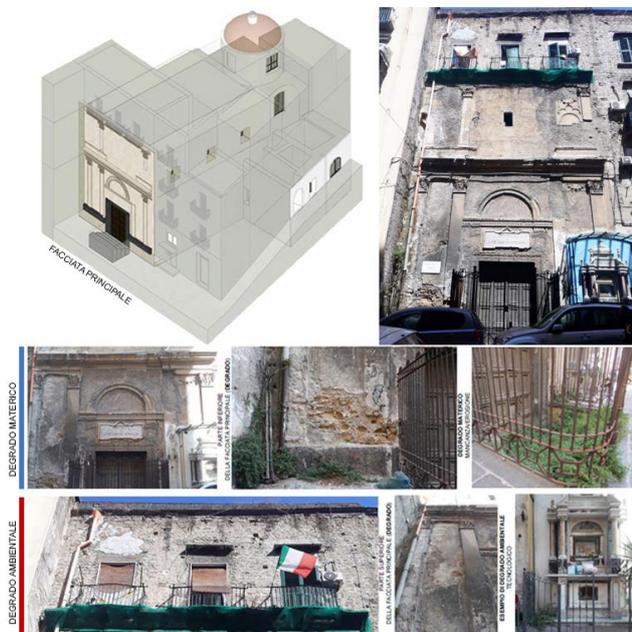
Figure 2. Facade of Church of San Pietro in Vinculis, state of conservation.

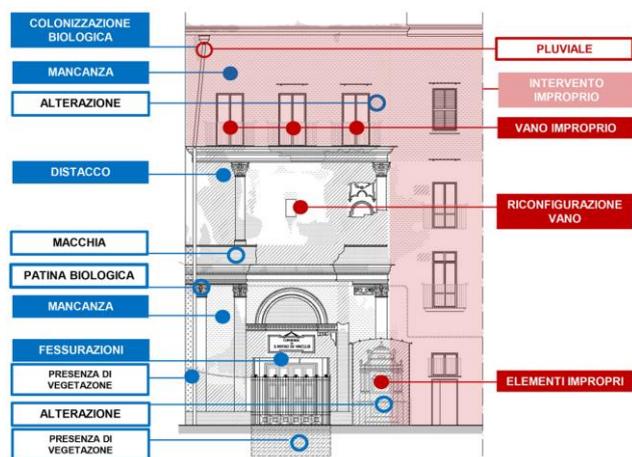
Figure 3. Facade of Church of San Pietro in Vinculis, decay mapping.

For the main façade, adopting the specific terminology that indicates the types of degradations and alterations reported in the mentioned UNI 1182 code, many phenomena of material decay have been identified (*chromatic alteration, dust, detachment, stain, loss, biological crust, presence of vegetation*), numerous cracks, as well as evident modifications in the original form of the façade, revealed by the presence of improper elements and systems of different nature.

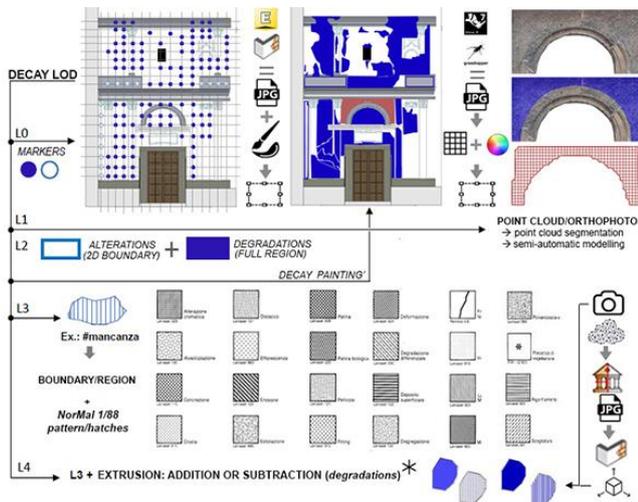
Figure 5. Five level of detail in decay representation: L0 L1, L2, L3, L4 between iconic and reality-based representation.

representation up to one that realistically reproduces the phenomenon. This solution is compatible with a LOIN-oriented approach, as it allows to implement the model through the graphical modalities considered more suitable to the LOD of the model itself, according to the specific in-depth phase of the digitalization process. In the realization of the software application, this need has been turned into the preparation of symbols that can be automatically added to decay areas and cracks, to be inserted by a check in the table of attributes of the smart object. These, like labels, allow a fast individuation of the analyzed theme also in the following phases of consultation of model consultation.

Also exploiting the automatism of the BIM environment has allowed the automatic and updatable creation of tables and legends of the mappings individuated on the model, adopting for them the pattern and the descriptions inferred from the *NorMaL - 1/88* lexicon (fig. 5).

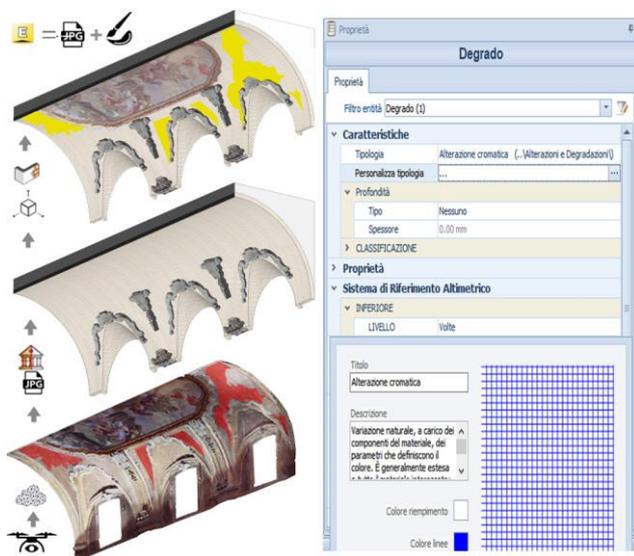
Figure 6. Parametric H-BIM objects: decay mapping of vaults.

The current version of the tool effectively meets the expectations in terms of time reduction and informative implementation, even for complex surfaces, that is those for which identifying planes is difficult. Surfaces with curvilinear direction, for example, are discretized into a series of small faces to correctly perform mapping. This kind of scenario occurred when mapping the surface conditions of vaults and molded stuccoes, elements that are known to be very present in the historical architectural heritage and that, therefore, cannot be overlooked by tools created for H-BIM (fig. 6).

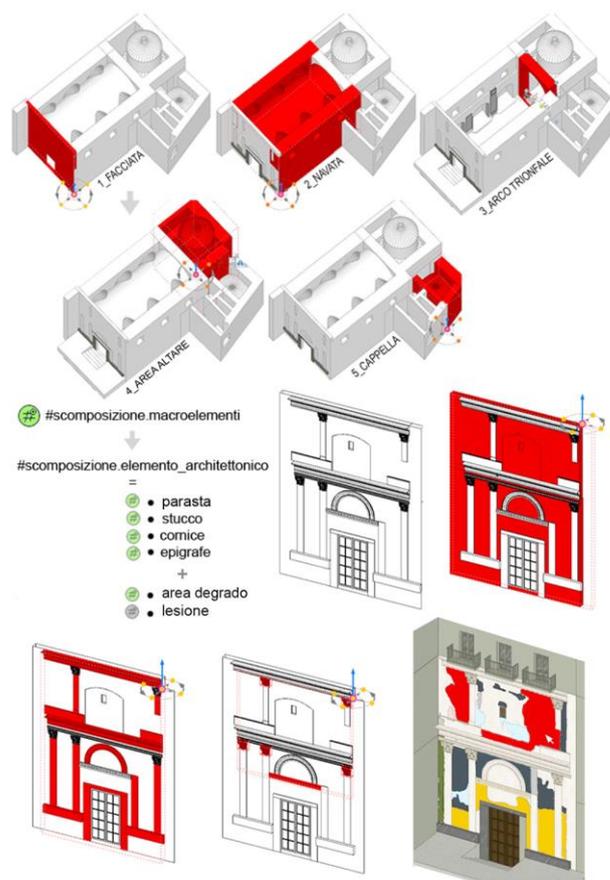
Figure 7. Semantic decomposition of architectural complex system: from macro-elements to micro-elements.

As for all the other aspects, parameters related to the material decay of the surface and to the crack pattern have been systematized into the organization of specific descriptive sheets to be attributed to the macro-elements or to the single elements composing the model (fig. 7).

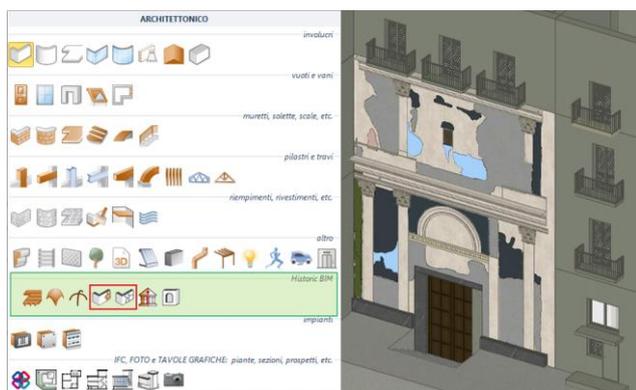
Figure 8. The *Heritage BIM Toolbar* (*Edificius* - ACCA software).

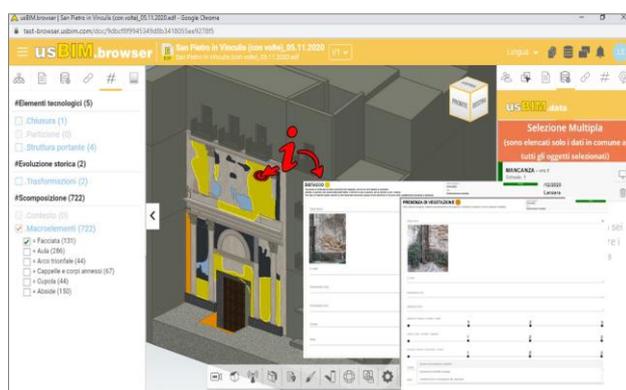
Figure 9. Data implementation: informative sheets (web-based CDE).

In the first part, the sheet layout provides the possibility to insert one or more photos of the phenomenon, notes on its displacement and reference eidotypes.

Then, a sequence of *sliders* and *checkboxes* express the descriptive parameters of the phenomenon from a geometric, chemical and physical point of view, as well as the possible causes. Finally, a slot allows the insertion of general notes. The sheets have been divided into *multiple* and *specific*.

While multiple sheets can be attributed to large portions of the model (macro element) and can contain the description of all the phenomena detected, these latter are specific for each typology of decay and, therefore, each one can be attributed to a single modeled area (fig. 9).

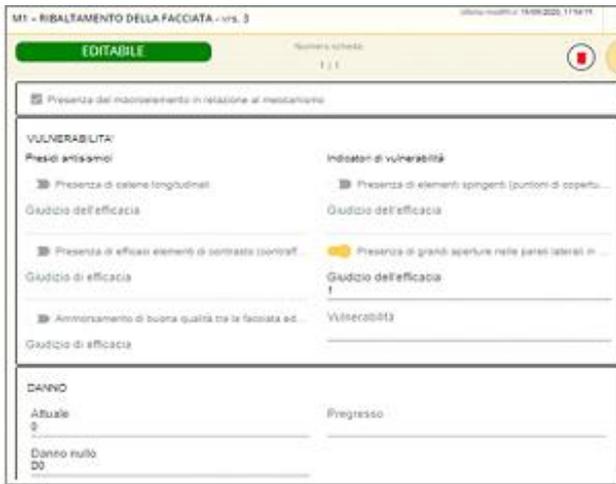
Figure 10. Structural information: on-line fillable data sheets.

The sheet shows the indication of the anti-seismic devices that can contrast the activation of each kinematic mechanism and a number of vulnerability indicators, which measure propensity to damage (fig. 10).

Each of them is associated to a judgment on the effectiveness modulated on three levels (0: ineffective; 1: fair; 2: good; 3: completely effective).

The last box reports damage assessment, which must be carried out in accordance with the 5 damage degrees suggested by EMS98 methodology. A distinction is also made between the current damage, corresponding to that observed at the time of the inspection, and the progressive damage, which is related to phenomena occurred before the seismic event under investigation. Thanks to a law of direct correlation between the seismic input associated to the different limit states and the detected vulnerability based on a statistical analysis of previous seismic experiences and provided by the abovementioned guidelines, the values of peak ground acceleration, corresponding to the Damage Limit State (SLD, *Stato Limite di Danno*) and to

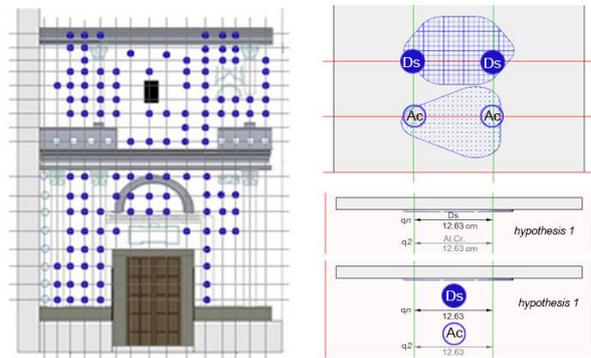
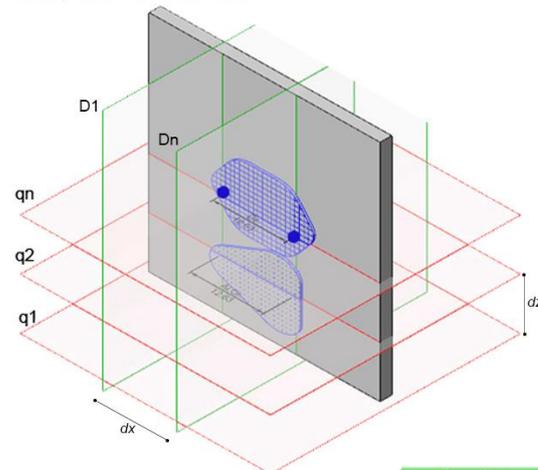
Figure 11. Semi-automatic - parametric decay representation (VPL): planimetric graph.

On the basis of these premises, the *work in progress* research activities are aimed at the algorithmic-generative (semi-automatic) representation/modeling of the decay areas reported in the orthophotos processed from the point clouds (fig. 11). The final objective remains the reduction of the time required for the output of significant data in H-BIM models.
