A proposed multimodal convolutional neural networks (CNNs) soluble salts mapping system of the subsurface: The case of the wall painting at the royal box at Herodium, Israel

Maya Ovadia^{1,2} and Anna Brook²

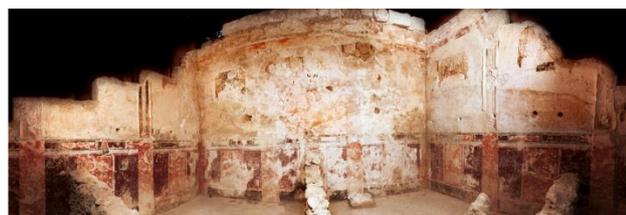
Figure 2. The Royal Box – general view (2010) (Neguer & Davidoff, 2015)

The central and most impressive chamber of a series of chambers at the top of the theater was termed the royal box. The Western, Southern and Eastern walls of the royal box are splendidly adorned with wall paintings and stucco decorations, preserved to a height of 6 meters (Fig. 2). The wall paintings were not made by a common fresco but in secco, painting with a binder on a dry surface, rather than on a wet surface (Netzer et al., 2010).

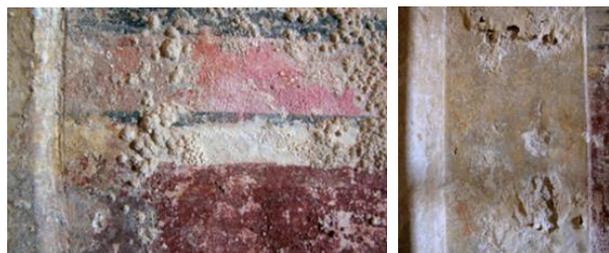
Figure 3. Efflorescence on the surface of the wall paintings at the Royal box, Herodium (Neguer & Davidoff, 2015)

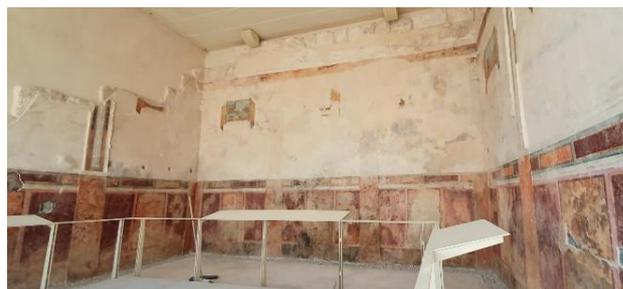
Figure 4. The Royal Box - present state (2021).

Since the beginning of 2021, the chamber is now open to the public (Fig. 4). The interior climate is now stable and controlled by air conditioning. However, according to a recent water penetration report (Sep. 2020) The enclosure contains unbalanced moisture areas in the chamber walls caused by construction faults (Cahana, 2020).

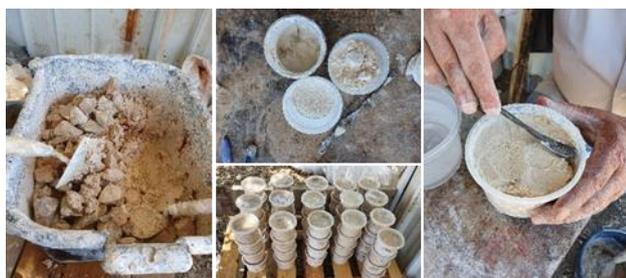
Samples (diameter 10 cm and 7 cm height) were created with similar substance that was used in the construction of Herodium. The mimic source mortar was created with a mixture of gravel, Arad sand, quarry sand, crushed ceramics, calcium oxide (burnt lime) in a ratio of 2:1:1:0.25:1.5 respectively. The first plaster layer mimics the *arriccio* layer consists of Arad sand, quarry sand and calcium oxide (burnt lime) in a ratio of 1:1:1 respectively. The top plaster layer which mimics *intonaco* (whitewash) was created with a mixture of stone powder and calcium oxide (burnt lime) in a ratio of 1:1 respectively (Fig. 5). The samples were constructed in three composition groups - limestone (A), Mortar (B) and Complex samples consist of limestone with mortar and on top two layers of plaster as described above. To avoid uneven lay in the construction the complex group was created with three repetition groups (C-E).

Figure 5. Creation process of the study Samples

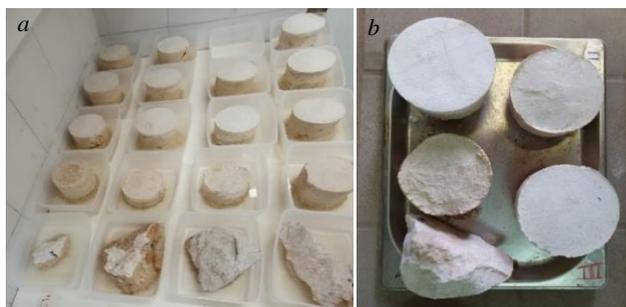
The chlorides and sulphates were examined in a set of treatments. The samples were once again divided into four groups, three treatment groups (1,2,3) and a control group (4). The samples in the three treatment groups were impregnated at the bottom of the sample with three water base salt solutions, (1) 0.01% sulphates (SO_4^{2-}), (2) 0.01% chlorides (Cl^-) and (3) 0.01% chlorides (Cl^-) and 0.01% sulphates (SO_4^{2-}) (Fig. 6). The samples were marked according to their composition and the given treatment group (Table 1).

Figure 6. (a) The impregnation process. (b) A group of samples drying after the impregnation process

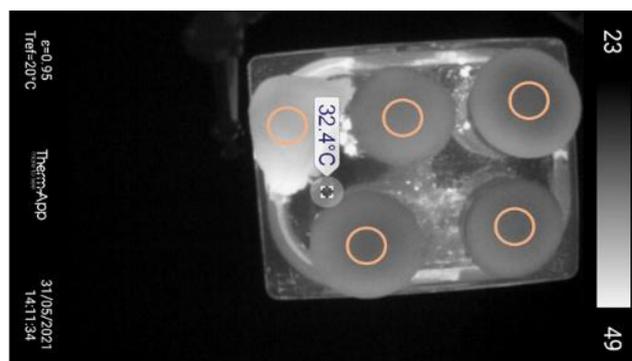
After the impregnation, the samples were set to dry for a month. The stones sample were suspected to be contaminated and were discarded. Once the Samples had dried, each treatment group was heated with external source to 45°C degrees and their cooling process was recorded with a sequence of thermal images taken every 10 sec for 5 min and every minute for 3 minutes more. The data was collected by NDTherm camera, by Opgal. The camera is a broad band system (7.5 – 14µm) with resolution of 384 x 288 pixels. The data was stored in the memory of the android and was processed with MATLAB 2020b. The data of each sample in the group treatment was filtered with a center circle mask that defined the region of interest (30 x 30 pixels) (Fig. 7).

Figure 7. Data recording with Therm-App

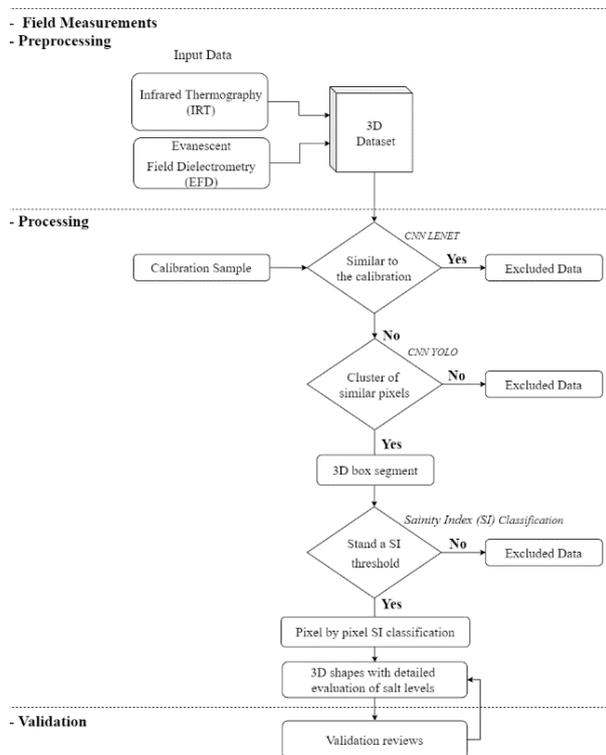
The proposed methodology design is based on five stages: (1) NDT field measurements, (2) Preprocessing – calibration, image registration and super-resolution CNN model (SRCNN), (3) Processing - deep learning model base CNNs architecture, (4) Postprocessing – Validation, (5) Change detection over time. The first four stages complete the deep learning-based soluble salts mapping system (Fig. 8), while the fifth stage is performed on two sets of the system outputs data taken at different seasons or after severe climate change to investigate shift of salt at the sub surface via change detection.

Figure 8. Setup diagram of the four stages of the deep learning-based mapping system

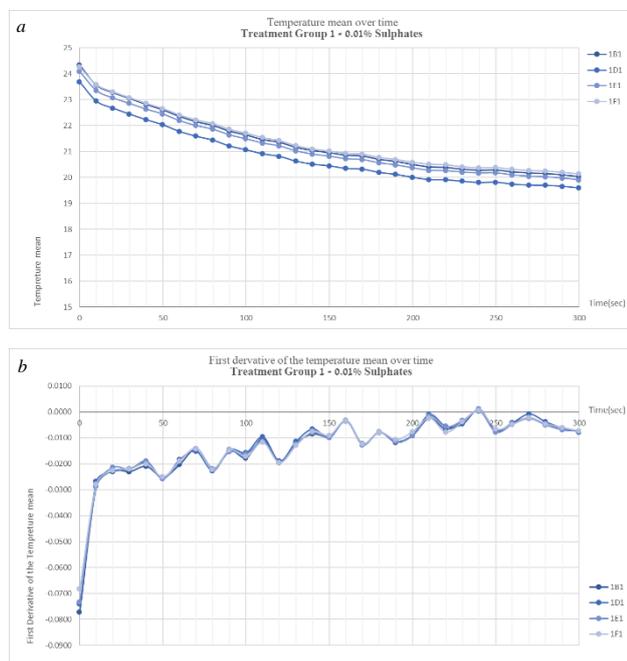
While comparing the samples temperature mean over a cooling time of 5 minutes with samples at the same group treatment (Fig. 9a) and with samples with the same substance composition no significant pattern has been shown. Furthermore, the results of computing the first derivative to the temperature mean over a cooling time showed mild patterns but not enough to understand any repetitive behaviour (Fig. 9b).

Figure 9. (a) temperature mean over time and (b) first derivative of the temperature mean over time.

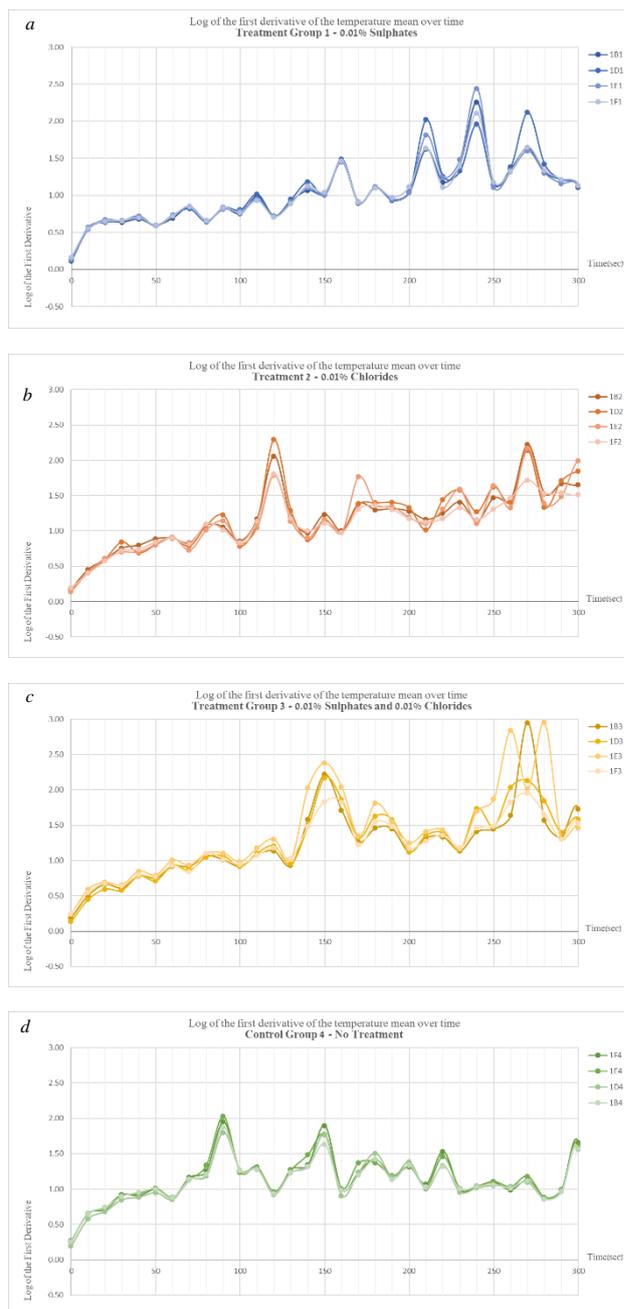
at the aim of sharpening the data at the search of the different thermochemical behaviour among the samples, a log of the first derivative was computed. The results were compared according to the four treatment group. In contrast to the previous comparisons, the results have showed more significant patterns in samples at the same treatment groups by peaking at similar times. The result of treatment group 1 (Fig. 10b), 0.01% sulphates, have showed a set of peaks at time of 210 sec, 240 sec

and 270 sec, while the middle peak is the higher among them. The result of treatment group 2 (Fig. 10a), 0.01% chlorides, have showed a set of peaks at time of 120 sec and 270 sec. The result of treatment group 3 (Fig. 10c), 0.01% chlorides and 0.01% Sulphates, have showed a set of peaks at time of 150 sec and 260-280 sec. Unlike the rest of the peaks the last peak pattern did not align at the same time and showed same shift. The control group 4 (Fig. 10d) also shown a match set of peaks at time of 90 sec and 150 sec.

Figure 10. Log of the first derivative of the temperature mean over time. (a) treatment group 1, (b) treatment group 2, (c) treatment group 3 and (d) control group 4

The different thermochemical behaviour of chlorides and Sulphates can be detected comparing the patterns. While the samples that have been impregnated with chlorides peaks at an early stage of the cooling process, at the first 120 seconds, the samples that have been impregnated with sulphates peaks only at

a later stage of the cooling process, at 210-270 seconds since the recording began. In contrast, a similarity pattern can be detected though all the treatment groups the around time of 270 seconds, a pattern that is not shown in the control group. While both treatment group 1, 0.01% sulphates, and treatment group 2, 0.01% chlorides, showed aligned peak at 270 seconds, treatment group 3, the mixed group, show a stronger peak that spread between 260-280 seconds. Another similarity can be drawn between the control group, group 4, and treatment group 2, 0.01% chlorides. Both peak at the same time of 150 seconds.
