APPLICATION OF MOBILE LIDAR MAPPING FOR DAMAGE SURVEY AFTER GREAT EAST JAPAN EARTHQUAKE

Emiko Ariyasu^{a*}, Megumi Koizumi^a, Masahiro Ikubo^a, Shuhei Hatake^a

^a Department of Geomatics Development, Asia Air Survey, 1-2-2 Manpukuji Asao-ku Kawasaki-shi Kanagawa, Japan –
(emk.ariyasu, mgm.koizumi, ff.ikubo, sh.hatake)@ajiko.co.jp

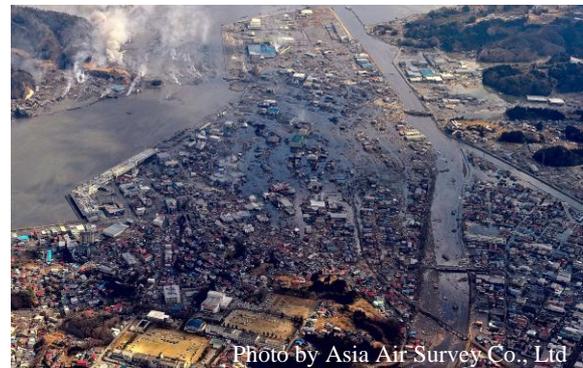
Figure 1. Kesen-numa city damaged by Tsunami

On March 11, 2011, at 2:46 JST (5:46 GMT) in the evening, Tohoku and Kanto region in Japan hit a magnitude 9.0 earthquake, and its quake generated a devastating tsunami (Figure 1). It is estimated that the initial tsunami wave took 10 to 30 minutes to make its first landfall, and the more than 10 m height of tsunami is reached along Pacific Ocean in 530 km. Also, the highest wave from the tsunami was estimated approximately 40 m at Ofunato, Iwate, according to 2011 Joint Survey Group. Such unpredicted massive tsunami caused extensive damage in Tohoku region, Japan. National Police Agency on April 12, 2012 reported that 15,856 people killed, 3,070 missing, 129,404 buildings totally collapsed, 3,918 roads, 78 bridges and 29 railways destroyed or damaged by the earthquake and the tsunami along the coast of Pacific ocean. Also, the latitude of earthquake, it is reported by Geospatial Information Authority of Japan (GSI) that the ground at Oshika Peninsula northeast of Sendai moved 5.3 meters eastward and fell by 1.2 meters by tectonic force, and the other places also were moved over a meter in the Tohoku region. In addition, it is reported liquefaction and landslides by field survey with academic and research organizations after Tohoku earthquakes. Such massive damage washed out existed maps or made existed maps useless for the broad-scaled crustal deformation, and changed the location of terrain features. Thus, the damaged area is rapidly required to make a new map for reconstructing the area.

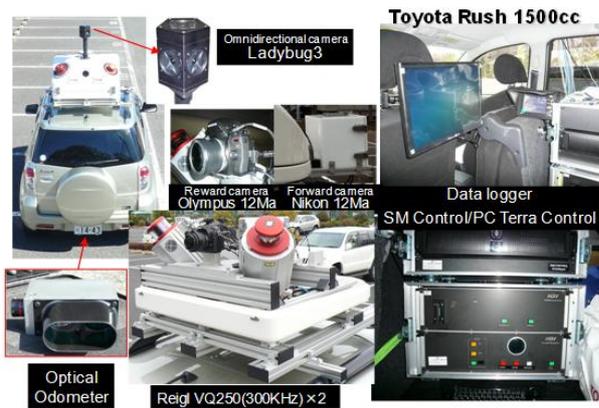
Figure 2. GeoMaster NEO 1

GeoMaster NEO 1 is the first system, which procured on March, 2011 from StreetMapper mounting systems from 3D Laser Mapping Company in England and IGI in Germany (Figure 2). The system is mounted two 2D laser scanners, VQ250 in Riegl in Austria, pulse 300 KHz, two 1200 MB pixels digital cameras in front and rear, spherical digital camera, Ladybug3, on the top of platform, and optical odometer at rear side of the car. This system was in training period when the earthquake occurred, but

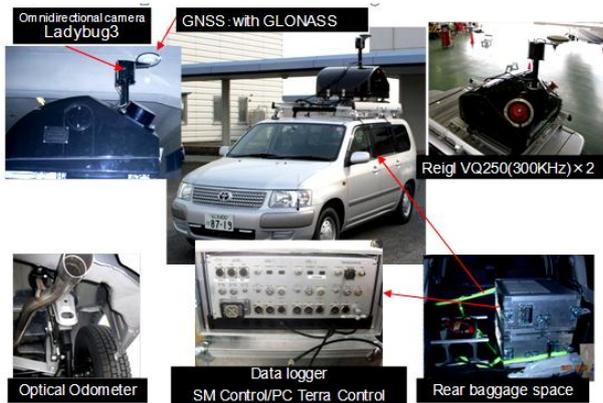
Figure 3. GeoMaster NEO 2

GeoMaster NEO 2 is as same as the first system but distributed at West division in December, 2011 (Figure 3). Since there is a problem in GeoMaster NEO1 which occurred lower image quality with higher driving speed, digital cameras both front and rear sides were altered to degrade into 500 MB pixels, considering more focus on the shutter speed. GNSS is also switched to one which GLONASS is receivable.

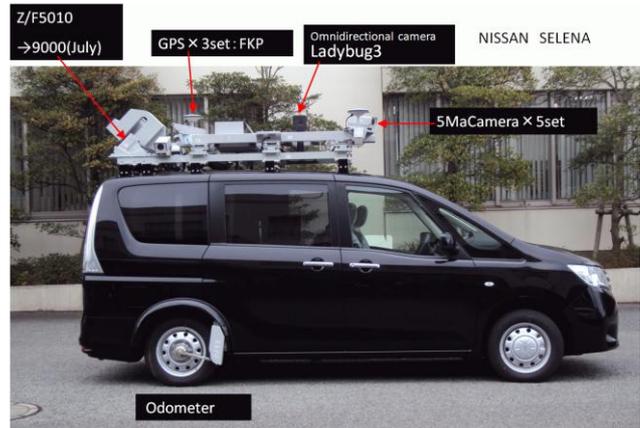
Figure 4. GeoMaster NEO 3

GeoMaster NEO 3 is procured from Mitsubishi Electronics in April, 2012, which differs from former systems (Figure 4). The difference is to be mounted a high-accurate LiDAR data collection, Z/F9000, at phase-shift type. As a result, it is available to collect more detailed LiDAR data in 1 mm resolution, even though the former systems are acquired with only 1 cm resolution at time-of-flight system. As the other advantages for GeoMaster NEO 3, the reflectance frequency is about 1000 KHz and the nodding rotation is performed 200Hz. Also, this system is mounted 5 digital cameras in the same type with the second system (right front, left front, right side, left side, and rear side) and spherical digital camera, Ladybug3. Those multiple sensors are expected to utilize not only for digital road mapping, but also for assessment of road surface control and road infrastructure management.

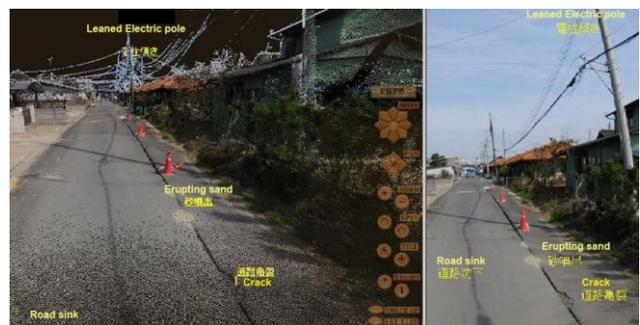
Liquefaction in Kasumigaura, Kanto-region was surveyed with GeoMaster NEO 1 in April 1, 2011. There are many places occurred liquefaction which caused by the soil type, called Kanto loam. It is a typical volcanic ash soil covering diluvial upland, as high hydraulic conductivity, high porosity, and complex soil texture (Yamazaki et al., 1963). The liquefaction was caused to collapse electric poles and houses and water-saturated sediments along roads after the earthquake. Our company was surveyed the disaster damage with MMS to understand the terrestrial condition, and it was succeeded to detect crack in the road, floated manholes, and leaned electric poles on a screen using a original display software for MMS, LaserMap Viewer (Figure 5).

Figure 5. Liquefaction in Itako city - MMS (left) and a picture (right)

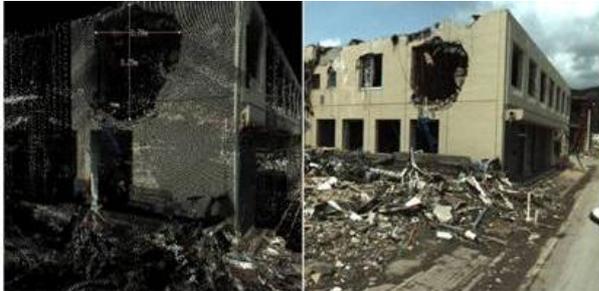
Onagawa at Oshika peninsula is a famous fishing harbor. This area hit 20m tsunami, so that, collapsed third- and four- floor building. A lot of buildings were devastated by objects like car. MMS was able to detect damages by the event (Figure 6).

Figure 6. Two images of the holed building by tsunami – left: point cloud data, right: photography image

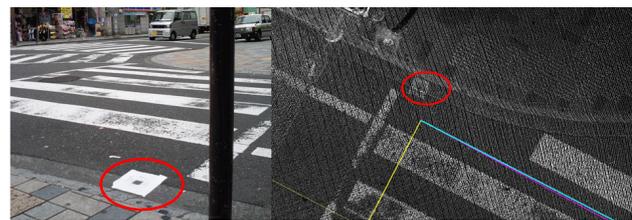
The MMS accuracy verification is implemented on an edge of white line like a pedestrian crossing, which is easily discriminated by reflectance intensity (Figure 7). Table 2 shows the values taken with 142 points by RTK-GPS survey at a good condition for receiving GPS. Both values of errors are applicable to product 1:500 scale geological map.

Figure 7. A targeting point for MMS accuracy verification

Horizontal Error (RMS)	6.3 cm
Vertical Error (RMS)	4.6 cm

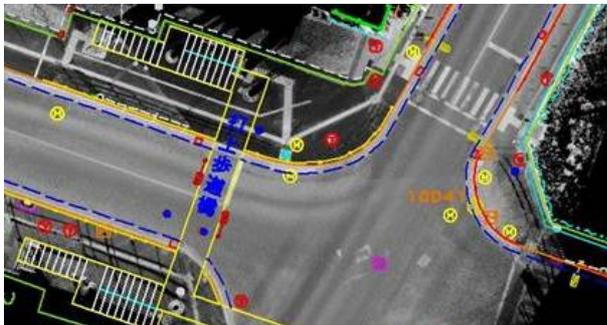
MMS is effective to utilize for collecting positioning data of public and private boundary along roads. In this technique has been implemented by Asia Air Survey Co., Ltd under a project, "Urban area parcel boundary fundamental study" (Tokyo) from Ministry of Land, Infrastructure, Transport and Tourism since 2010. Targeting areas will be surveyed the all along every drivable roads, and features taken in the field survey for relating with cadastral current situation map are below;

- Features indicating with parcel boundary (road ditch, fence)
- Boundary peg
- Edge of building and edge building foundation
- River and channel
- Spot height

Figure 8. Current situation map with MMS data
