PHOTOGRAMMETRIC AND LIDAR DOCUMENTATION OF THE ROYAL CHAPEL (CATHEDRAL-MOSQUE OF CORDOBA, SPAIN)

KEY WORDS: Cultural heritage, orthoimage, rectification, TLS, non-metric camera, calibration

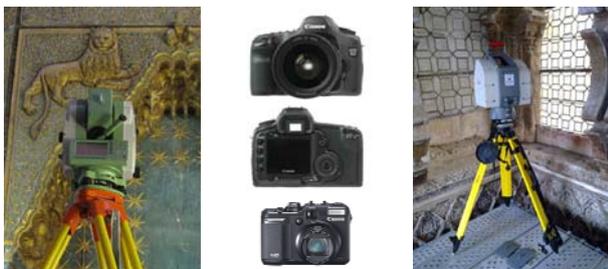
Figure 3. Left: Leica TCRA 1203 with diagonal eyepiece for point measurements in the upper part of the chapel. Middle: front and rear views of SLR EOS D5 and Powershot G10 cameras. Right: TLS Scanstation HDS3000 set up on scaffolds at the vault level.

A Leica Scanstation HDS3000 was used for the TLS survey. Point clouds were processed with Leica Cyclone® 5.8 and Maptek I-Site® 3.3 for laser data processing.

Two digital cameras were used: a full frame reflex 12.8 Mp Canon EOS D5 equipped with different fixed focal length lenses (from super wide angle to telephoto lenses) and a 14.7 Mp compact Canon Powershot G10 with a 6.1-30.5 mm zoom lens. So calibration procedures (both at field and laboratory) were needed. With respect to the photogrammetric processing software, two stereoscopic DPW's (BAE System Socet Set® 5.0 and Leica Photogrammetry Suite® 9.1) for orthophoto generation and DEM edition were employed. Additionally a close range photogrammetry system, Photomodeler Scanner® 6.0, was used for initial approximate image orientation. And besides, some own developed routines for camera calibration and image rectification were also applied. Figure 3 shows all data acquisition instruments.

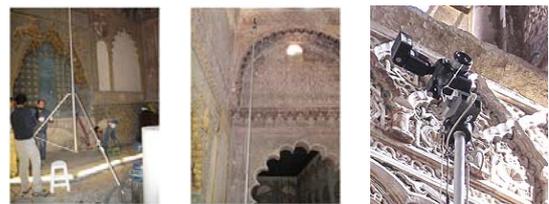
Figure 8. Telescopic mast used in the side wall photographs.

In the case of side walls, the 35 mm lens was chosen in order to obtain orthophotographs at 2 mm resolution. In this case the heights of the walls were up to 10 m (measured from the floor). Networks of parallel shots (at 5-6 m distances) were designed combined with convergent photographs (which helped to control point densification, camera calibration and avoid hidden areas in the blind arches). The camera was raised with a telescopic mast. The mast head could be remotely controlled and the camera was connected to a laptop with an USB link so there was a full control of exposition conditions. In the longest sides (11m at the east and west sides) the mast was set up at 6 stations and in the shortest sides (6 m at the south and north sides) 5 stations. In each station three photos were taken at approximately 2 m, 6 m and 9 m height covering the whole walls with stereoscopic coverage (Figure 8).

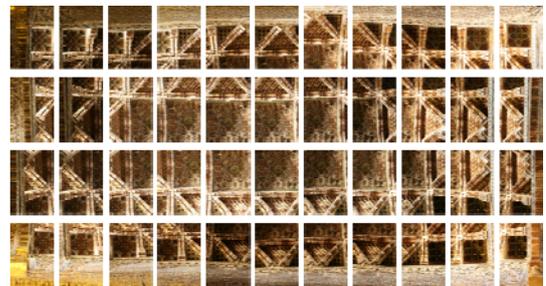
Figure 9. Image block geometry in the vault survey.

The vault was also surveyed from the floor. The final product was an orthophotograph of 1 mm resolution. That image resolution could be obtained using a telephoto lens (135 mm) set up in a tripod at the floor level. The reason to make photos at that distance, instead of raising the camera with the mast and using a shorter focal length, was related to large difficulties to move the extended mast and because, at longer work distances, large hidden areas (because ribs and arches in vault) could be avoided. Because large depth differences in the vault existed, depth of field was critical and the f-stop ring was set at the maximum value. That meant very large exposition times so camera was mounted on a conventional tripod. The survey covered an area of 6 m x 6 m. It was necessary four strips with 12-14 photographs per strip (Figure 9).

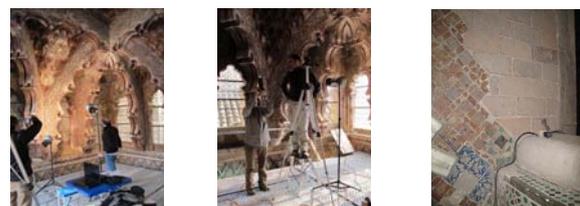
Figure 10. Taking Canon G10 photographs of the sides of the ribs and arches in the vault (left and middle), and oblique shot at the extreme south part of the floor (where vertical shots couldn't be properly taken).

With respect to another areas (edge of the floors, arch intrados, side walls of the vault ribs and cusped arches, etc.), photographs were taken with the G10 camera, well set up on tripod or hand held. Details in the vault were registered after the last scaffolding stage reached the vault base at 10 m height. In these cases a large variety of situations were found so parallel, convergent and oblique photographs were taken (Figure 10).

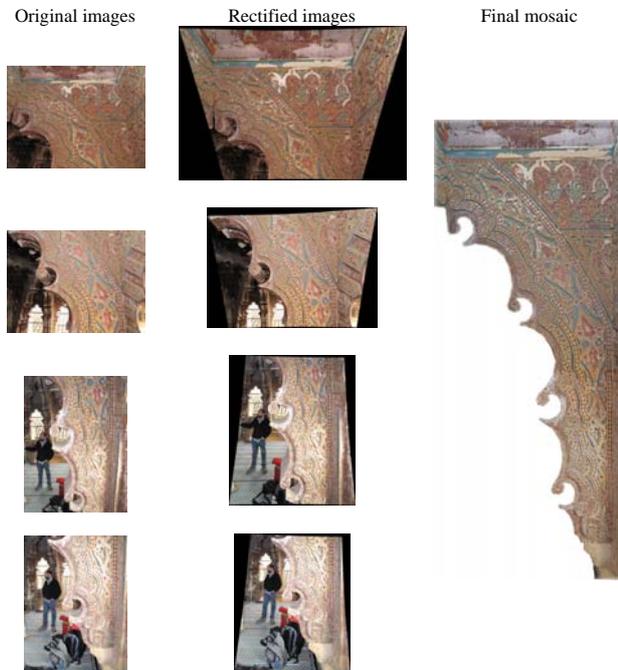
Figure 15. Rectification process in ribs and arches at the vault.

The process of mosaicking rectified images is shown in Figure 15. It describes an example of an arch in the south part of the wall where the work distance is 1 m because of limitations in the workspace. The camera was the Powershot G10. Final resolution in rectified images was 1 mm although accuracy was limited to the rectification plane. Depending on the arch and plane the accuracy was 1-2 cm as average.
