## GEOGRAPHICAL INFORMATION ANALYSIS OF TSUNAMI FLOODED AREA BY THE GREAT EAST JAPAN EARTHQUAKE USING MOBILE MAPPING SYSTEM

M. Koarai<sup>a,\*</sup>, T. Okatani<sup>a</sup>, T. Nakano<sup>a</sup>, T. Nakamura<sup>b</sup>, M. Hasegawa<sup>b</sup>

<sup>a</sup> Geography and Crustal Dynamics Research Center, Geospatial Information Authority of Japan, Kitasato 1, Tsukuba, Ibaraki, 305-0811 Japan - (koarai, okatani, t-nakano)@gsi.go.jp

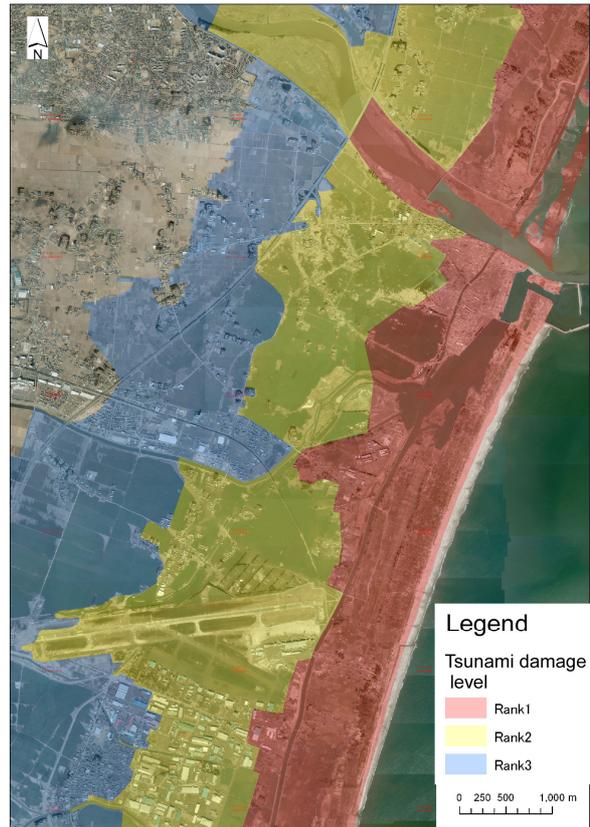
Figure 1. Tsunami damage map of Sendai Plain

The authors divided tsunami damage into three categories by interpreting aerial photos; first rank (Rank 1) is the completely destroyed area where almost wooden buildings were lost, second rank (Rank 2) is the heavily damaged area where a large number of houses were destroyed by the tsunami, and third rank (Rank 3) is the flooded only area where houses were less destroyed. Figure 1 is tsunami damage classification map of a part of Sendai Plain where close to the Sendai Airport.

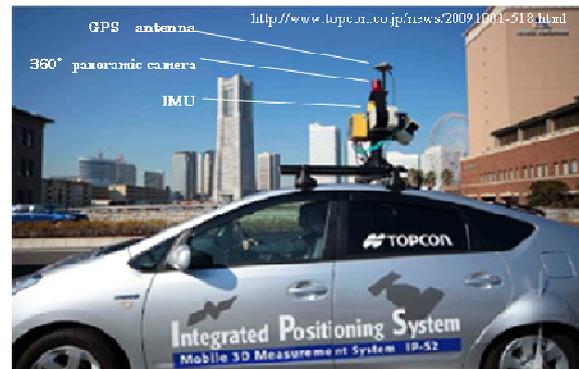
Outline of MMS is shown in Figure 2. MMS obtains 360 degree panoramic image by cameras on a vehicle. IP-S2 by Topcon Corporation was used for this study, and the system is composed of 6 cameras, GPS antenna and IMU (inertial measurement unit). GPS antenna and IMU measure positions and tilts of cameras. Cameras can obtain image data at rates of 16 frames / second. Using this system, we obtain the image data with three dimensional location information. To select the position of tsunami flooded marks and ground surface in this image, it is possible to measure the tsunami flooded depth by calculation of image data (Figure 3).

Figure 2. Outline of Mobile Mapping System (MMS)

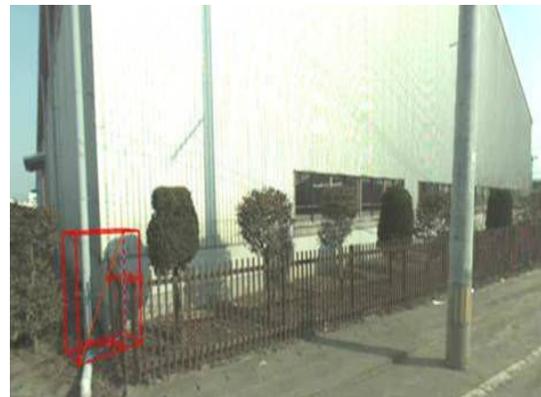
Figure 3. Measurement of tsunami flooded depth by MMS

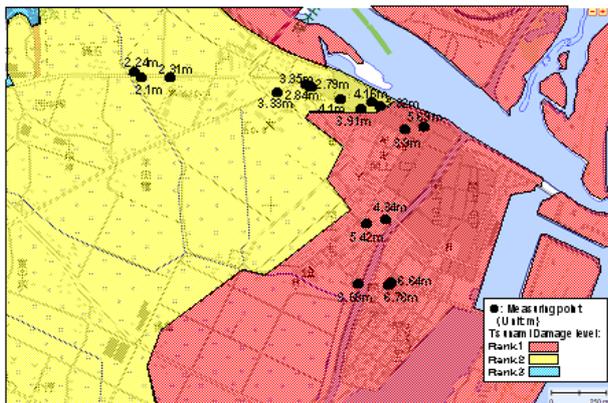
Figure 4 and 5 show overlay maps of tsunami damage level and tsunami flooded depth measured by MMS at Yuriage area, Natori City, Miyagi Prefecture and at the Sendai Airport area, Iwanuma City, Miyagi Prefecture, respectively.

These figures show that the area with over 4m tsunami flooded depth is equivalent to the rank 1, and the area with over 1.5m tsunami flooded depth is equivalent to rank 2.

Figure 4. Tsunami flooded depth measured by MMS at Yuriage area (base map is Cyber Japan Web System)

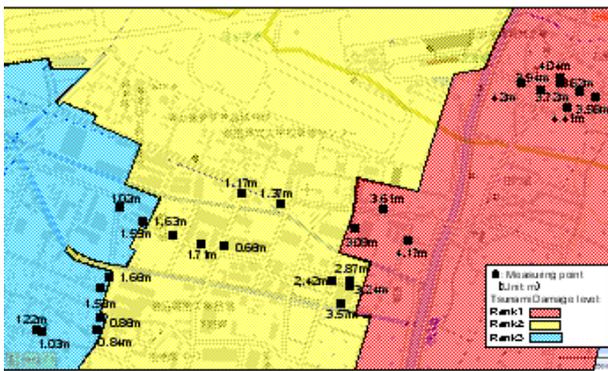
Figure 5. Tsunami flooded depth measured by MMS at Sendai Airport area

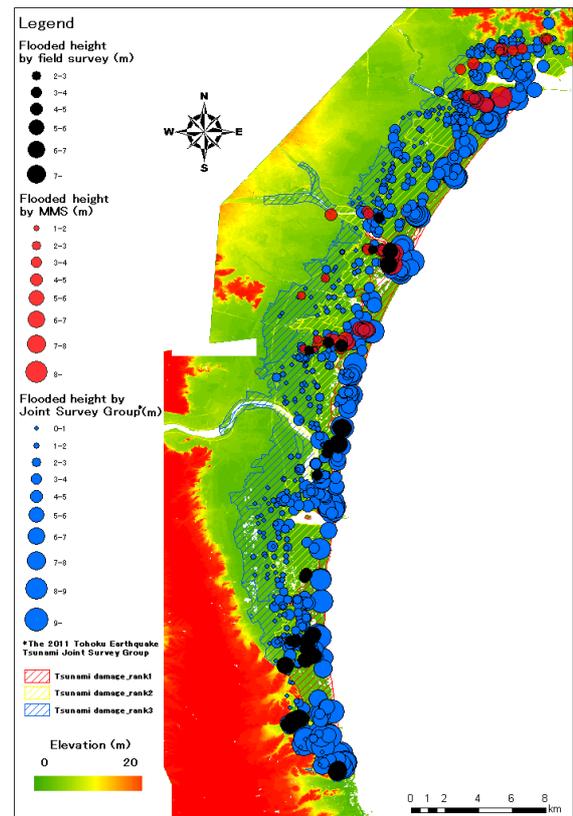
Figure 6 shows the distribution of tsunami flooded height measured by field survey results of the 2011 Tohoku Earthquake Tsunami Joint Survey Group (2011) and the authors' field survey and by MMS of GSI. Tsunami flooded height is calculated by the following formulas: Tsunami flooded height = tsunami flooded depth + LiDAR DEM. The measurement results by MMS correspond well with the measurement results by field survey.

Figure 6. Distribution of tsunami flooded height measured by MMS and other research group

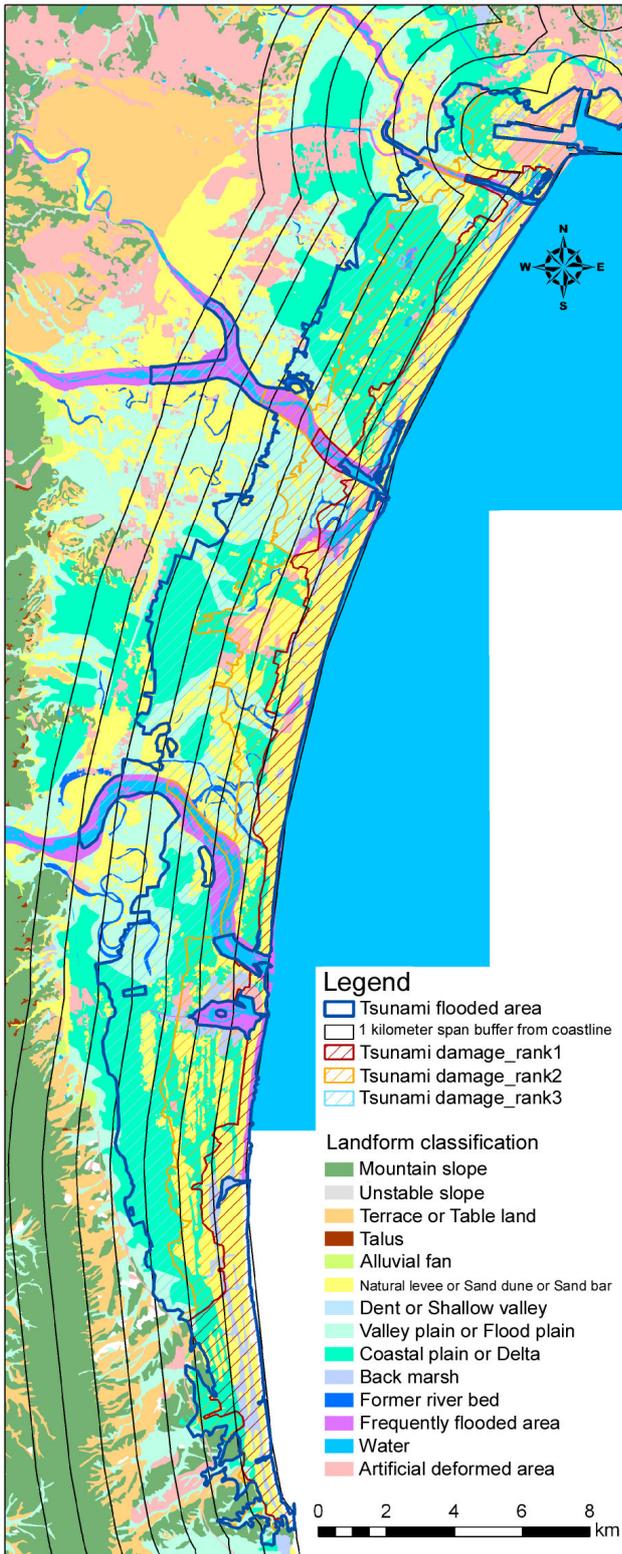
The results of overlay analysis about geographic information and tsunami damage categories are shown in figure 7, 8, 9. Figure7 is overlay map of tsunami damage and landform classification. Figure8 is overlay map of tsunami damage and DEMs. Figure9 is overlay map of tsunami damage and land use.

Figure 7. Overlay of tsunami damage and landform classification

Landform within 1 km area from the coastline is mainly sand dune or sand bar with little higher elevation. Wide sand bars are dominate in the northern area from Abukuma River, but several narrow sand bars are dominate in the southern area from Abukuma River. Landform of inland area over 1km from the coastline is coastal plain or delta. Valley plain or flood plain is dominated along Nanakita River, Natori River and Abukuma River. Natural levee and former river bed are only dominant along main large rivers.

- 1) The completely destroyed area (Rank 1) was located within 1km area from the coastline. Flooded depth of this area is over 4m, and landform classification of this area is almost sand dune or sand bar which has a little higher elevation compared with other area (Figure 7, 8). Contrary to a poor relationship between tsunami damage and landform condition such as landform classification or elevation, there is a good relationship between area of tsunami damage rank 1 and distance from coastline.

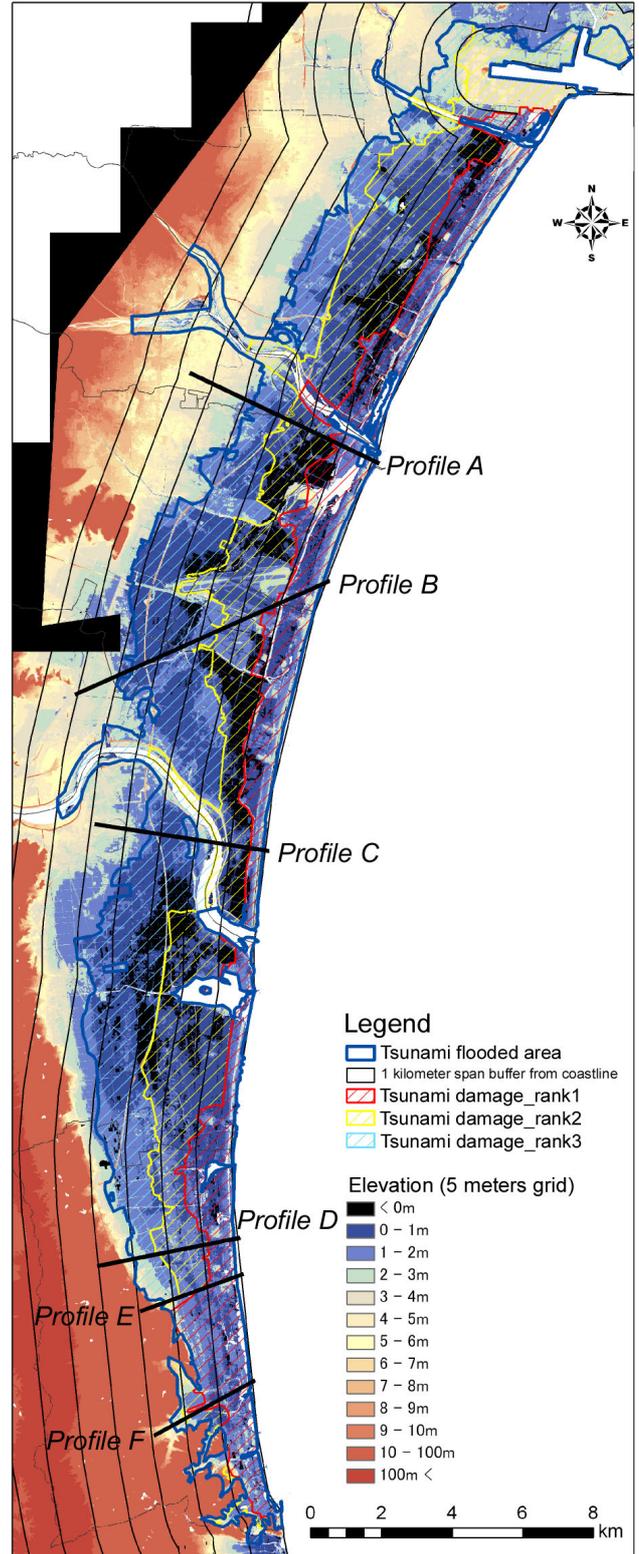
Figure 8. Overlay of tsunami damage and LiDAR DEM

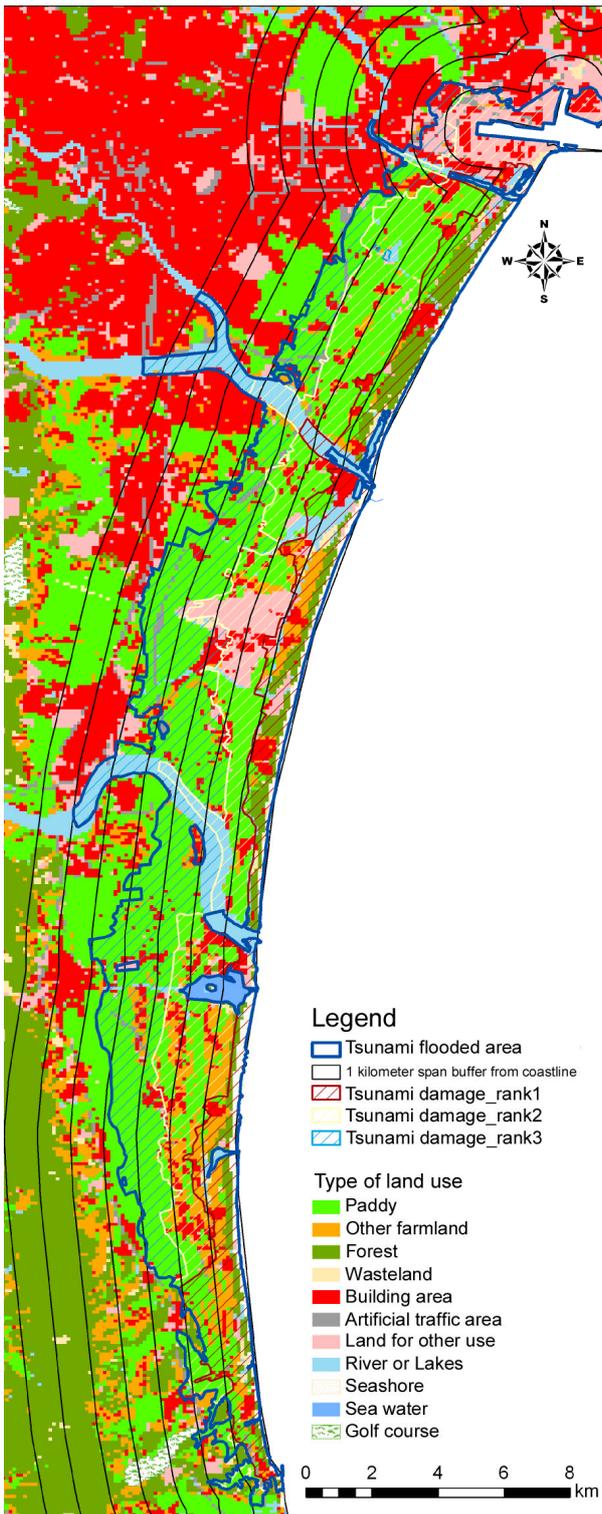
Figure 9. Overlay of tsunami damage and land use

Land use on sand dune or sand bar is forest, other farmland and building area. Forest is dominant in the northern area from Abukuma River, however, other farmland is dominant in the southern area from Abukuma River. Land use of inland area over 1km from coastline is mainly paddy field. As building area and other farmland in inland area have zonal distribution along the coastline, these land use located on sand dune or sand bar in inland area.

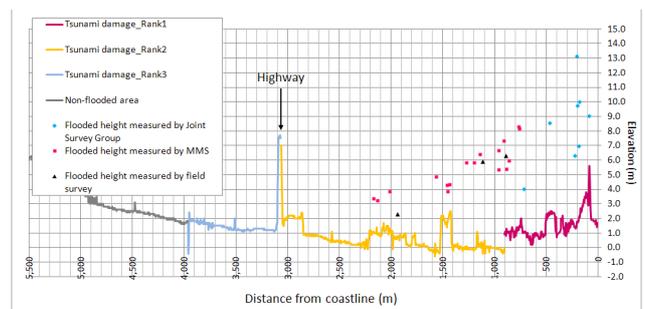
The area of tsunami damage level rank 1 is limited within 1km area from the coastline. This area has a little higher elevation such as 1-3m, and flooded depth of this area is over 4m. Just after tsunami ran over a little higher landform such as sand dune or sand bar to lowland with 0m elevation such as coastal plain or delta, the tsunami flooded height was decreased suddenly and the tsunami damage level was changed from rank 1 to rank 2 (figure 10, 11).

Figure 10. Cross section along EW direction of ground surface and tsunami flood depth on profile A (Yuriage, Natori City)

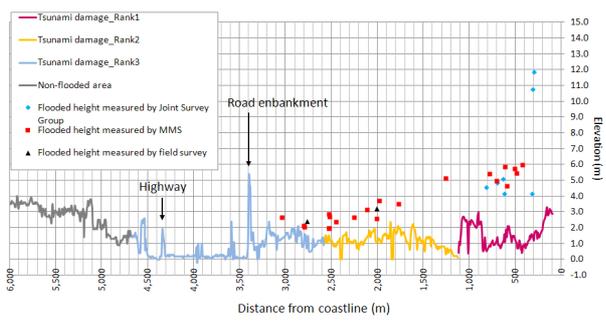
Figure 11. Cross section along EW direction of ground surface and tsunami flood depth on profile B (Sendai Airport, Iwanuma City)

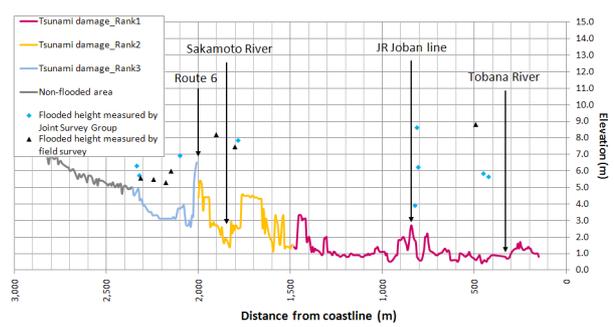
In the southern part of Yamamoto Town, the boundary line between tsunami damage level rank 1 and rank 2 was located in 1.5km from the coastline (figure 14, 15). We assumed the reason of difference of location of the boundary line is brought by the difference of elevation of sand dune or sand bar compared to another area. As the elevation of sand dune or sand bar in the southern Yamamoto Town is about 1m, the tsunami flooded height did not change just after tsunami run over sand dune or sand bar. The tsunami flooded depth was over 4m at 1.5km from the coastline, the tsunami damage level did not change.

Figure 15. Cross section along EW direction of ground surface and tsunami flood depth on profile F (JR Sakamoto Station, Yamamoto Town)

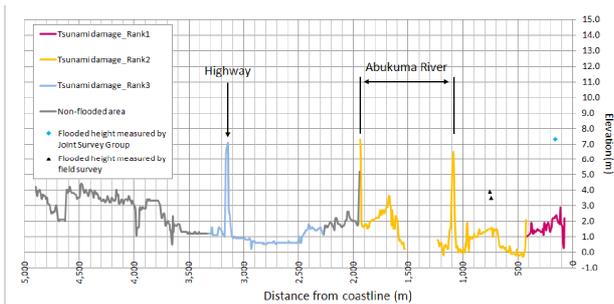
On the north of the mouth of Abukuma River, the width of sand bar, which is about 500m, is narrower than other area. At the area of 500m from the coastline, elevation of ground surface decreases from 2m to 0m, and tsunami flooded depth also decreased from 5m to 2m, and the tsunami damage level was changed from rank 1 to rank 2 (figure 12).

Figure 12. Cross section along EW direction of ground surface and tsunami flood depth on profile C (Mouth of Abukuma River, Iwanuma City and Watari Town)

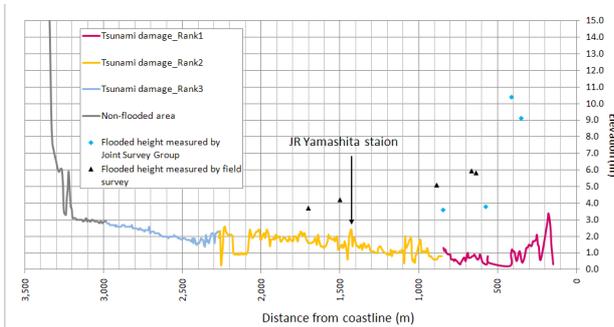
In the area close to JR Yamashita Station, the elevation of ground surface and tsunami flooded height are decreased suddenly from 2m to 0m and from 7m to 3m respectively at the position of 500m from coastline, but tsunami damage level does not change (figure 13). The boundary line between rank 1 and rank 2 was located at 900m from the coastline. We assumed the reason of difference of tsunami flood damage to another area is brought by the difference of land use and landform. Forest is dominant with wide width on sand bar in the northern area from Abukuma River, but other farmland is dominant with narrow width on sand bar in the southern area from Abukuma River. It may be presumable that difference of distribution of the completely destroyed area was brought by difference of roughness of ground surface, such as forest and other farmland.

Figure 13. Cross section along EW direction of ground surface and tsunami flood depth on profile D (JR Yamashita Station, Yamamoto Town)

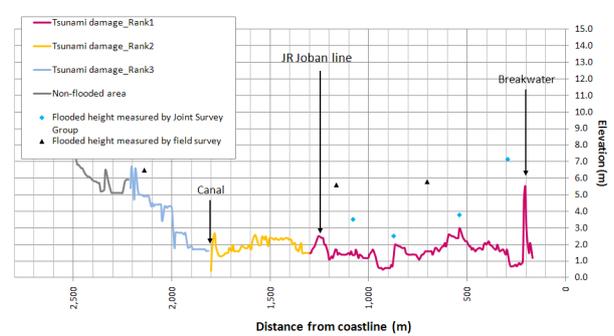
Figure 14. Cross section along EW direction of ground surface and tsunami flood depth on profile E (Takase, Yamamoto Town)
