INTEGRATED KNOWLEDGE ON A THREE-DIMENSIONAL BASIS: THE FOUNDATION OF THE CONSERVATION PROJECT AND POSSIBLE IMPLICATIONS IN THE BIM AREA THE CASE OF THE PORTRAIT ROOM OF PALAZZO BOREA D'OLMO IN SANREMO

2. THE CASE OF THE PORTRAIT ROOM OF PALAZZO BOREA D'OLMO IN SANREMO

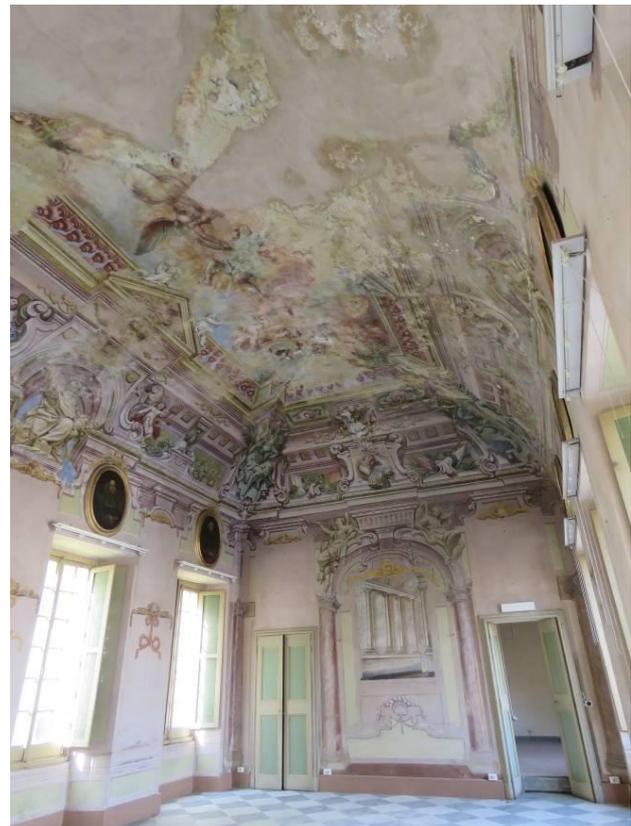
The Hall is decorated with eighteenth-century frescoes and it has been seriously damaged by "accidents of various kinds", strengthened over the time and manifested themselves in a repeated manner, never fully fronted and solved.

Figure 1. Family Portrait Room on the second noble floor of the Palazzo Borea d'Olmo, Sanremo (IM).

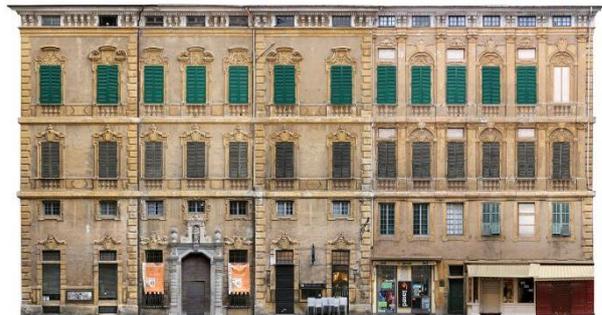
Figure 2. Main front of the Palazzo Borea d'Olmo, Sanremo (IM), Via Matteotti.

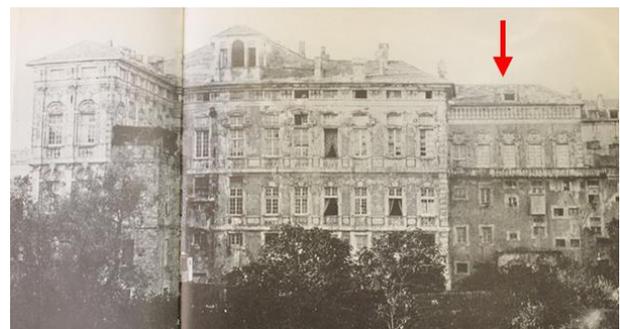
The roof structure is in pitched wood with tile covering. Only the northern portion, above the Family Portrait Room, has been replaced by a terrace. The time of realization of this modification is unknown, but from the observation of the historical photographic documentation it is ascribable to the period between 1860 and the immediate second post-war period. The pictures below, n. 3 and 4, show the Palace in the 1860 and 1950 year.

Figure 3. collection Guido Orazio Borea d'Olmo, iconographic text "Sanremo com'era", Editrice Collins, Milano 1974.

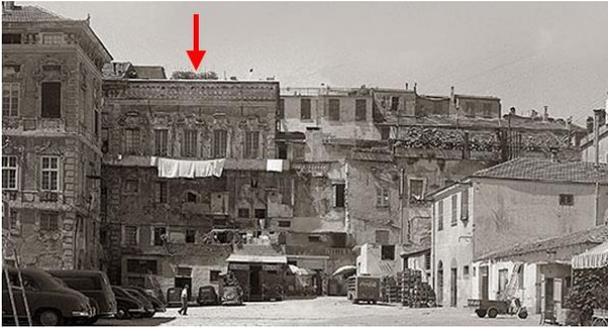
Figure 4. Photo archive Moreschi, Sanremo. Piazza Borea, 1950.

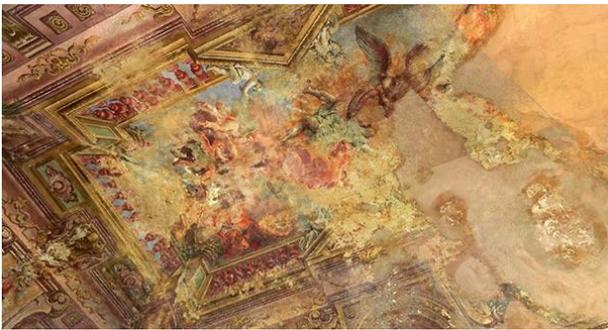
Figure 7. RGB three-dimensional view – 3d model of the vault elaborated with photogrammetry.

The comparison, instead, between the RGB view of the 3D model (dense cloud) and the reflectance view has clearly highlighted the problems of humidity and infiltration in the contact areas between the original masonry vault and its rebuilt portion after the collapse.

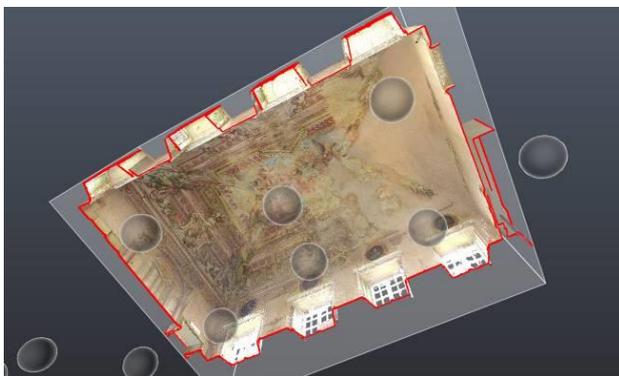
Figura 14. RGB three-dimensional view – 3d model of the vault elaborated with laser scanner
