THE *TEMPIO DELLA CONSOLAZIONE* IN TODI: INTEGRATED GEOMATIC TECHNIQUES FOR A MONUMENT DESCRIPTION INCLUDING STRUCTURAL DAMAGE EVOLUTION IN TIME

F. Radicioni^{a,*}, P. Matracchi^b, R. Brigante^a, A. Brozzi^a, M. Cecconi^a, A. Stoppini^a, G. Tosi^a

^a Dept. of Engineering (DI), University of Perugia, 06125 Perugia, Italy - fabio.radicioni@unipg.it

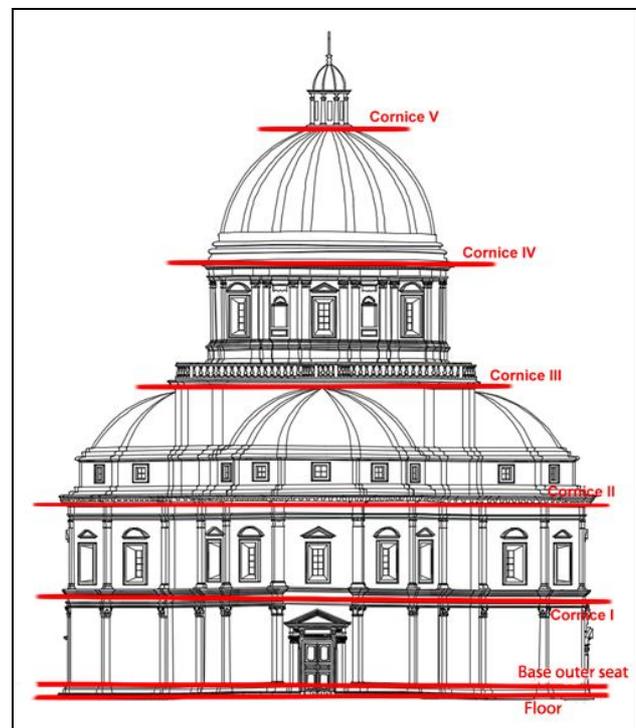
Figure 5. Location of some architectural elements

Figure 5 shows the location of some architectural elements measured and analysed. Internally, the measures interested the cornices at different altitudes and the floor. The cornice V (lantern base) was excluded from the final analysis because the total station measures were very inclined, thus with a lesser accuracy with respect to the others.

For each element was computed the height difference Δz between the highest and the lowest point (Tab. 1).

By means of a procedure included in the Leica Cyclone software (also used for the laser scanning analysis, see Par. 2.4), interpolating planes were computed for the various levels of Fig. 5, determining for each one the line of maximum slope and its inclination angle α from the horizontal direction (Tab. 1). For the cornice I, due to an architectural discontinuity, the points in the altar area and those in the remaining part of the church were analyzed separately. Table 1 shows the mean value of α .

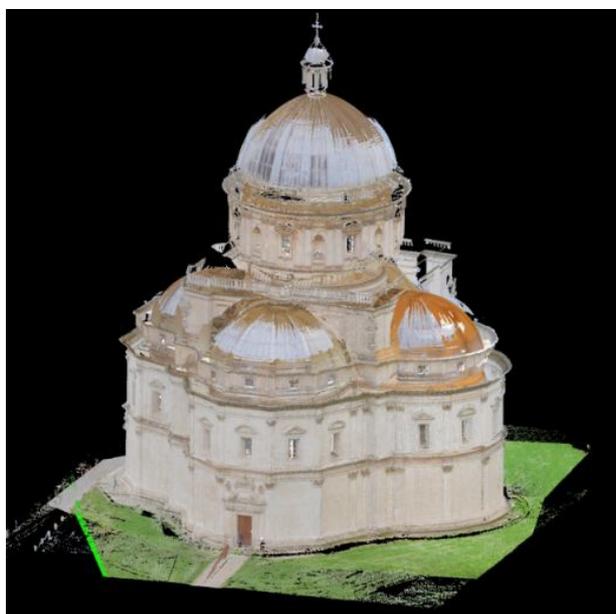
Figure 9. Point cloud assembled and coloured

Thereafter, to the cloud points were associated the RGB colour values deriving from digital photographs acquired with high resolution cameras: for the 2014 surveys a Nikon D200 on a calibrated mount on top of the Riegl scanner; for the 2016 campaign, a Nikon D800E and the digital camera included in the Faro scanner. The RGB colours "paint" the point cloud obtaining a realistic view (Fig. 9).

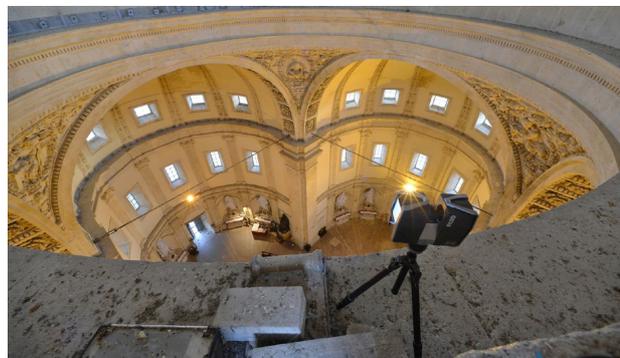
Figure 10. Internal scan from the dome base

The scans were carried out by placing the laser on appropriate points so as to minimize the shadow areas. With the Faro instrument, which is very compact in size, an internal scan was carried out from the cornice just below the dome. Never before a scan had been performed from this position (Fig. 10).

For the church floor, more than 800 points were extracted from the point cloud creating a contour lines model with a 2 cm interval. From such model, the floor shows a lowering of about

0.375 m in the north-south direction (toward the altar area), confirming what previously obtained from the total station survey (Par. 2.1). Measuring coordinates on various architectural elements (cornices, pillars, ...) from the 3D point cloud by means of the Cyclone software were obtained values matching at one centimeter level those deriving from the direct survey described in Par. 2.1.

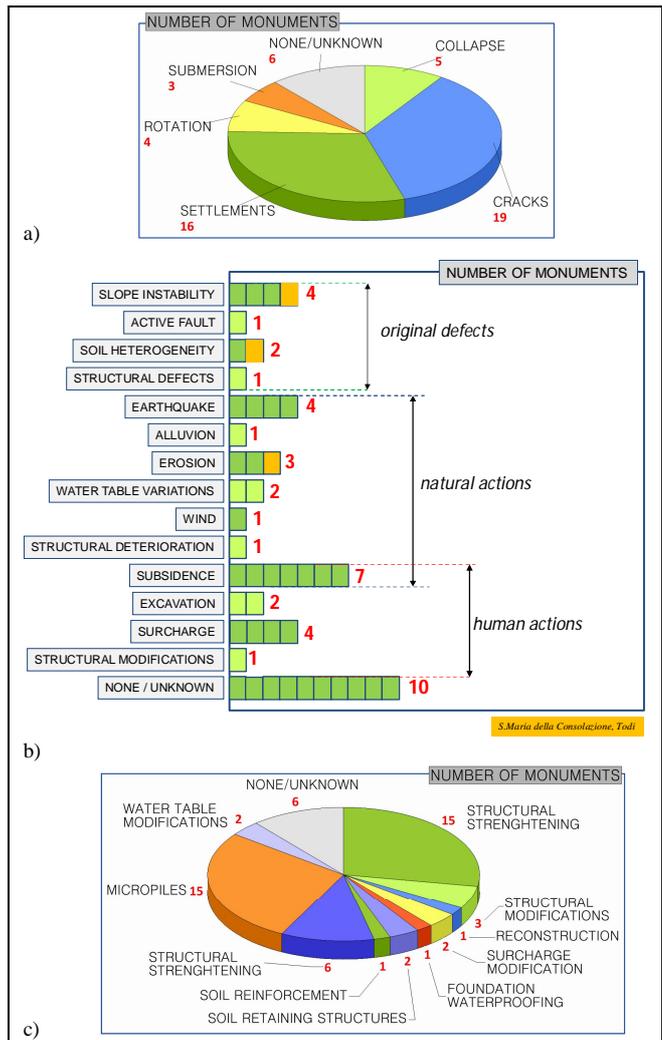
A systematic study of the saving projects carried out in Italy (until 1995) and including thirty-four buildings of different kinds with regard to style, age, use, shape and dimensions has shown that structural strengthening together with underpinning by micropiles have been the largely predominant type of measure (Fig. 14c). The adoption of micropiles is taken whenever cracks or settlements are observed, although the causes of damage maybe very different from case to case. (Cecconi et al., 1997). The *Tempio of S. Maria della Consolazione* in Todi is among the monuments included in this cited previous study, where the observed damage (cracks, settlements) are mainly associated to possible causes such as slope instability and soil heterogeneity (i.e.: original defects). At present, this scenario could be updated for the case at hand by including *rotation* among the observed damage. With regard to the preservation measures, by accounting on published data, Cecconi et al. (1997) identified structural strengthening among the most significant ones. In fact, as already mentioned in the previous paragraphs, structural and geotechnical countermeasures have been undertaken recently, consisting in underpinning, diaphragm walls made of large piles and structural reinforcement (Mariani, 2006, 2008).

Figure 14. Analysis of some Italian monuments (modified from Cecconi et al. 1997): a) damage types; b) possible causes of damage; c) preservation measures.

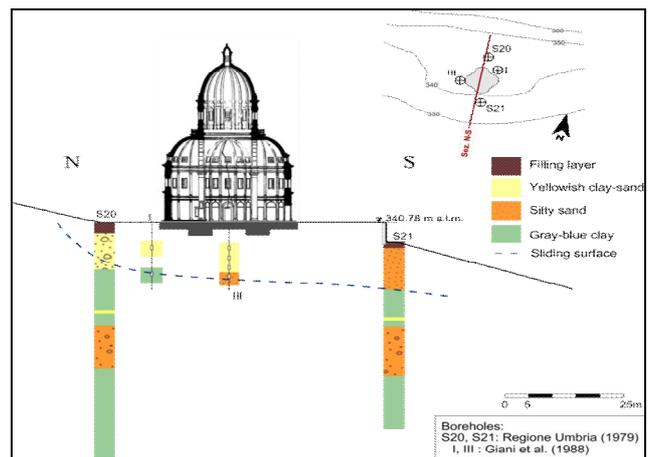
From a geological/geotechnical point of view the hill of the city of Todi is made up of clastic sediments in lacustrine and fluvial-lacustrine facies, from basal clays to conglomerates at the top (Cencetti et al., 2005). Based on the information gained from the geological data relative to two borings, S20, S21 (http://dati.umbria.it/dataset/banca-dati-indagini-geognostiche-geo-fisiche) and those reported by Giani et al. (1988), Figure 15 shows a section of the soil profile along the N-S direction. The dashed line represents the trace of a sliding surface documented in Mariani (2006). The main countermeasures adopted in recent years are not represented in this Figure (Mariani, 2006, 2008).

Figure 15. Soil profile from previous in-situ investigation.

As a first attempt to capture the measured rotation α along the main axis ($\alpha \cong 0.5^\circ$), which is consistent with the total settlement ($w = 0.375$ m) measured at the north side, along the direction N-S, the rotational stiffness of the soil-foundation system has been introduced (K_θ , Tab. 3). Although the subsoil

In this simple assumption and by imposing that rotation α towards the north is only due to gravity load (= 170MN) eccentricity, it can be inferred that gravity load at the foundation level should have an eccentricity of about 1.4 m with respect to the centre of gravity. Lower values of eccentricity could be attained by relying upon a higher deformability of the foundation soils.
