EXPERIMENTAL CONSOLIDATION WORKS IN RAMMED EARTH WALLS: THE CASE OF THE BAÑUELO IN GRANADA (SPAIN)

J.M. López-Osorio ^{1,*}, P. Bel-Anzué ²

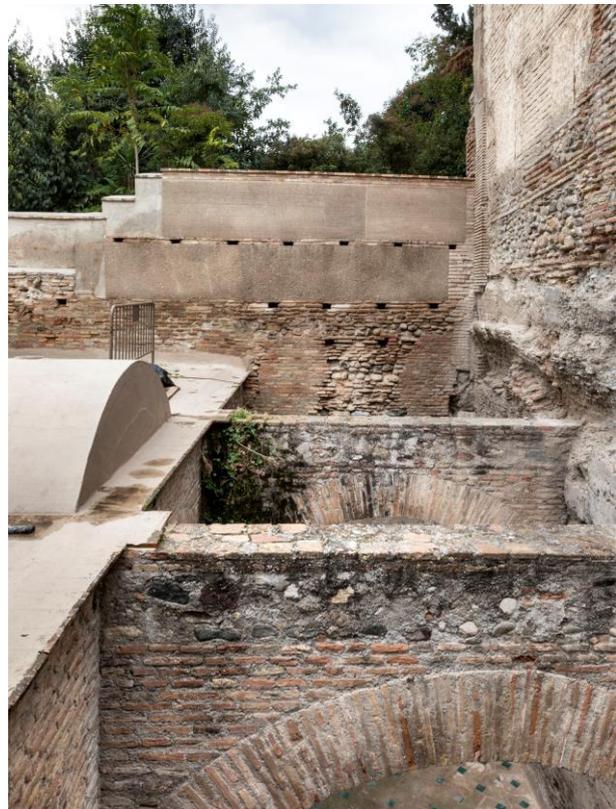
Figure 1. Overview of the service room of the Bañuelo. At the bottom: west dividing wall. Photograph: Cristina García-Zarza.

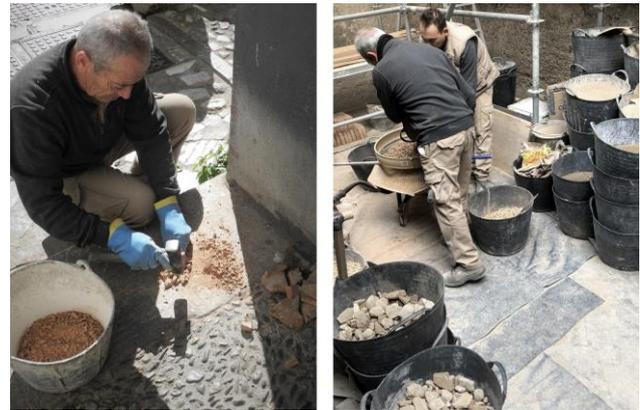
Figure 4. Chamotte preparatory works and development stage of the different masses of earth.

To facilitate the mixing and elaboration of the replacement material, the two soils were sieved using a 4 mm sieve to obtain a homogeneous starting material that facilitates its application, eliminating those remains, organic matter and other elements that were considered unsuitable. However, the discarded material was screened again, recovering different gravel particles that were classified into different fractions (4-6, 6-20 and 20-60 mm), being added again to the replacement material depending on the needs of the new formulations (Figure 4).

To these starting materials, sand from a local quarry (0-4 mm) and a smaller proportion of chamotte or fired ceramic powder were added, all in order to reduce the plasticity of the earth. The chamotte was obtained by manually crushing fragments of Arab tiles (Figure 4), as it appeared in the original wall, obtaining two types of grain size. The largest would be added to the material for rammed earth walls (0-20 mm), and the finest would be used for filling of holes and superficial reintegrations (0-6 mm) (Chamotte, Table 1).

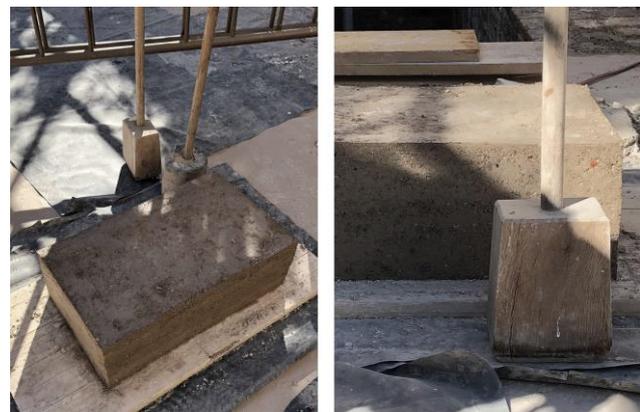
Figure 5. Rammed earth test specimen built *in-situ*.

In order to improve the stabilization and durability of the replacement material, taking into account the results of the previous laboratory tests described in section 3, different percentages of powdered calcic lime from Estepa Company (Sevilla) were added, as well as linseed oil in a percentage of 2-5%. To check the effects of these additives for volume reintegrations carried out with rammed earth wall, a test specimen of 60 x 35 x 20 cm was prepared (Figure 5). Likewise, application tests were carried out on the renders used for filling voids and surface reintegrations, which were formulated with different dosages and consistencies, and applied to the eroded wall surfaces, incorporating anchoring systems to improve adhesion and performing finishes with different textures, as will be detailed in the next section.

Once the results of the tests carried out on site were analysed and contrasted, the use of linseed oil was ruled out, despite considerably improving the surface resistance. It had caused a slightly whitish colour that it was not acceptable. Likewise, in the case of surface reintegration applications carried out in layers, the oil favoured exfoliation and made adherence of individual layers difficult. Table 1 shows the formulations finally adopted, depending on the different application techniques.
