A LOOK AT THE ERRONEOUS RESTORATION OF THE HISTORICAL KASBAH OF AGADIR, MOROCCO

M. Nassir^{1,*}

KEY WORDS: Diagnosis, Evaluation, Erroneous Restoration, Degradation of architectural features, Preservation, Earthen Building

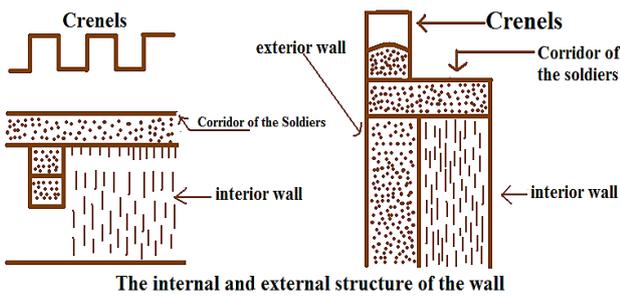
Figure 6. Longitudinal and cross-sectional design of the inner and outer structures of the kasbah walls.

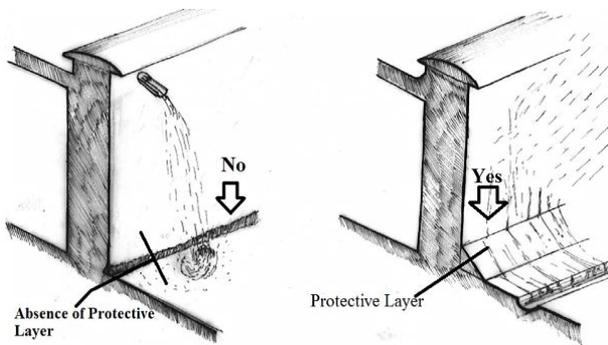
Figure 7. Protective layer.

4.2.8 Reinforcement of the wall foundations: It is noticeable that the protective layer is absent in the wall foundations. Coping is a covering of stone or terracotta or any appropriate material on the exposed top of a wall to prevent seepage of water. It plays an important role in protecting walls and foundations from erosion due to water pouring from roof scuppers and water streaming along the walls (Boussalh et al., 2005). Indeed, the absence drainpipes damaged the lower part of the walls of the kasbah.
