## RECOVERING VALPARAÍSO'S URBAN ELEVATORS: THE RESTORATION OF THE CORDILLERA FUNICULAR

C. Giribas<sup>1</sup>, G. Paredes<sup>2</sup>, A. Riquelme<sup>3,\*</sup>

The restoration of the Cordillera elevator was carried out by the Chilean Ministry of Public Works between 2016 and 2018. Its original construction effectively represents the infrastructure that illustrates Valparaíso's historical, urban and social configuration from the 19th Century until today.

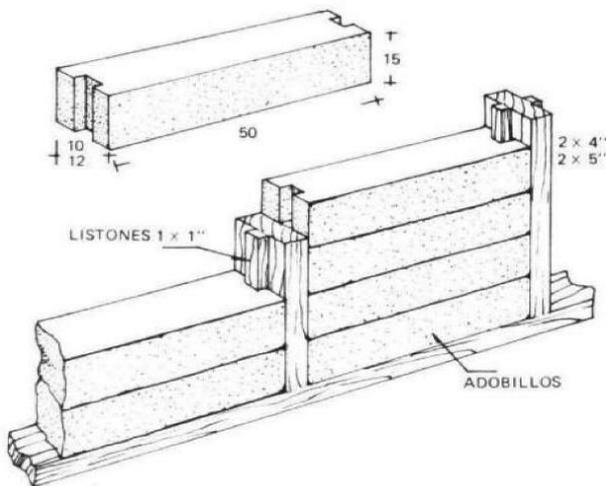
Figure 9. The *adobillo* building system.  
Source: Euclides Guzmán.

**5.3.1 Emptying of structures:** As a result of the diagnosis, *adobillos* between structures were removed. This was carried out through partial demolitions in order to generate spaces through which the blocks could be maneuvered and removed completely for later reuse. Broken pieces of removed blocks later served as mortar for new masonry.

**5.3.3 Slat replacement:** The integration of a 1x1 slat of impregnated pine wood was implemented to ensure fixing of earthen blocks. This element replaced old poplar ribbons which showed significant degradation both due to general rot and, in some specific sectors, the activity of xylophagous insects. Poplar wood has low levels of extractives, making it highly vulnerable to the appearance of xylophagous damage.

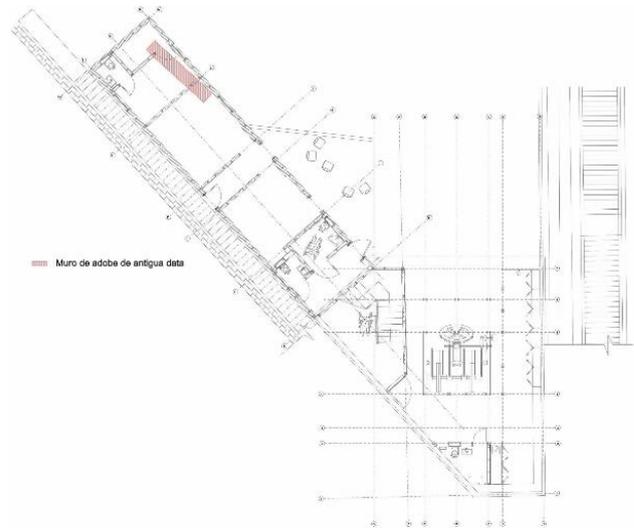
One of the significant events within the period of execution of the restoration work happened in 2017, when the floor of one of the precincts of the upper station was removed. Traces of an adobe wall were discovered under this floor. Further archaeological excavations uncovered a wall measuring over two meters high. Extending 130 cm up from the base, the wall was built with irregular stone masonry. Then, to increase the height by 20 cm, two rows of burnt brick were laid on top. The upper part of the wall consisted of twelve rows of adobe blocks which reached a total height of 130 cm, out of which the last adobe layers were the ones visible after the floor was removed.

Figure 14. Plan of the upper station with the archaeological finding.

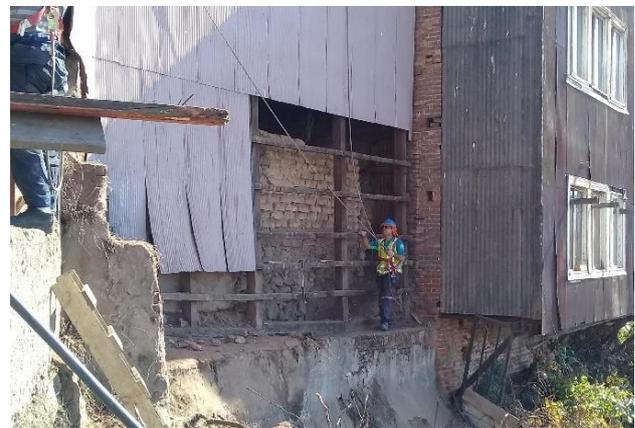
Figure 15. View of the wall discovered during restoration works.
