DOCUMENTATION AND MONITORING OF BUILT HERITAGE IN ABU DHABI, UAE

Salman Muhammad

Abu Dhabi Tourism and Culture Authority, Abu Dhabi, UAE
salman.ali@tcaabudhabi.ae

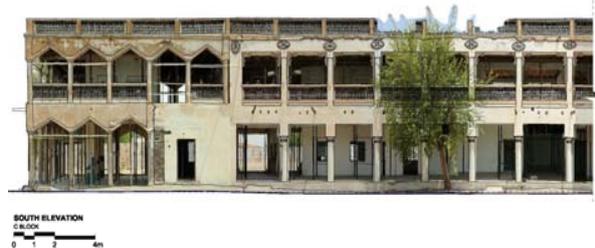
Figure 6. A rectified south elevation of private block.

As part of documentation measured surveys of the building and topographical survey of the site in its as-found state is a prerequisite to conservation planning to provide the base data for conservation architects, conservators and archaeologists, and assist them in devising conservation interventions and supporting site presentation schemes. The Conservation Section has been working on producing topographical and measured building surveys (fig. 5) using instrument-based REDM technology with a total station and allied software package. Detail surface features and architectural decorations were documented with the help rectified photography (fig. 6).

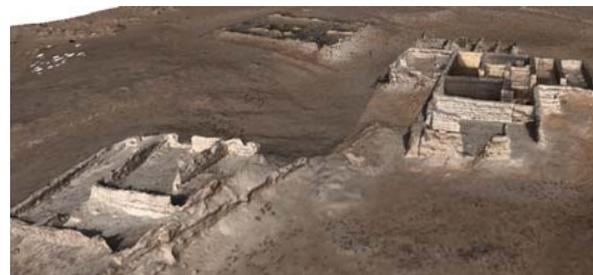
Figure 7. A snap shot of 3D model shows all three houses of Hili 17.

The main purpose was to create a digital 3D model to complement the field survey (Fig. 7). Over 100 scans at a 5mm resolution and more than 3000 digital photographs were taken in four days to create the 3D model which was geo-referenced by GPS measurement. 3D model was used to extract secondary products like contours, sectional elevations, plans and the rectified (orthogonal rubber-sheeted) images of each wall elevation (Fig. 8). These plans, elevations and sections extracted were used to accurately map conditions. A detailed GIS system with additional panoramas was created as a management tool to document each wall of the site. (Salman, Chabbi, 2012).

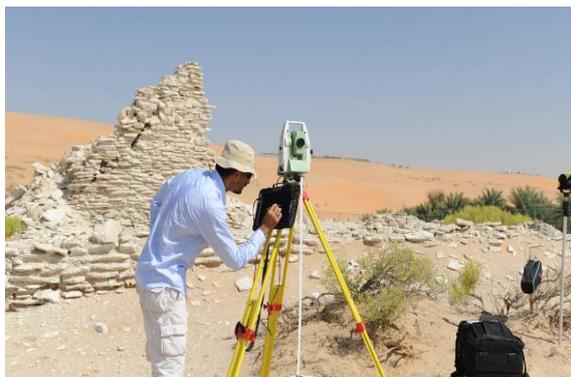
Figure 9. Monitoring survey of a major crack with total station at Om Hosn site in Liwa.

A large section of wall on the south is still intact but with a huge vertical structural crack. An instrument-based survey (REDM) with a total station was preferred due to its high accuracy and precision (Fig. 9). Four permanent reflective targets were fixed on the both sides of crack and their positions were recorded three-dimensionally with total station from a permanent benchmark on the ground. The field measurements were collected by a field computer and directly processed in real-time with a combination of softwares on site. The 3 dimensional coordinates of each target were collected during three separate surveys in one year and then analyzed (Fig. 10). Very minor movements were observed during the analysis of the targets positions. A rectified elevation of wall was produced to document the process.
