THE MENSIOCHRONOLOGY ANALYSIS SUPPORTED BY NEW ADVANCED SURVEY TECHNIQUES: FIELD TESTS IN MILANESE AREA

L. Cantini *, M. Previtali, R. Moioli, S. Della Torre

KEY WORDS: Mensiochronology, Photogrammetry, Brickwork, Vimercate, high-resolution rectified pictures

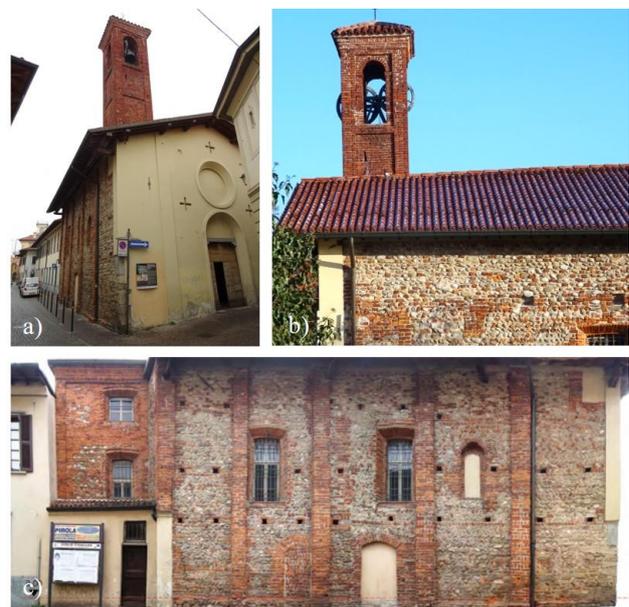
Figure 2. St. Antonio Oratory: a) the façade; b) the bell tower and c) the rectified north side with its stratifications.

Although a small building, S. Antonio's church (Figure 2) in Vimercate features several construction phases, whose technologies can be easily observed on the external walls that are not plastered. Its origin is uncertain (Bairati 1994), the first two building phases encompassing the unique nave. Unpublished archival documents enable to give an undisputable date (after 1574) to the internal pointed arches supporting the roof, and the contemporary raising of the lateral walls (Figure 3). The original semi-circular apse was substituted by a wider square choir in 1615-1625, enriched by a classical triumphal arch, expressing the will and the taste of the bishop Federico Borromeo.

S. Antonio's bell-tower is a special topic of this analysis. A small tower had been built between 1590 and 1615 in the same position of the existing one, that is in the northern corner of the façade, but the date 1673 legible on the bells suggested to previous authors that in the same year the bell tower itself was built. The problem is therefore open, and the bricks measures could support one of the hypotheses. The bell tower enables both to identify a good sample testing photogrammetric methods and a small sample of bricks at the internal base, which can be measured directly.

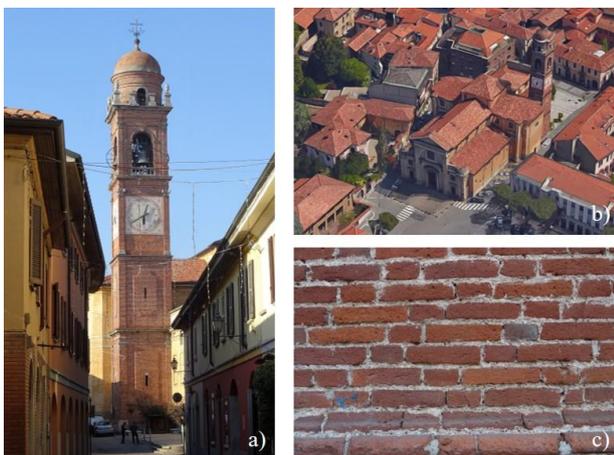
Figure 4. The Sanctuary of the Holy Virgin of the Rosary: a) the bell-tower; b) a sky view of the church and c) its masonry.

As for the other bell tower of Holy Virgin Sanctuary (fig. 4), specific documents on its building history have been found in the Plebano Archive in Vimercate (Sannazzaro 1995: 178-179). The works were directed by the engineer Francesco Bianchi from Milan, who is deemed to be also the author of the project and lasted from 1688 to 1694. The external facades are accessible from the public street, so in this case it is possible to carry out direct measurements and to shoot photos. The sample represents also an optimal choice to be placed on the Time axis.

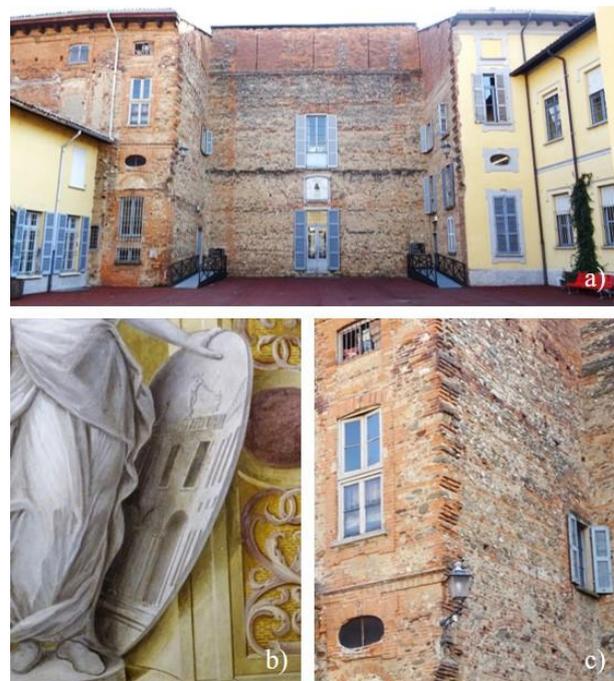
Figure 6. Trotti Palace: a) main courtyard with the incomplete side; b) the representation of the courtyard in a fresco at the ground floor and c) detail of a connection for the cloister.

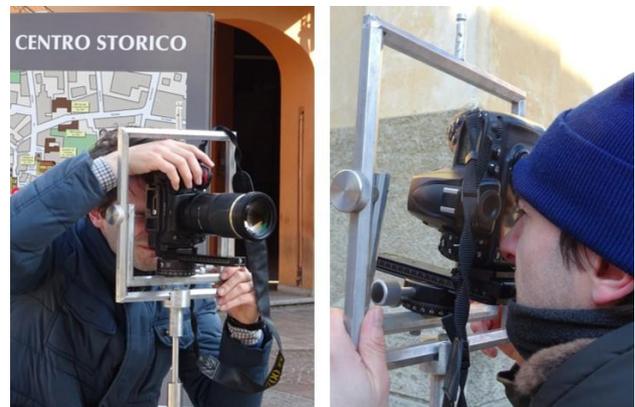
Figure 8. The cardan joint based rotating camera system.

To create such a rotating camera, we developed an ad-hoc mechanical rotating head that consisted of a cardan joint that allows the camera to rotate around it (Figure 8). The Rotating head needs to be calibrated in order to find the perspective centre for a generic lens mounted on the camera (Barazzetti et al., 2013). Images acquired with a rotating camera can be registered and stitched through homography. The transformation between two images i and j can be expressed as follows (Hartley and Zisserman, 2004):
