## A COMPARISON AMONG DIFFERENT OPTIMIZATION LEVELS IN 3D MULTI-SENSOR MODELS. A TEST CASE IN EMERGENCY CONTEXT: 2016 ITALIAN EARTHQUAKE

F. Chiabrando <sup>a</sup>, G. Sammartano <sup>a\*</sup>, A. Spanò <sup>a</sup>

<sup>a</sup> Politecnico di Torino, DAD, 10129, Torino, Italy - (filiberto.chiabrando, giulia.sammartano, antonia.spano)@polito.it

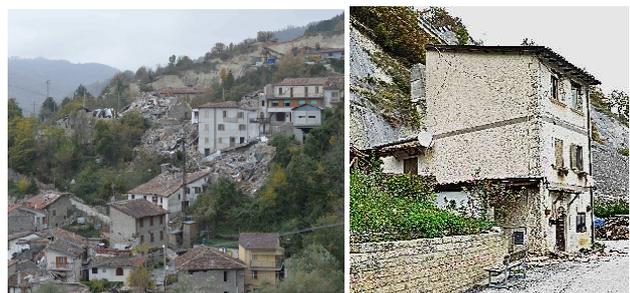
Figure 1. Pescara del Tronto perched village, in Arquata del Tronto, AP, October 2016 (left). The object of focus: a stand-alone damaged building (right).

The present paper is focused on the ancient perched village of Pescara del Tronto, in Arquata del Tronto municipality where a group of differently damaged buildings (Figure 1b) were selected. In this area 3D image-based metric survey has been performed, with combined use of terrestrial and aerial sensors.

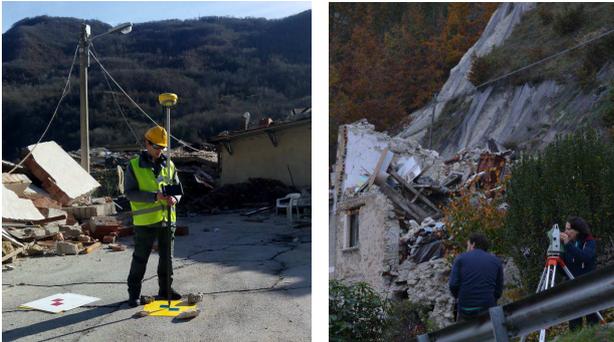
Figure 2. Survey operation with the Geomax Zenit 35 GNSS (left), Leica TS06 total station survey (right)

The whole area in Pescara del Tronto involved in metric survey was covered by almost n°40 GCP materialized on ground by target as Figure 2a. Three of these aerial target were positioned in the neighbourhood of the damaged building. Moreover, for each building that was measured and imaged by multisensor

acquisitions, a set of natural points were detected on object. For this stand-alone damaged building n°35 points have been measured (Figure 2b) on the main elements, as the roof edges, the façade, the windows and the door, the stone elements, useful for both the aerial and the close-range blocks.

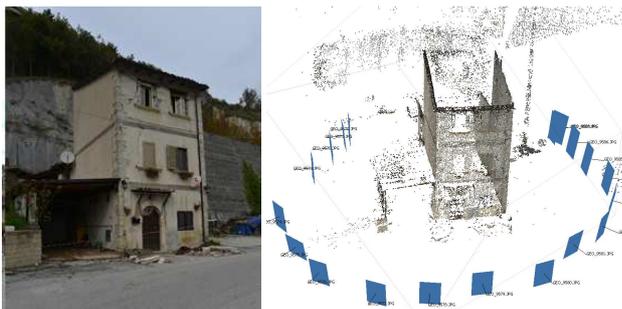
Figure 3. A series of terrestrial images and close-range cameras estimated position

**3.1.2.1 Close-range photogrammetry.** The images were acquired by a Nikon D800E reflex digital camera equipped with a 24x36mm frame. The camera has a 36 Mpx full-frame CMOS sensor with a pixel size of 4.89µm. Around the building 20 images (7360 x 4912 pixel) have been shot from almost 8 m (Figure 3). Then the cameras were post treated for balancing light and colours and masked for the bundle block adjustment.

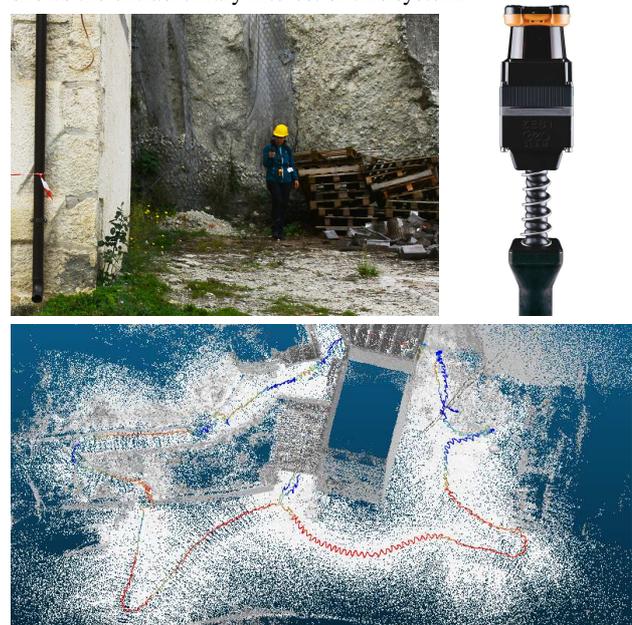
Figure 4 Zeb 1 by Geo-Slam: an acquisition moment (left), the instrument (right). (Down) Geo-Slam path, with quality of registration attribute in scalar colour

This device (Figure 4b) consists in a 2D lightweight time-of-flight scanner with 30 m maximum range (Hokuyo scanner) and an Inertial Measurement Unit (IMU), which ensure roughly the position. They are both mounted on a spring so that when the

operator moves in the environment to be mapped, the device swings freely and randomly determining the 2D scanning plane invests the environment generating a 3D point cloud. (Bosse, Zlot, Flick, 2012). The mapping system is based on the Simultaneous Localization And Mapping (SLAM) technology, which is the prominent for indoor environments since it uses the environment to update the position of the device (Riisgaard, Blas, 2005). ZEB1 uses the raw trajectory to roughly calculate the surface normals and potential constraints (features recognition) within a single sweep of the scanner. Then a cloud to cloud registration generate the 3D cloud using an iterative process, which relies on geometric objects and features within the scans. The importance of the features constrains, essential to align subsequent scans, is well visible in Figure 4c that shows how the quality of the recording is less accurate when the operator has moved away from the building. Although the system is provided for outdoor and indoor mapping, the processing presented in the next paragraphs show different accuracies and level of detail for different portions of mapped objects, as other tests do (Thomson et al. 2013). The consideration that the cloud was acquired in just 5 minutes shows the extraordinary interest of this system.

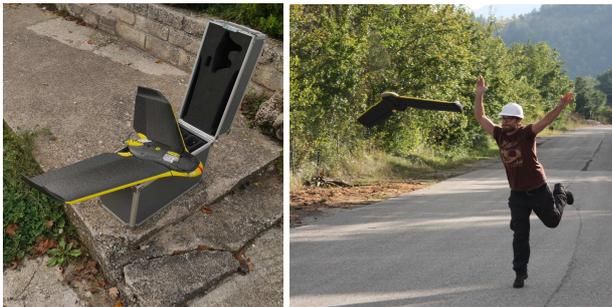
Figure 5. eBee platform (left), take-off phase (right)

(Boccardo et al., 2015). The eBee system (Figure 5 left) is certified by ENAC as EBM-1539 and it is approved as inoffensive by the Italian Department of Civil Protection too.

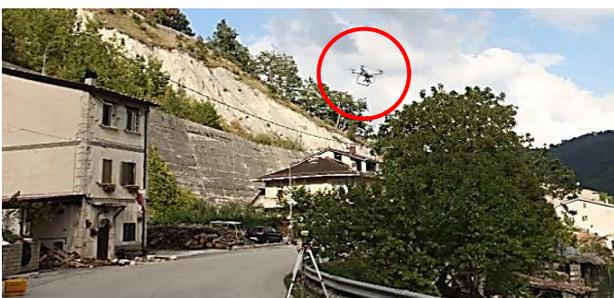
Figure 6. Phantom 4 DJI piloted drone (in red circle) during aerial acquisition

The elevation of the flight with the DJI were performed at an elevation between a maximum of 20 m up to a minimum of 10m. In detail using this UAV (Figure 6) the data were acquired following the two available approach: the 4K video recording (and then the frame extraction) and the single shooting set-up, that allow to acquiring nadiral and oblique images and videos (Figure 8). A set of 64 nadiral images were acquired by DJI camera in regular grid as Figure 8b; moreover, almost 140 frames were extracted from the 08:19 min video with 29frames/sec (1frame/3,5sec) (Figure 8a).

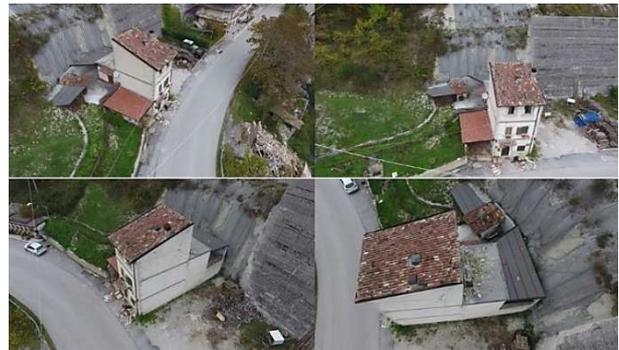
Figure 7. Some frames extracted from 4K video by DJI camera

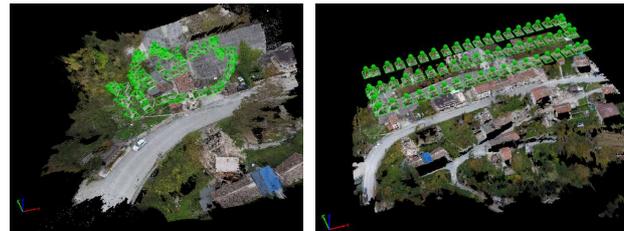
Figure 8. Nadiral and oblique configuration for DJI acquisition

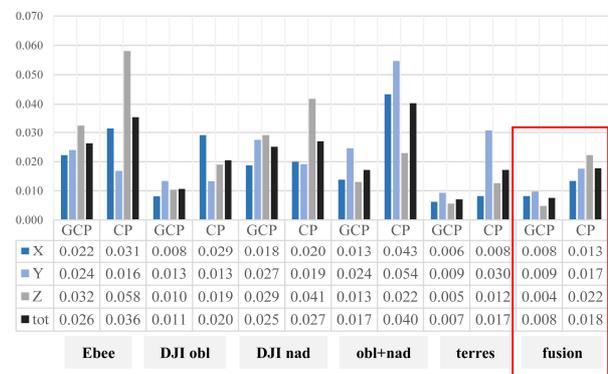
Table 1. Accuracy on RMSE (m) GCP and CP on processing: eBee flight, DJI flights, fusion of aerial data, close-range acquisition, and total data fusion. We can consider this last one as the best verified result so that it can be used as ground-truth.

For the close range photogrammetry, three level of quality have been verified (Tab.2); the high performance is undoubtedly the most competitive in terms of accuracy on GCPs and CPs

(Tab.1) and detail on geometry. Time of processing (almost 5 hours), however, is not easily sustainable among the others.

The analysis of processing data clearly demonstrates the differentiated role of sensors in the contribution for geometry definition. Finally, a data fusion of aerial and terrestrial images were thus implemented, in three progressive level of high processing parameters (Tab.4). Accuracy results in Table 1.

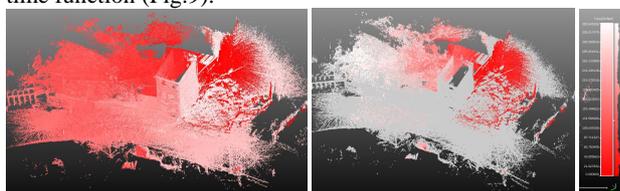
Figure 9. ZEB point cloud presented in scalar colours according to acquisition progression with time variable (0-350sec, from red to white), left; first two minutes acquisition sample (right).

In Pescara del Tronto, due to the critical area conformation and the contingent performance of the path, the procedure of cloud registration ended with a residual error of 3 tens of cm. Another advantageous point of the system is that the results are offered as a series of structured datasets, relative to the cloud and the trajectory, offering the ability to segment the cloud using the time function (Fig.9).

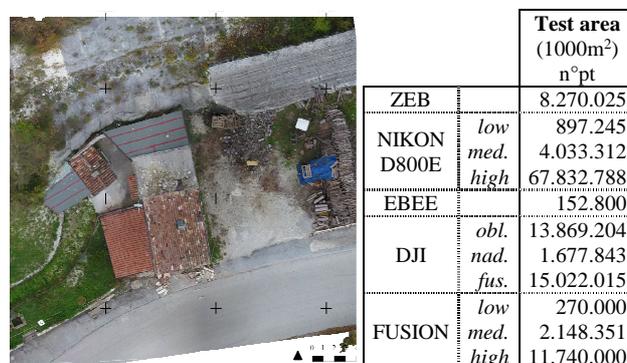
Figure 10. Test area (Point cloud data on Table 5)

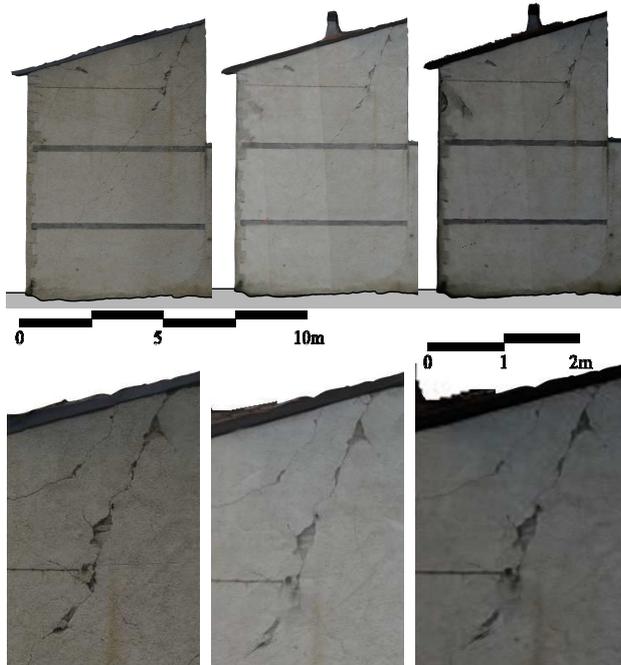
Figure 11. Orthoimage of the East side. According to the available detail and the accessible qualitative information, the aerial model (oblique and nadiral cameras), can be comparable to the high quality terrestrial photogrammetric one (top), as well as the fusion model one (centre).

An aerial model by commercial DJI drone, as in Orthoimage, is highly competitive in terms of quality of RGB information. The standard of comparison is a well-known terrestrial close-range photogrammetry, a solution less viable in these contexts of timing and accessibility to spaces. Most of damages and creeps on all the façades are clearly visible even in the aerial model (as in example in Fig.11), better than in the fusion one.

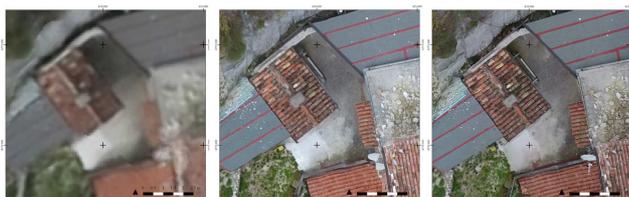
Figure 12. Comparison for a zoomed excerpt: eBee, average GSD=5 cm/px (left); DJI Phantom, average GSD=2,18 cm/px (centre); fusion model, average GSD=0.92 cm/px (right)

More reflections that are interesting to be carried out are on the typical aerial representation of the site surface. For a DSM, data extraction could usually concern, for example isolines and elevation points. For the 3D documentation of the building and its surrounding areas at environmental scale, ZEB1 point cloud has provided good results, as in Figure 13. For planimetric information at architectural scale, a HQ fusion model offers the best level of detail of the building and around (Fig.12).

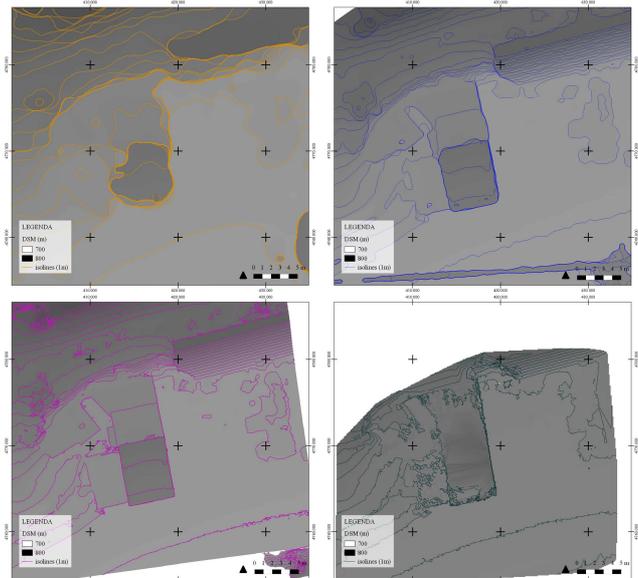
Figure 13. DSM comparison. Top: eBee DSM (left); DJI DSM (right). Down: fusion model DSM (left); ZEB1 DSM (right).

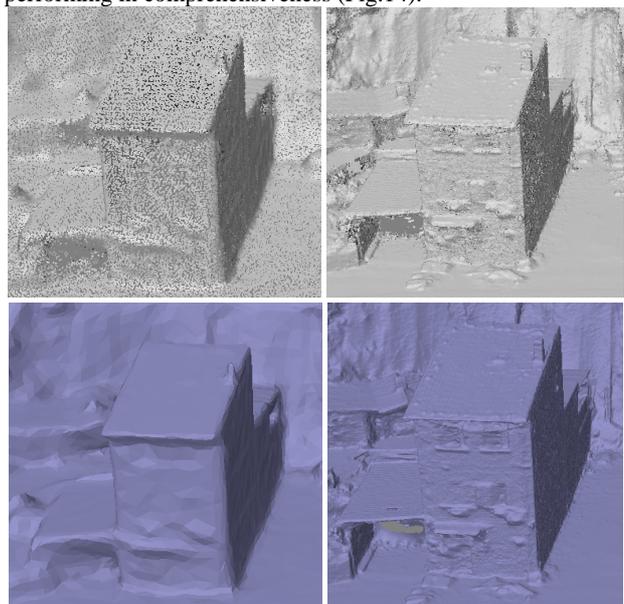
Figure 14. Data fusion model. Top: (left) low and (right) high parameters point cloud. (down) 3D mesh

Initially we can approach to the modelling with a more volumetric shape and then a more analytical and specific modelling was create (Tab.2-3-4) to test level of detail among sensors in this test object. Fusion model in this instance is much performing in comprehensiveness (Fig.14).

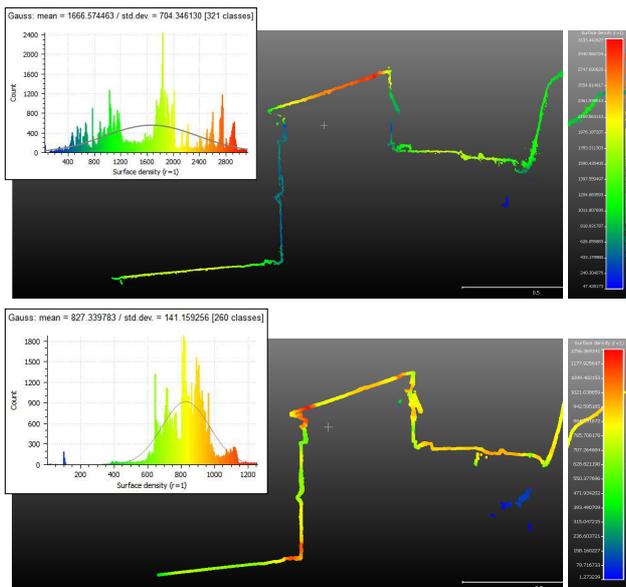
Figure 15-16. Density for aerial point cloud (top). Density for data fusion point cloud (down)

Density indexes (Tab.6) is here significantly for differentiate the contribution of each sensor for the geometrical definition. Despite the close-range one is the richer in dense points on the façade, is the most non-uniform (st dev), together with the ZEB1 one. As expected, the fusion model presents a uniform distribution of measurements of the whole building in comparison to the aerial one. We can verify than the fusion of models contribute to the geometric definition not in terms of average density, but for the standardisation of distribution.

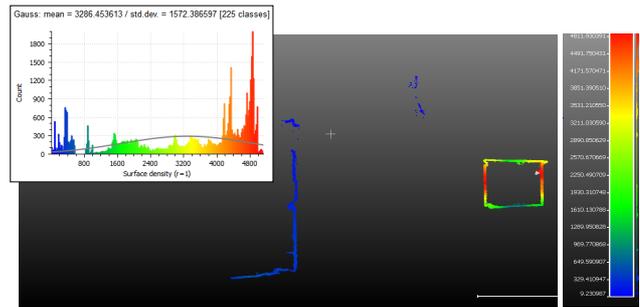
Figure 17. Density for ZEB point cloud Section (4)

We can affirm that the extensiveness data from fusion of terrestrial and aerial images can be integrated with a union of the LiDAR ZEB1 data (Fig.17) that have been georeferenced, in order to produce a complete profile of the building with hits geometry in relationship with the rear rock face.

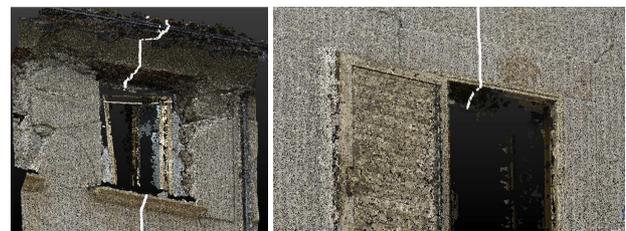
Figure 18. Section (4) on terrestrial photogrammetric model

**5.3.1.2 Windows axe.** In comparison with the very high scale easily accessible by terrestrial photogrammetry technique (Fig.18), we want to evaluate here the higher level of geometrical definition of aerial acquisition in comparison to a data fusion model from both terrestrial and aerial imaging (Fig.18).

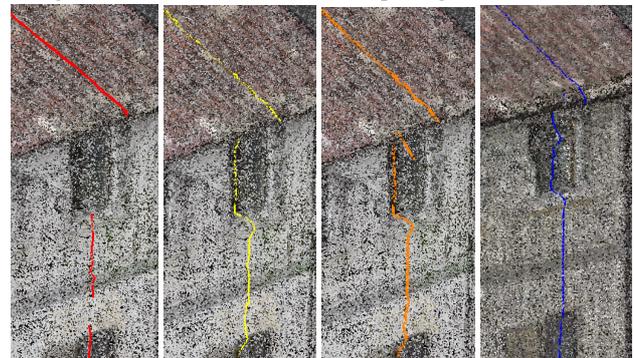
Figure 19. Section (4) on a zoomed excerpt. From left: nadir cameras; Oblique cameras, aerial model, HQ data fusion model.

The data fusion model offers of course the best solution for both levels of detail on façade elements and 3D point uniformity, for example (Fig.19). Through a sample of deviation of measures on the polyline section, we can affirm that the aerial model is anyway a good compromise if terrestrial feasibility is compromise.

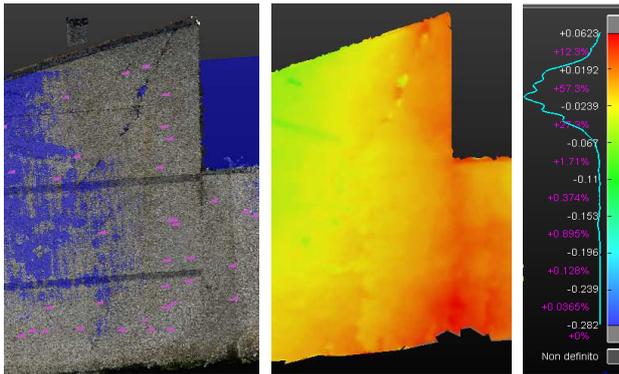
Figure 20. East wall surface analysis: data fusion with terrestrial ground-truth

model by data fusion has finally the lower discrepancy on CPs and better fits with the terrestrial measurements (Figure 20). Unless very accurate information is necessary for specific focus analysis on the building, an aerial model could be suitable; the integration of aerial and terrestrial does not add a significant improvement in level of geometric definition for a first-step damage documentation and assessment, and in any case, the detail of terrestrial imaging could not be reached. Nevertheless, according to the achieved results and preliminary analysis, is possible to underline that a UAV nadir-oblique close-range acquisition, open to improvement in the use of high resolution cameras, could obtain a very strategic level of information. It is not so much the density that rises using the aerial camera merging, but, of course, is the homogeneity (st.dev) cloud density, that allows extracting less fractionated sections.
