LESSONS LEARNT FROM THE RECONSTRUCTION OF THE DESTROYED MAUSOLEUMS OF TIMBUKTU, MALI

T. Joffroy^{1,*}, B. Essayouti²

ABSTRACT:

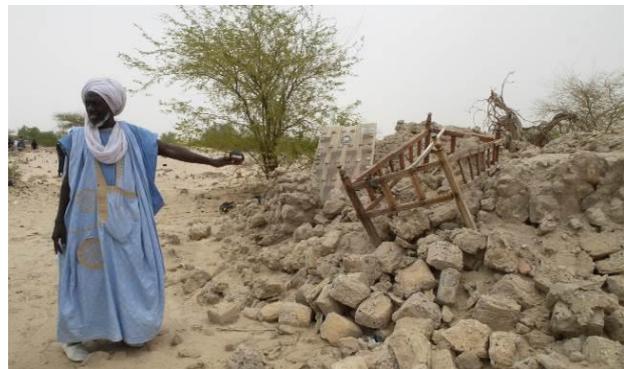
Figure 1. Mausoleum of Cheik Sidi Ben Amar, destroyed on June 30, 2012 © Joffroy T. CRATERre.

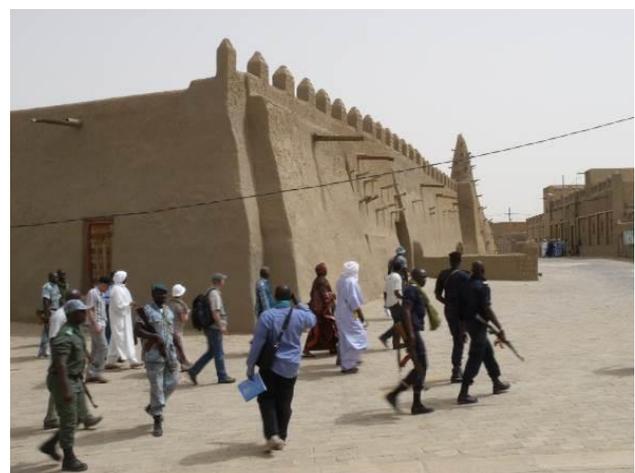
Figure 2. Inspection of Djingarey-ber mosque on June 6, 2013
© Joffroy T. CRAterre.

Therefore, UNESCO¹⁰ decided to organise several missions, first with a group of national experts (architects and heritage specialists) from May 28, and later involving international experts¹¹. This first international assessment mission took place on June 6 (Figure 2).

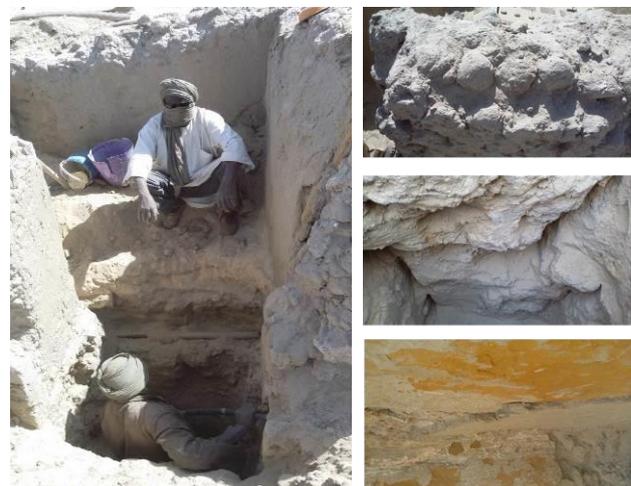
Several archaeological digs – limited to exploratory pits located beside the gate, as authorized by the custodians – were also undertaken¹⁴. These showed that some of the mausoleums had a very long history¹⁵ with both continuity and rupture. The stratification observed inside the excavated mausoleums revealed that these had already been prone to several – if not many – deterioration / repair cycles. Some of the findings at some strata gave clear evidence that the roof had collapsed and had been rebuilt without trying to re-use or remove the collapsed elements¹⁶. It was also observed that the walls had been raised above the original structures and that this had been done on several occasions. As a result, the buildings that we knew before their destruction by the armed groups in 2012 were in fact located far above the original ones. Explorations only went 3m deep as going further would have involved digging larger pits and installing struts, something which the traditional custodians would not have been willing to accept (Figure 3).

Figure 3. One of the archaeological digs and samples of strata observed © Yamoussa F. DNPC.

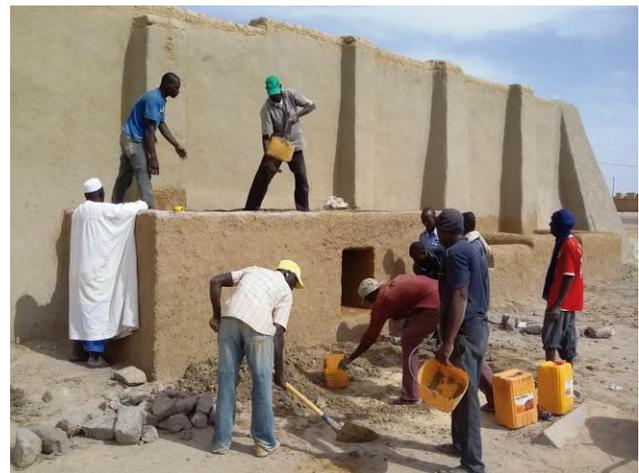
Figure 4. The pilot reconstruction project at the juxtaposed mausoleums of Cheikh Sidi Mahamane al Foulani and Cheikh Sidi Baber Baba Idjé © Koné M., Audex.

The reconstruction was planned as an iterative process. The idea thus was to start with one of the smaller mausoleums and possibly in a place which was both safe and easily accessible. Fitting these criteria, the cautious choice for this first activity was that of the two juxtaposed mausoleums of Cheikh Sidi Mahamane al Foulani and Cheikh Sidi Baber Baba Idjé, located against the west wall of the courtyard of the Djingarey-ber mosque, along one of the main streets of the city. This (re)construction site was a chance to organise discussions between conservation experts and traditional masons, using it as a sort of structural model of the larger mausoleum structures (40-50 % scale) to be reconstructed. This allowed them to check different information on the building materials (stones, two kinds of earth, palm trees and branches, etc.), their origin and selection criteria, building techniques, tools and methods on the (re)construction site.

An evaluation of this first sample work was carried out after the 2014 rainy season. This led to some adjustments, which mostly concerned the size and shape of the waterspouts and the composition of the mortar for the plastering.

The waterspouts needed to be much longer and more sloping to project rain water far enough from the wall to avoid drips on the plaster (due to wind) and also to protect the base of the structure from splashing and pools of water that could lead to wall base degradation.

The plastering was only partially satisfactory and the superficial erosion after just a season (though quite a good one) led to reconsidering its composition. The issue had been discussed earlier, some advocating adding more sand to avoid cracks and get a smooth surface, others preferring a high clay content,

including more straw to provide a thicker layer with a raw finish, locally called *sanfa sanfa*, with handprints clearly visible on the surface, breaking the speed of the water and thus erosion. Under pressure from those who wanted a very neat, smooth surface for the finish, the sandy solution was selected for the pilot project. However, as foreseen, it did not prove satisfactory. Thus, the later recommendation, *sanfa sanfa*, was the one finally chosen for the overall project as it offered greater protection to the eastern elevations by adding additional layers (2). This required a search for potential new quarries for the *Terre de bas-fond*²⁴ as those close to Timbuktu appeared to have already been overexploited and so had limited potential for ensuring both quantitative and qualitative requirements for the mausoleums and the other projects planned (maintenance / repair / partial reconstruction).

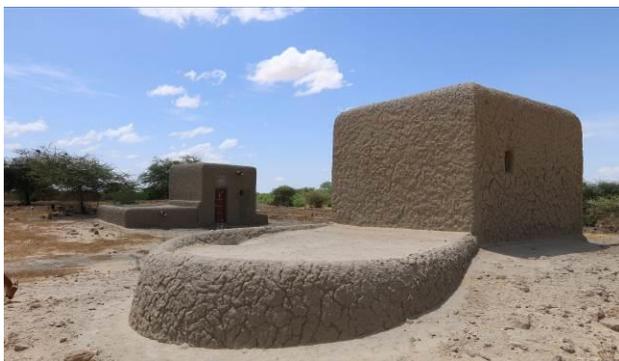
Figure 5. Mausoleums of Cheik al Tawaty (front) and Cheik Sidi Mohammed Mikki (back) after reconstruction, September 2015. © Joffroy T. CRAterre.

The second phase (Figure 5) was planned taking into account the results of the pilot reconstruction project beside Djingarey-ber, both technically and for the estimation of costs needed to ensure the proper involvement of young masons alongside their elders (Figure 6).

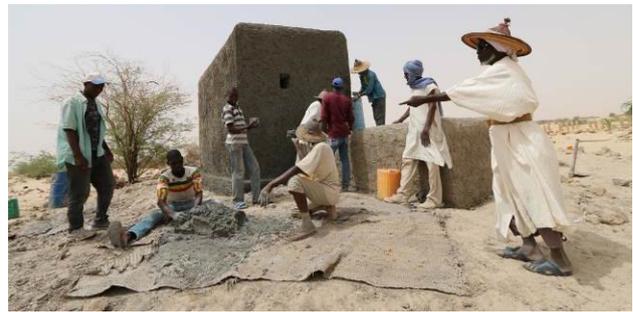
Figure 6. Preparation of mortar for plastering by young masons supervised by the head of the masons' corporation. Mausoleum of Cheik Sidi Ben Amar, April 2015 © Joffroy T. CRAterre.

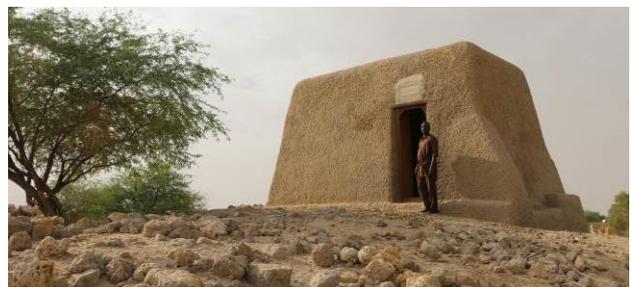
Both phases 2 and 3 included larger and smaller mausoleums to be reconstructed. An important criterion for being in the third phase was that of complexity. Thus, the Mausoleum of Alpha Moya (Figure 7) with its very distinctive semi-pyramidal shape and some old broken walls was part of this phase. It also included the three mausoleums located in Kabara, the port city 15 km from Timbuktu on the north bank of the Niger River where safety conditions were sufficiently ensured to allow the architects and the head of the masons' corporation to supervise on a regular basis.

Figure 7. Mausoleum of Cheik Alpha Moya after its reconstruction - September 2015. © Joffroy T. CRAterre.

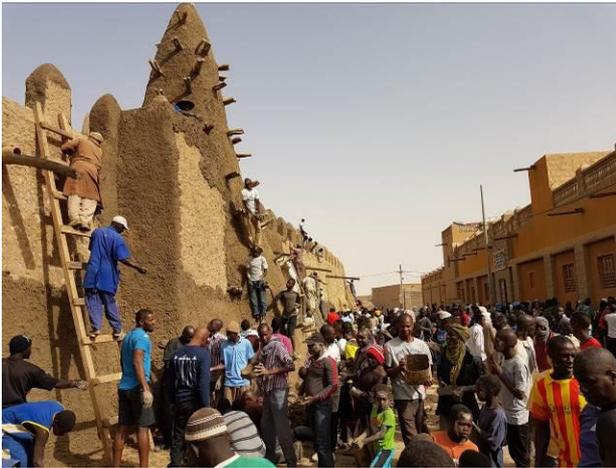
For the mosques, funding was allocated mostly to facilitate maintenance (Figure 8) and to implement preventative conservation measures. Some more important conservation works were also implemented.

Figure 8. Traditional plastering of Djingarey-ber mosque by the masons and the community of Timbuktu on February 19, 2017.
© UNESCO - Bagayoko M.

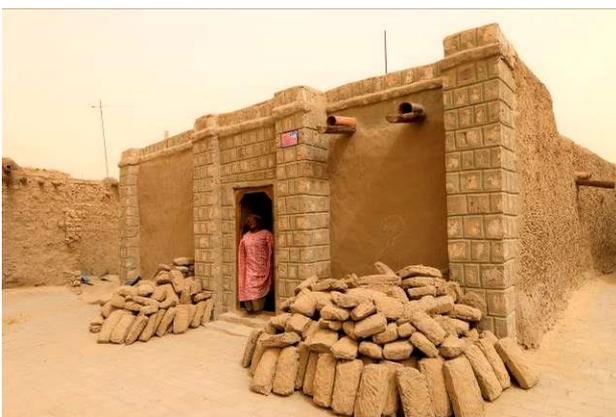
Moreover, the project managed to positively combine heritage conservation with the needs of the affected population for recovery. With the help of AIMF²⁶, a series of interventions were planned within the old town to assist a selection of inhabitants whose family structure had been affected by the occupation (directly or indirectly through family members having migrated to the south, mainly to Bamako). Two series of works were implemented, with a strict selection of the beneficiaries by representatives of the municipality and condition surveys carried out by national architects, taking into account guidance provided by the project for the purpose. This project lasted three years and made it possible to undertake preventive measures and urgent repairs at twenty-five private properties in the old city centre, contributing to both the recovery process and safeguarding the main characteristics of its historic fabric (Figure 9).

Figure 9. Restored house of widow Nana Ber, ready to carry on with additional repairs © Joffroy T. CRATERre.

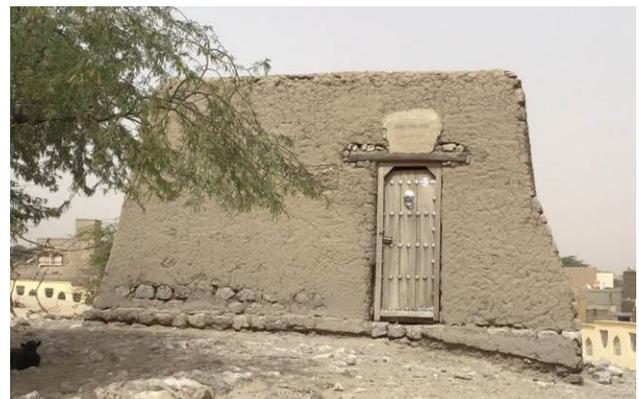
However, when looking at the state of conservation, the situation is less positive. The inside of the mausoleums is kept clean and well maintained, but the external plastering has been washed away in most places, with a serious impact on the eastern elevation, the most exposed to the driving rain during the rainy season in Timbuktu (an average of 5 heavy rains per year). In fact, after 5 years the plastering should have been done at least once at every mausoleum, but only one of them (that of Cheikh Sidi Mahamane al Foulani al Macini, located in Kabara) benefited from this traditional maintenance practice. While the masons everywhere obviously have very good knowledge of what should be done and of the “maintenance guide” drawn up within the project, it appears that nothing has been done while the condition of some of the mausoleums should be cause for their concern (Figure 10).

The responses given by the custodians here are vague, often referring to the difficulties to get the right materials for the maintenance, or saying that today maintenance should be decided by professionals and done under their supervision. Though there is probably a financial aspect linked to this “wait and see” behaviour. Even though the custodians probably receive some tips/gifts from visitors/worshippers, they are not convinced that these should fund the works or even justify the purchase of the materials needed. For their part, the masons also probably expect to be paid for the work to be done. The overall cost would not be excessive but they seem to be acting on principle.

Figure 10. Mausoleum of Cheik Alpha Moya in January 2020.
© Essayouti B. MCB.

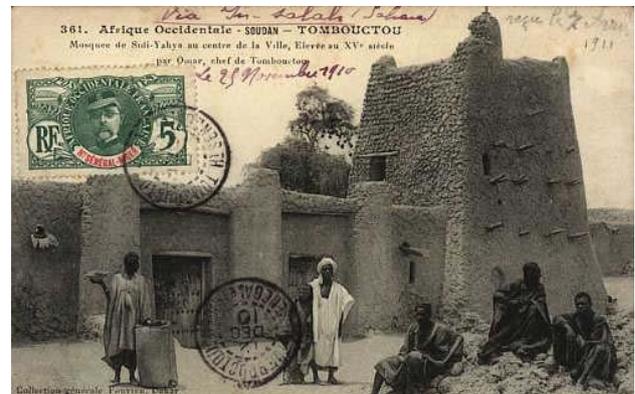
At present, the monuments in Timbuktu are living heritage. They have always evolved over time both with annual cycles (that of the rain and the erosion of the plastering it entails); that of regular maintenance (every three to five years); repairs of structural pathologies, often adding buttresses³⁰; and at times more important works, including extensions and raising of the roof structure.

Figure 11. Postcard sent on 25 November 1910 showing Sidi Yahia Mosque with serious erosion of the eastern elevation of its minaret. (Collection Fortier – archives MCT).
